PRIME Building Inspections

Home Inspection Report

123 Main Street, Anytown NJ, 01234
Inspection prepared for: John and Jane Doe
Inspection Date: 12/30/2011 Time: 1:00pm - 4:00pm
Age: 51 years (Built 1960) Size: approximately 2,007 square feet
Weather: 49 degrees. Sunny

Inspection No. SCsample1
Date of Report: January 2, 2012

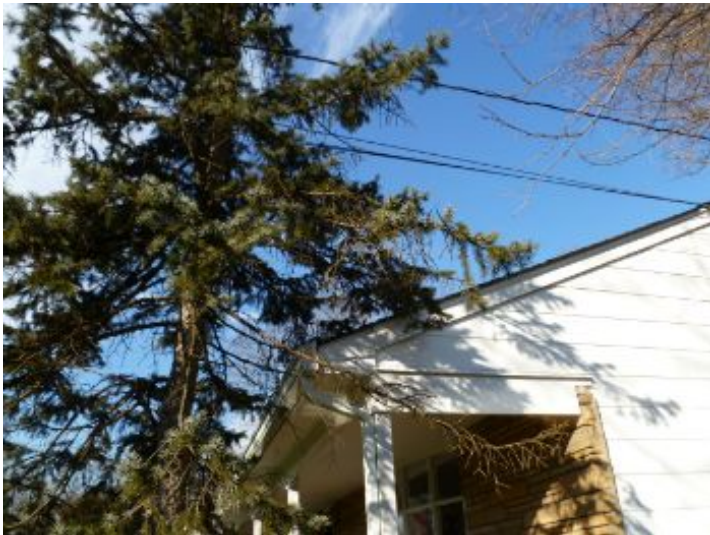
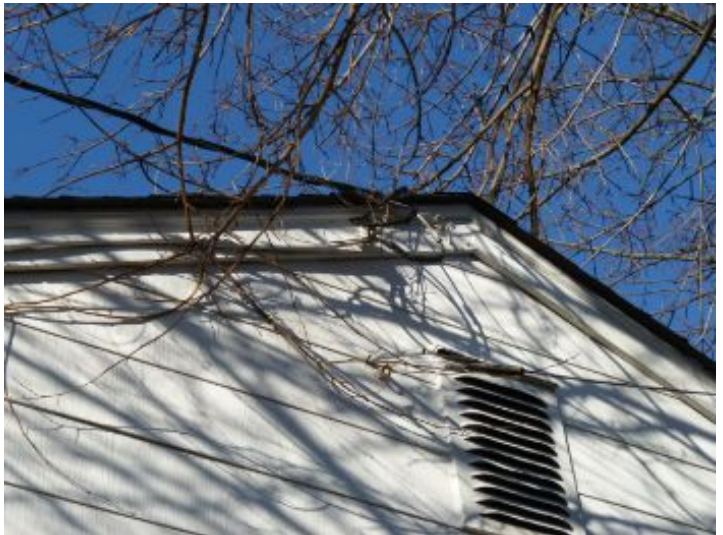
- Two large trees adjacent to the house at east side overhang or are in direct contact with the house. RECOMMEND trimming trees to prevent pathways for insects, pests, and damage to roof shingles due to abrasion and fallen branches.

Tree in contact with house

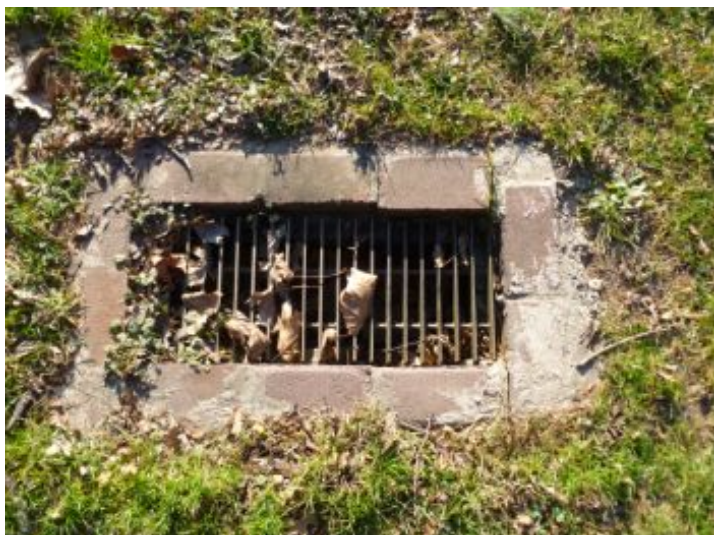
- Grading and surface drainage is generally away from foundation at most areas.
- Raised grade at retaining wall is moderately grade away from house towards east.
- Observed both area drains were filled with leaves and debris that clog and impede storm drainage. RECOMMEND removing leaves and debris.

Area drain at rear yard filled with leaves/debris

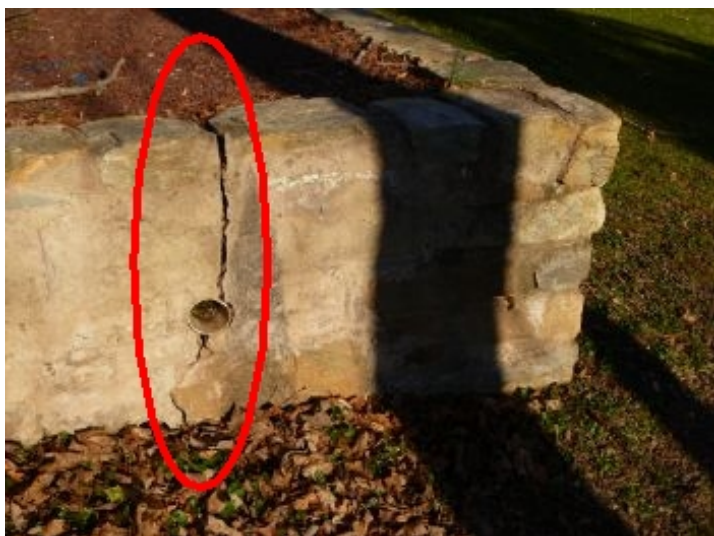
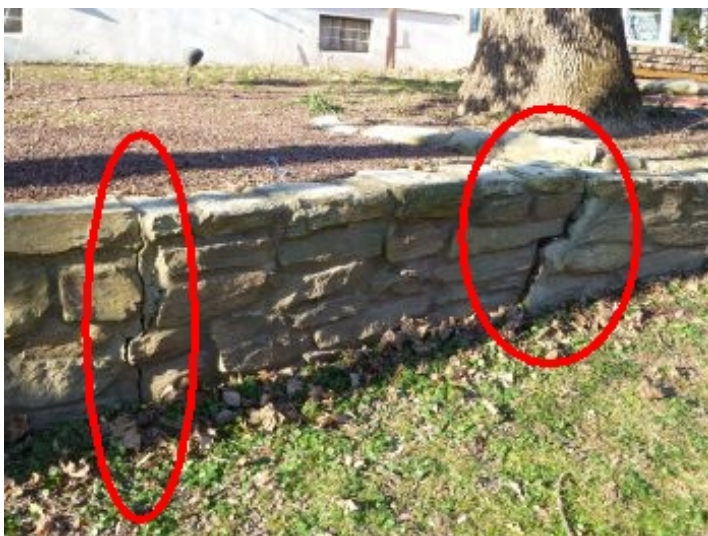
- Observed several cracks in retaining wall due to pressure exerted by tree roots. RECOMMEND monitoring for further cracking and damage.

Crack in retaining wall

Cracks in retaining wall

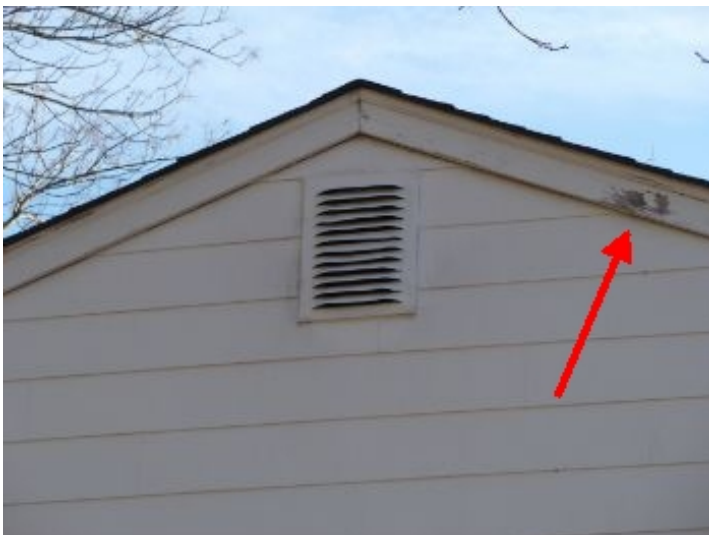
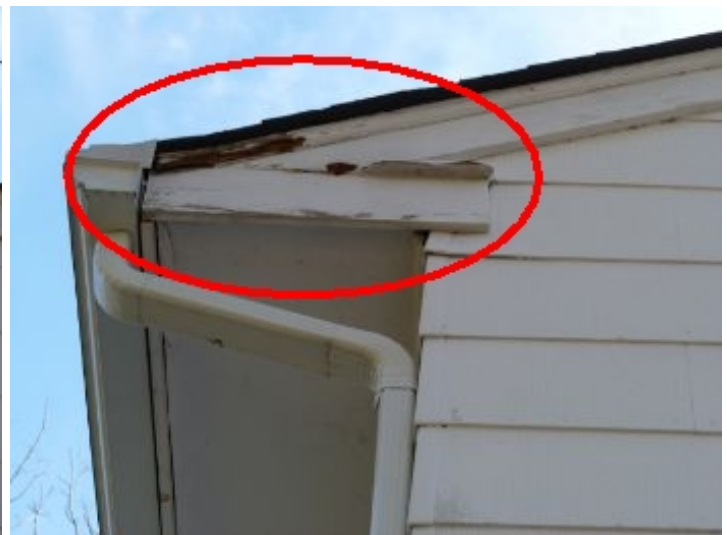
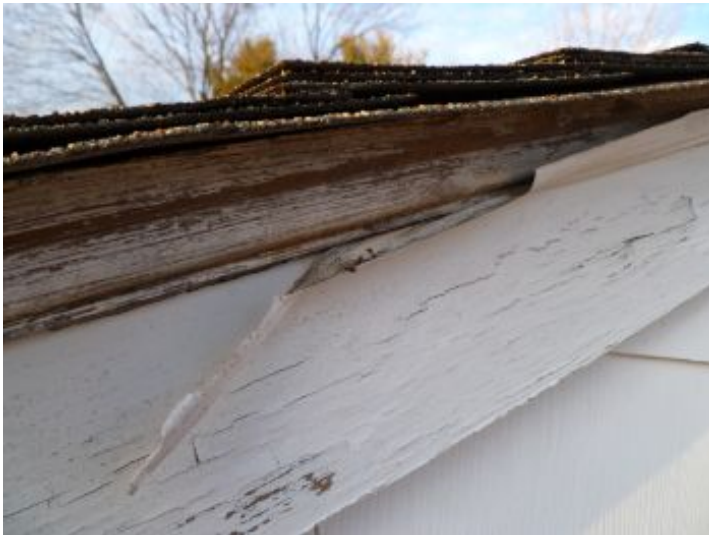
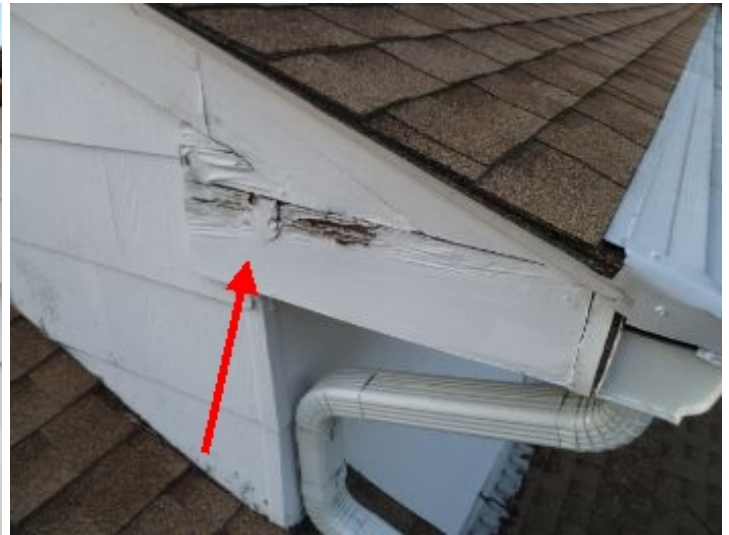
- Paint peeling at wood rake trim at gable ends of roof. RECOMMEND scrape, clean, prime and re-paint with exterior-grade paint.
- Observed damaged and rotted wood in rake trim at northeast corner and northwest corner. RECOMMEND repair or replacement top prevent water and pest intrusion.
- Observed soffit overhangs were solid wood and did not have ventilation openings to provide intake air into attic. See "Attic and Insulation" section for additional details.

Peeling paint

Peeling paint and damaged/rotted wood trim

Peeling paint at rake trim

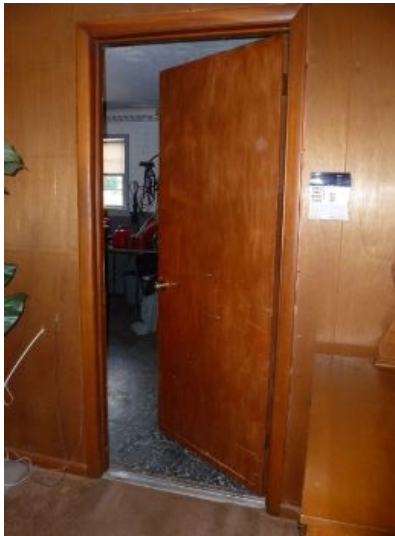
- Existing hollow-core door does not provide any insulation to prevent loss of heat and energy.
- **SAFETY CONCERN:** Current building industry and jurisdictional standards require garage entrance doors to be metal or solid wood-core with self-closing hinges to protect against fire hazard in the Garage. HIGHLY RECOMMEND replacing door and hinges to meet compliance with jurisdictional requirements

Existing garage entrance door to be replaced

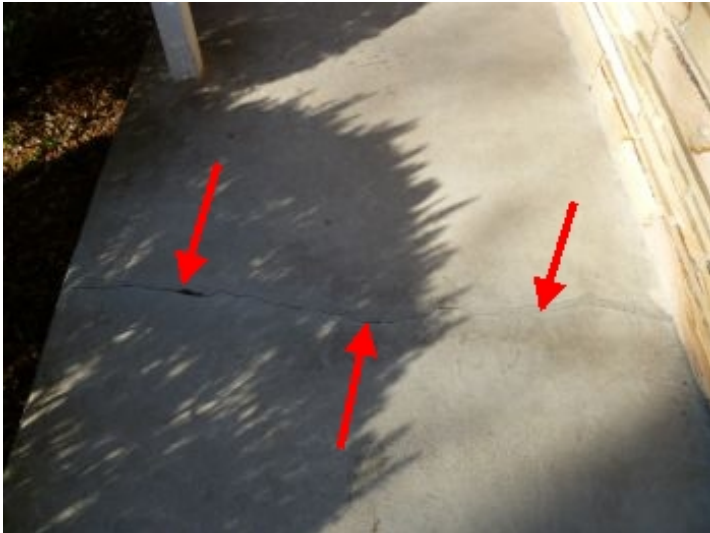
- Front porch is in good functional condition with normal wear and tear with one minor non-structural crack in concrete. RECOMMEND filling crack with epoxy or concrete filler to prevent water entry that can expand crack when water freezes.
- 12" high concrete step between front porch and walkway is high. RECOMMEND adding one 6" high x 12" deep intermediate step for enhanced safety.

Minor non-structural crack in front porch

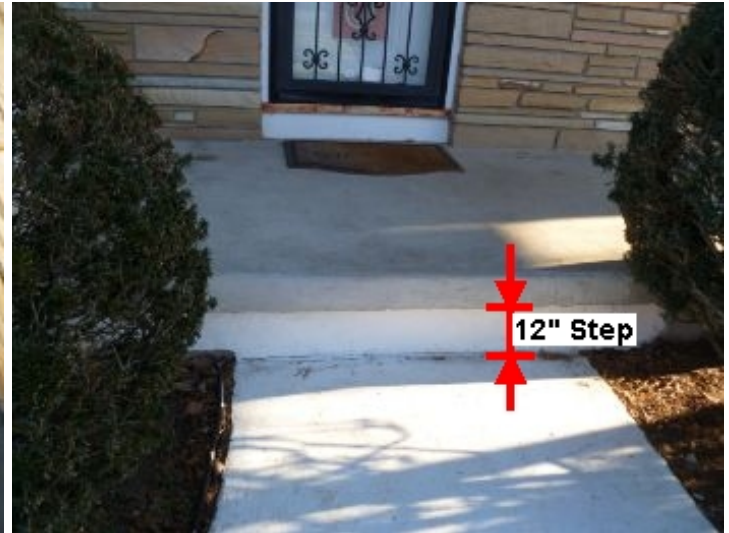
12" step too high

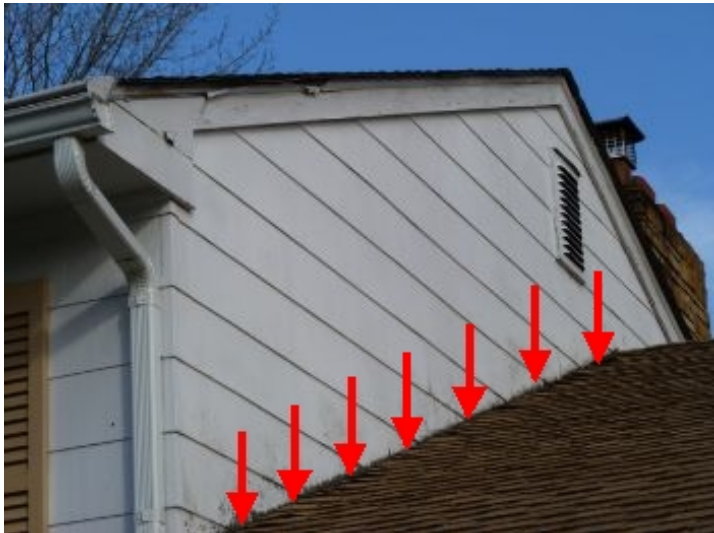
- Description:
- Standard asphalt composition shingles
- Age:
- Approximately 5 years
- Observations:
- Roof covering is in functional condition with normal wear and tear, except as noted below.
 - Continuous line of buckled shingles along flashing at low roof and east wall.
- RECOMMEND engaging a qualified roofing contractor to repair/remediate buckling to prevent water intrusion to interior.

Buckling shingles

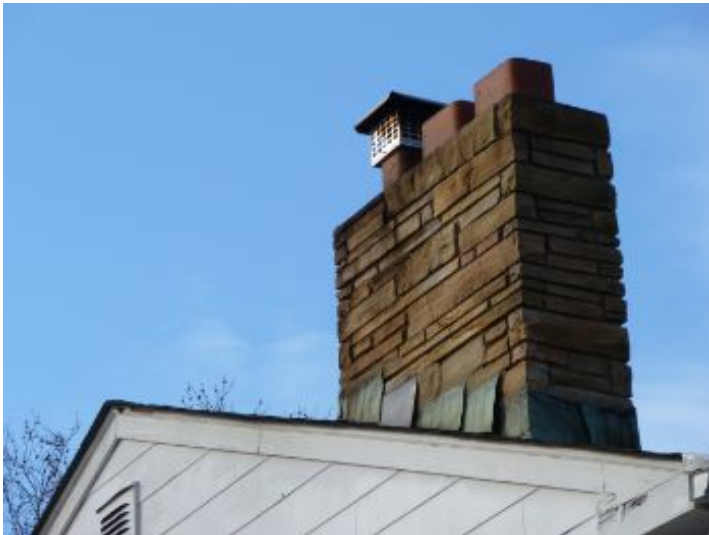
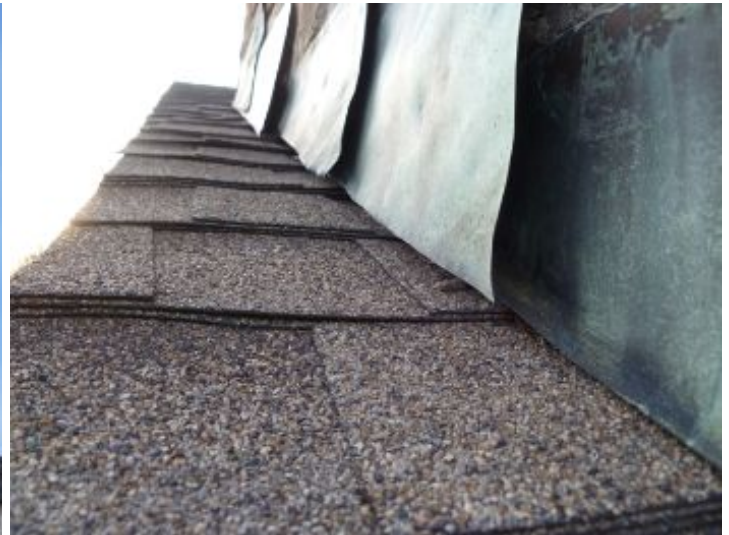
- Materials:
- Metal
- Observations:
- Where exposed for inspection, roof flashing is in functional condition with normal wear and tear, except at chimney as noted below.
 - Horizontal legs of chimney step flashing were improperly cut during previous re-roofing and can lead to potential water intrusion. New metal flashing was inserted behind existing step flashing. Tops of new flashing are not sealed and old flashing were not secured and sealed. HIGHLY RECOMMEND engaging a qualified roofing contractor to professionally repair and/or replace chimney flashing to prevent water intrusion.

Improper chimney flashing

Horizontal legs cut and open seams at chimney flashing

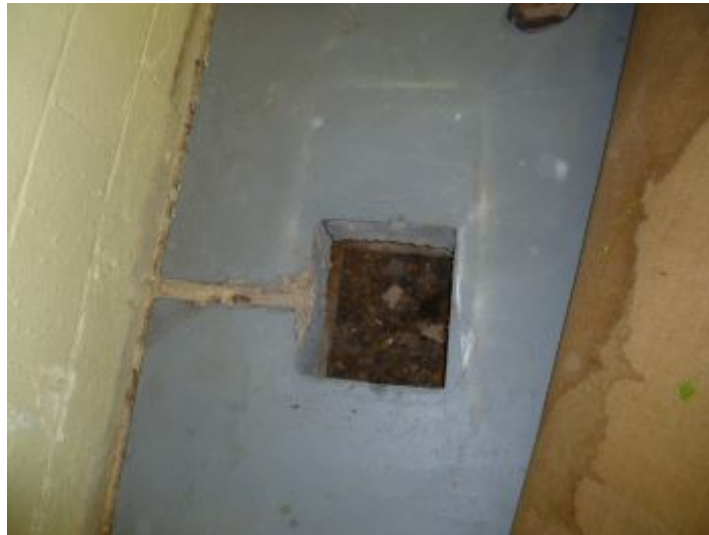
- A shallow drywell pit (approximately 10"x12") beneath carpet near northeast corner of basement was exposed by Seller's son. Pit was used to collect water from perimeter "french drain" and recharged back into ground. No conventional sump pit and sump pump were found.

Shallow drywell pit in Basement

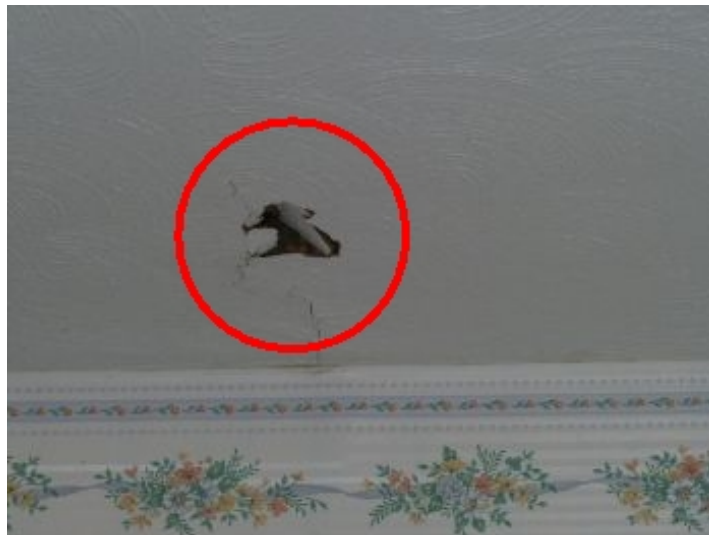
- Walls and ceilings are in functional condition with normal wear and tear, except as noted below.
- Observed hole damage in ceiling above toilet in Master Bathroom #1. Damaged area was observed to be non-standard thin ceiling material - not drywall. RECOMMEND engaging a qualified contractor for further evaluation and to replace ceiling material with drywall to improve structural integrity and to minimize heat/energy loss to attic.

Hole damage in Master Bathroom#1

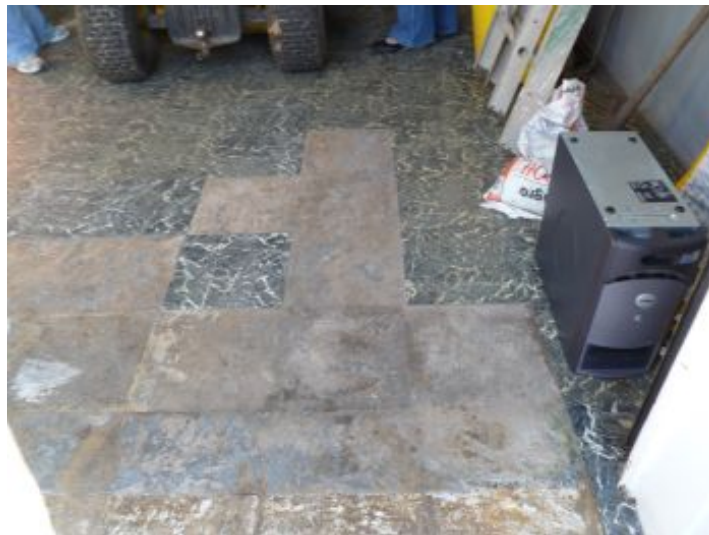
- Several vinyl floor tiles in Garage are missing.

Missing vinyl tile at Garage floor

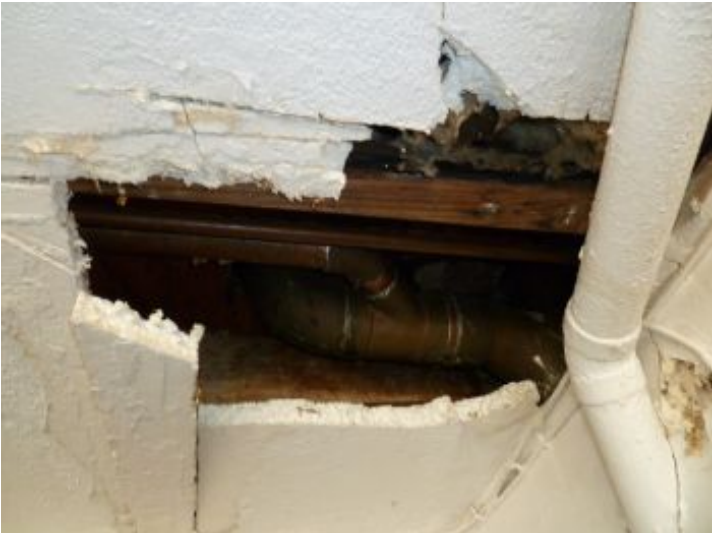
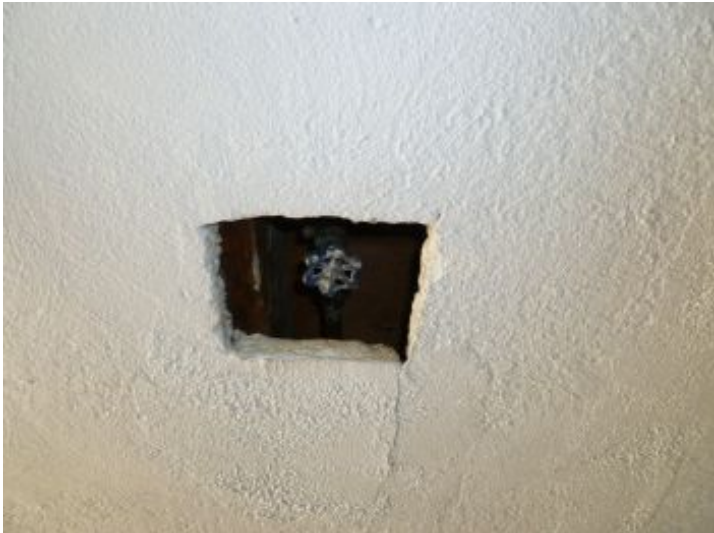
- **SAFETY CONCERN:** There is no separation barrier in ceiling between Garage and Bedroom to meet current building industry and jurisdictional requirements. **HIGHLY RECOMMEND** engaging a qualified contractor to cover rigid foam insulation with 5/8" Type X drywall for enhanced fire safety and to meet compliance with local jurisdictional requirements.
- **FIRE HAZARD:** Ceiling material in Garage was observed as rigid foam insulation. This material is highly flammable when exposed without any cover material. **HIGHLY RECOMMEND** engaging a qualified contractor to cover rigid foam insulation with 5/8" Type X fire-resistant drywall.

FIRE HAZARD: Exposed rigid foam insulation in Garage

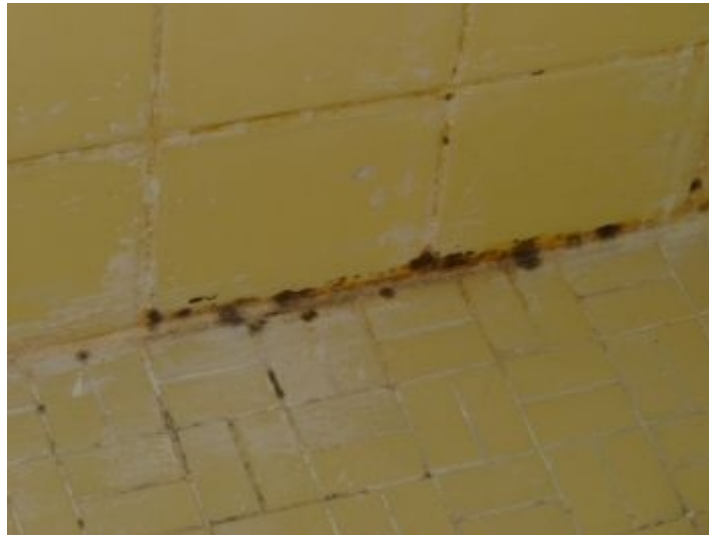
- Shower is in functional condition with normal wear and tear, except as noted below.
- Suspect mold observed at base of shower. Per Client's authorization, mold sampling was collected via surface swab for analysis by certified laboratory.

Suspect mold in shower stall

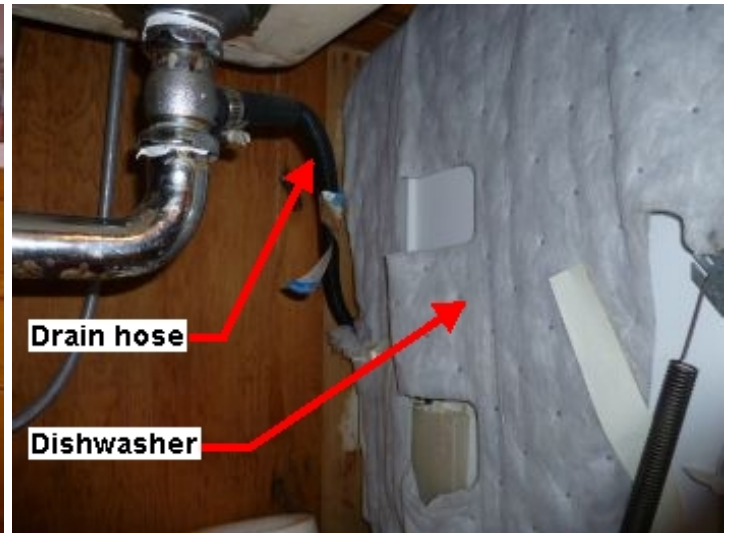
- Test-operated and functioned normal.
- **SAFETY CONCERN:** Based on visual inspection, drain hose was installed without a "high loop" to prevent siphoning of dirty water into dishwasher. This is a potential health hazard. HIGHLY RECOMMEND confirmation of high loop behind dishwasher unit. If no high loop is present, re-install of drain hose with high loop or provide installation of air gap device.

Dishwasher drain hose without high loop

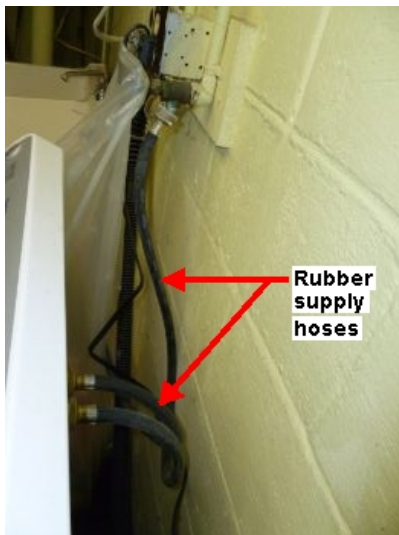
- Test-operated and functioned normal.
- Observed rubber supply hoses were used and age could not be determined to estimate remaining service life. Due to to high water pressure (85 psi), RECOMMEND replacement with braided stainless steel hoses for prevention against water bursts.

Rubber supply hoses

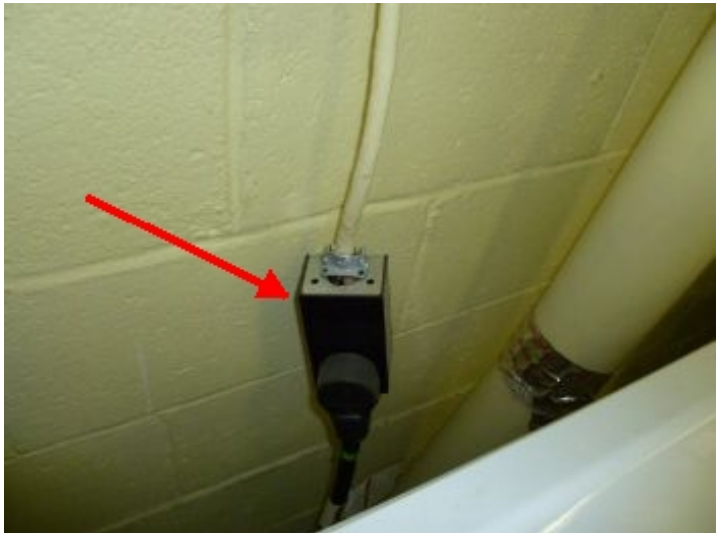
- Dedicated 220 volt electric receptacle outlet box was not permanently secured to wall. Current electrical and jurisdictional standards require permanent installation of outlet box. RECOMMEND engaging a qualified electrical contractor to provide permanent installation of outlet box.

Loose outlet box for clothes dryer

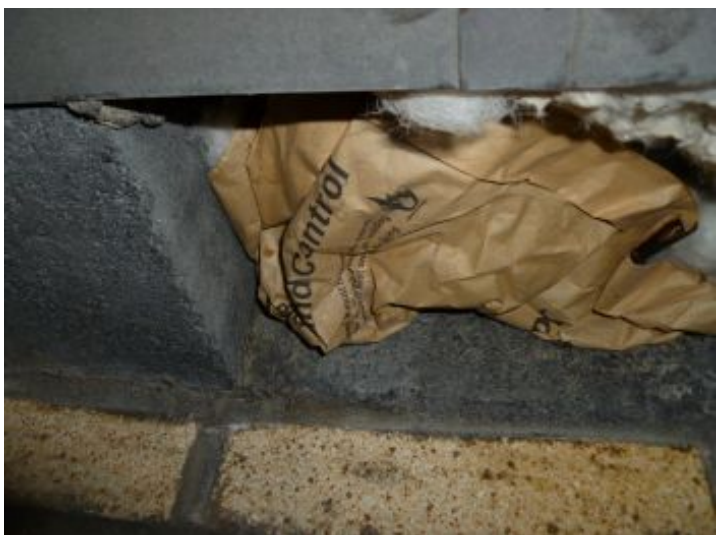
- RECOMMEND having flue and damper cleaned and inspected by a qualified and experienced chimney sweep before use.
- Observed kraft-faced batt insulation was stuffed into flue opening of built-in oven/grille. HIGHLY RECOMMEND immediate removal to prevent accidental fire during use.

Remove kraft-faced insulation from built-in grill/oven

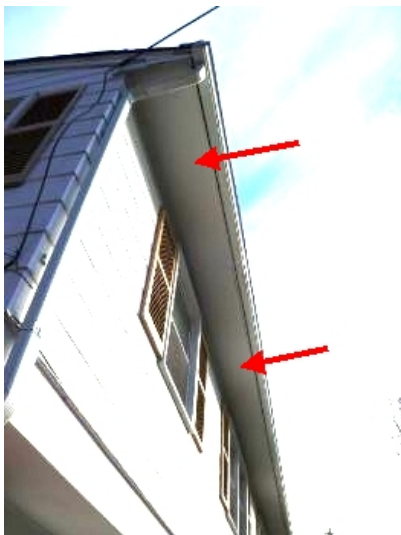
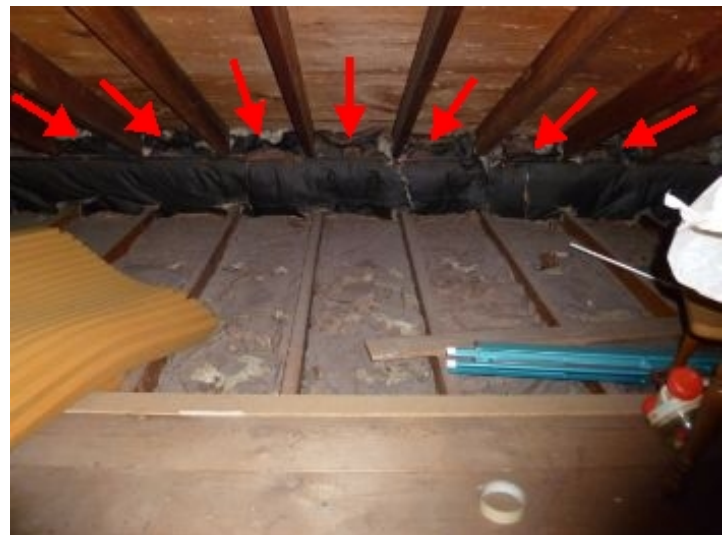
- Attic ventilation is in poor condition because there is no intake air ventilation to replace air that is exhausted through gable vents.
- Existing attic ventilation is inadequate and improper. Improving attic ventilation may help avoid ice damming and increase the useful life of the roof covering. RECOMMEND engaging a qualified contractor to install soffit vents and to remove insulation blockage at wall/soffit intersection to provide free-flow air ventilation.

No ventilation openings in soffits for intake air

Blockage prevents any free-flow soffit ventilation

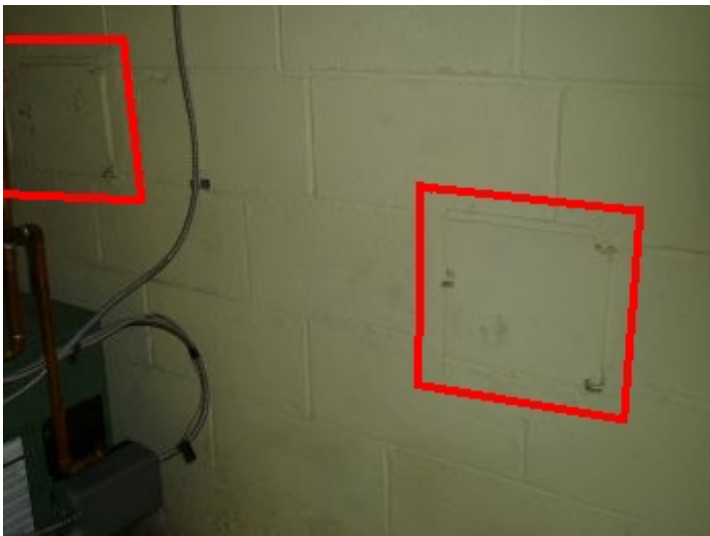
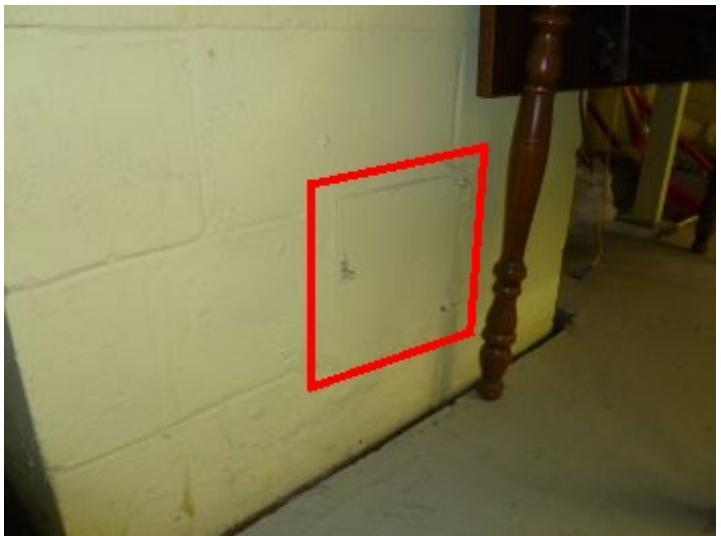
- RECOMMEND engaging a qualified and experienced chimney sweep to inspect and clean all chimney flues for safe and efficient operation.
- Ashpit pit cleanout doors were stuck in place and could not be opened for inspection. RECOMMEND engaging a qualified and experience chimney sweep to open cleanout doors and clean ashpits as necessary.

Asahpit cleanout doors stuck in place

Ashpit cleanout door stuck in place

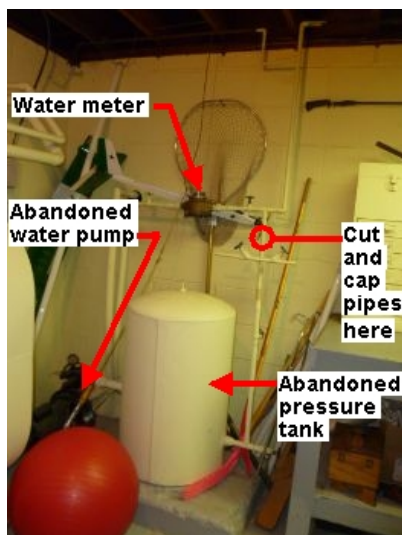
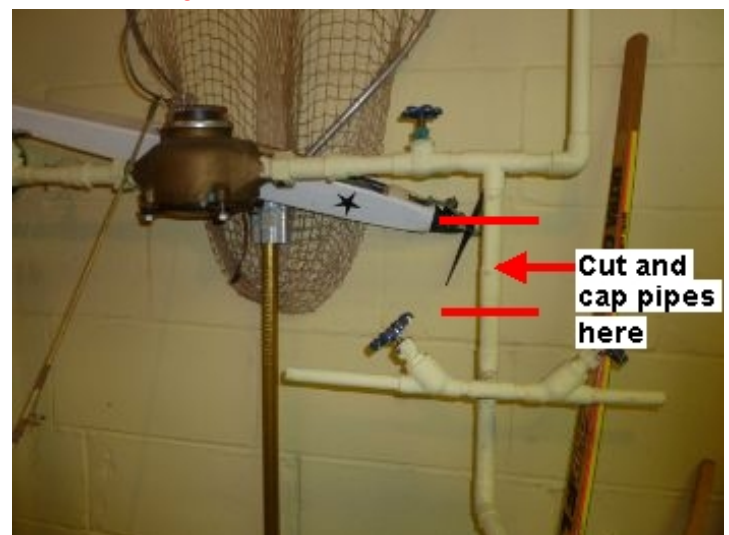
- No deficiencies observed at the visible portions of the supply piping.
- Water pump and pressure tank for abandoned private water supply system is still connected to domestic water supply in house. HIGHLY RECOMMEND engaging a qualified licensed plumbing contractor to evaluate pipes for abandoned private water system be cut from active public water supply to prevent cross-contamination of untreated water into domestic water for drinking and domestic use.

Cut & separate water supply sources

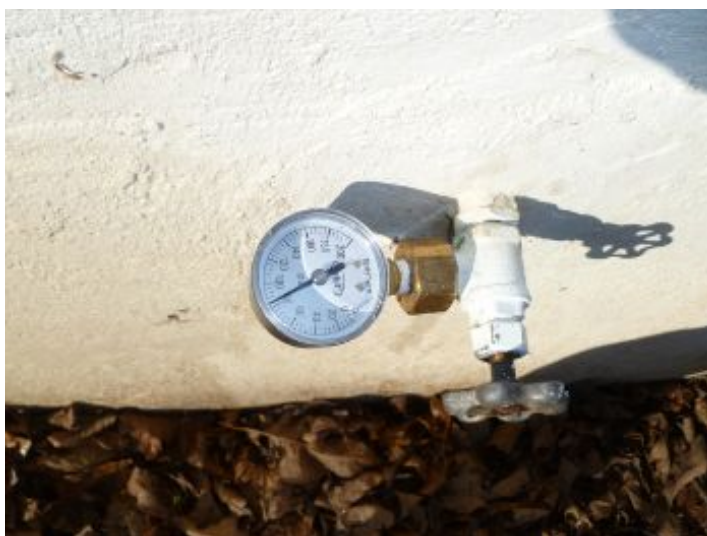
- The water pressure was tested and was found to be over 80 psi and is considered moderately high. The plumbing system may be prone to leaks in piping, fittings are other components. It is advised to install a pressure regulator to reduce the pressure under 80 psi. Most jurisdictions require an expansion tank if a regulator is installed.

85 psi water pressure

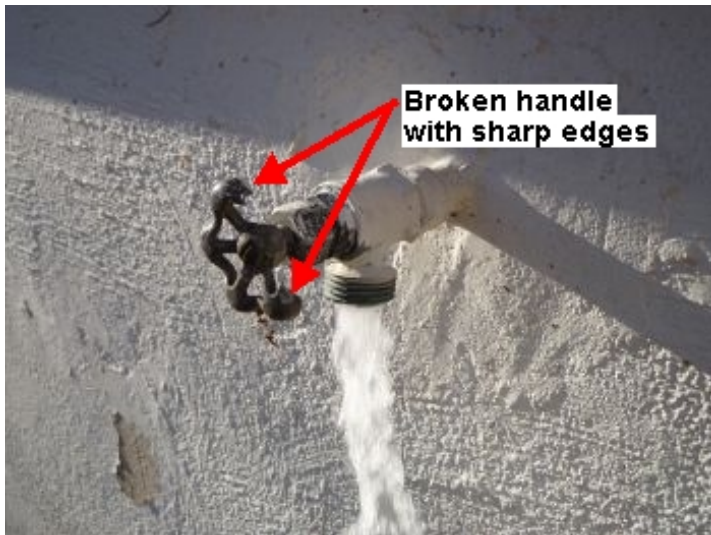
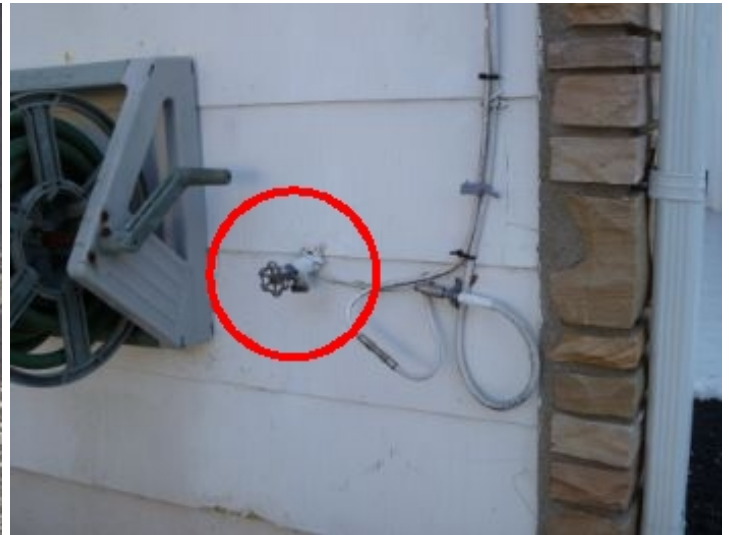
- Hose bibb at rear of house has broken handle with sharp edges that can cause personal injury when turning water on. RECOMMEND engaging a qualified licensed plumber to replace hose bibb.
- Hose bibb at side of Garage was not functional. RECOMMEND engaging a qualified licensed plumbing contractor to repair or replace hose bibb.
- RECOMMEND engaging a qualified licensed plumbing contractor to replace all standard hose bibbs with frost-proof anti-siphon hose bibbs to prevent potential introduction of fertilizers and other chemicals from entering water system.

Hose bibb with broken handle

Non-functional hose bibb

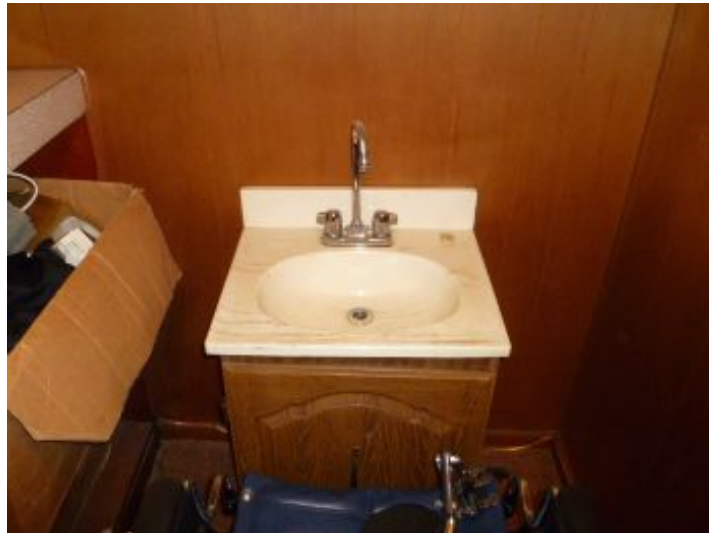
- Bathroom sinks are drop-in ceramic sinks.
- Kitchen sink is a drop-in stainless steel bowl.
- Sink at Bar is non-functional (no water service).

Non-functional sink at Bar

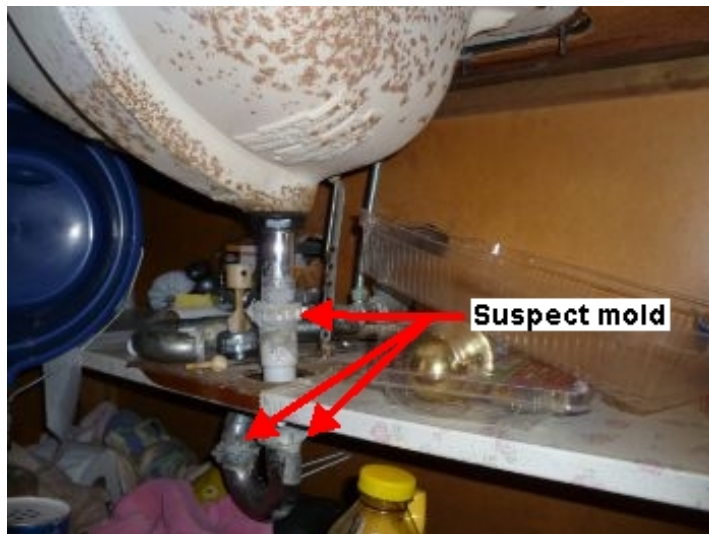
- Water was run through the fixtures and drains. Functional drainage was observed.
- Suspect mold observed at P-trap in Bathroom #3 and cabinet. Per Client's authorization, mold sampling was collected via surface swab for analysis by certified laboratory.

Suspect mold in Bathroom #3

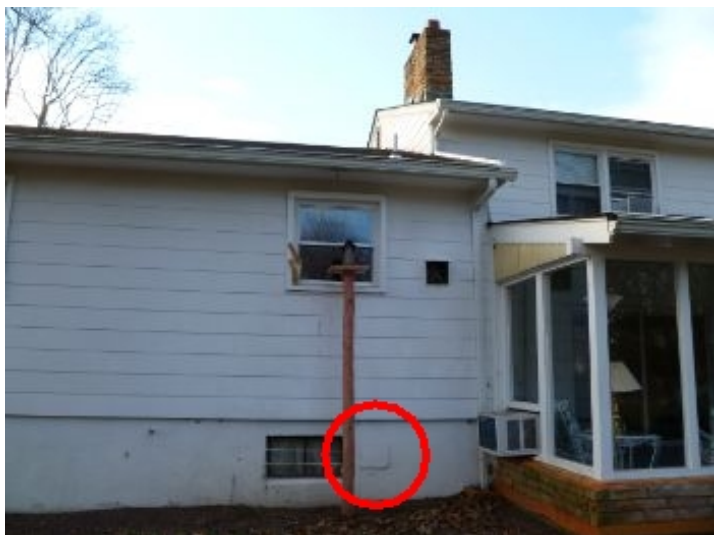
- Observed fresh air inlet (FAI) at main house trap was permanently blocked on the exterior. HIGHLY RECOMMEND engaging a qualified licensed plumbing contractor to evaluate this condition for functional plumbing operation and safe/healthy occupancy.

Fresh air inlet permanently sealed

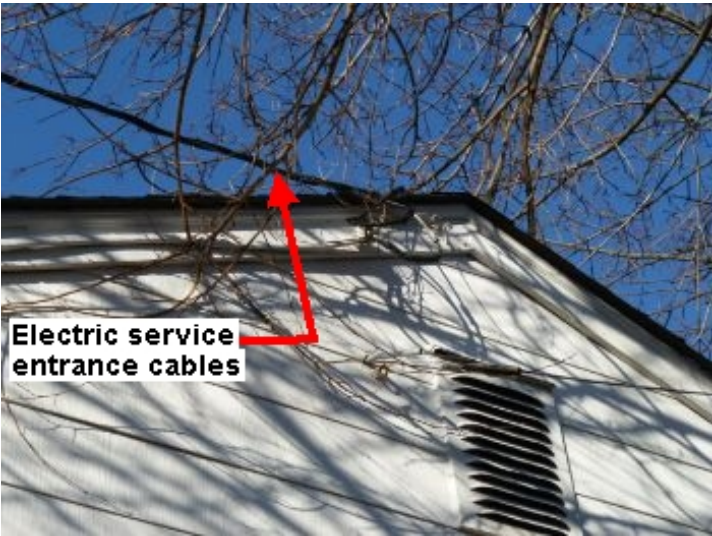
- Description:
- Overhead service with meter located on east side of house.
- Observations:
- Service entrance cables are touching trees, RECOMMEND review by the local Utility Company for repair as necessary.
 - Observed a double electric meter box with one active electric meter. This is an indication of two previous electric services entering the house in the past.

Service entrance cables in contact with trees

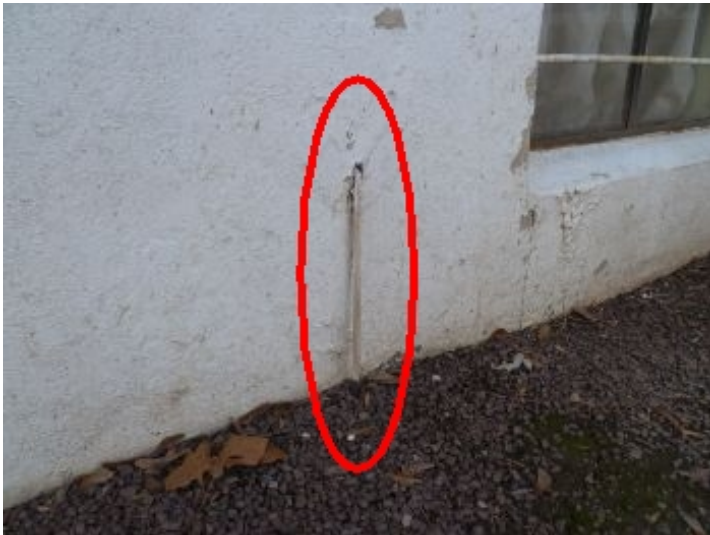
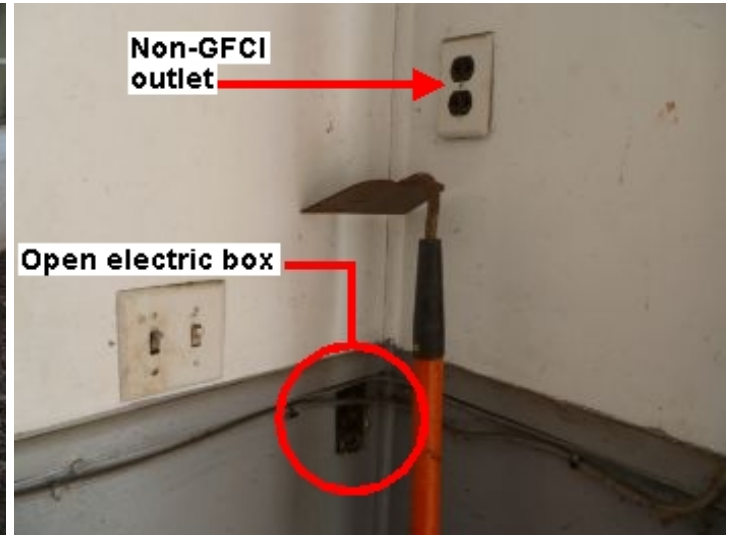
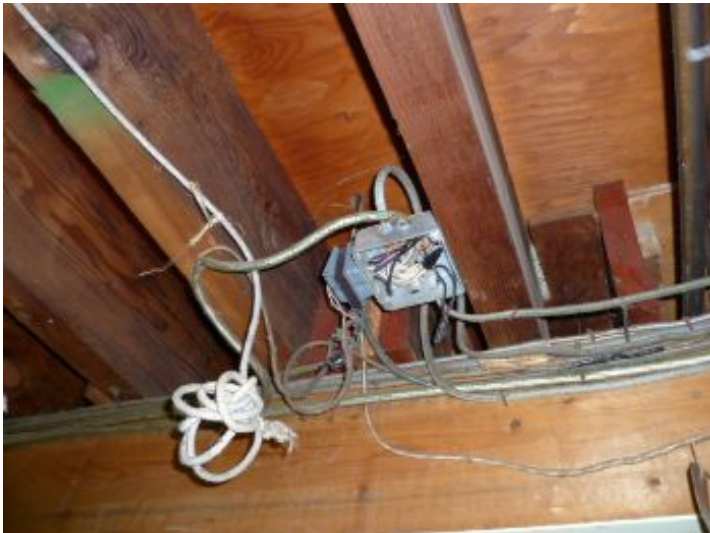
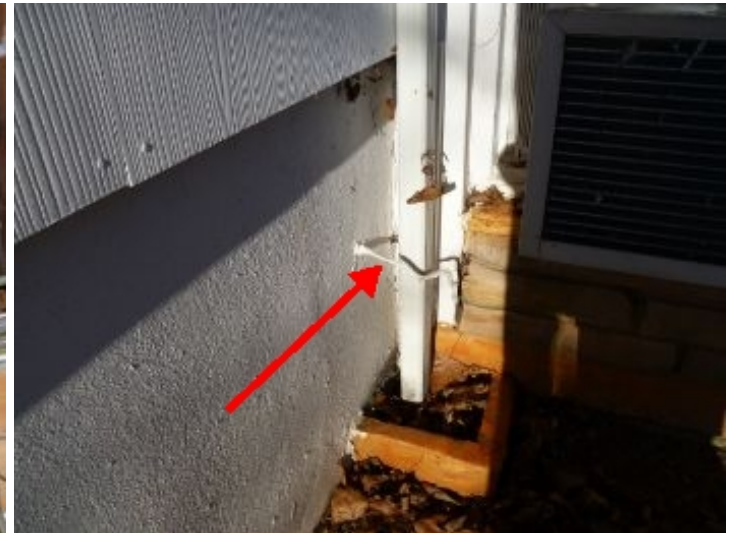
- SAFETY CONCERN: Observed ungrounded distribution wiring throughout house. HIGHLY RECOMMEND engaging a qualified and licensed electrical contractor for further evaluation and converting electrical system to a fully grounded system for safe operation and compliance with current electrical industry standards and jurisdictional requirements to protect against electric shock.

Exposed/unprotected cable on exterior and underground

Electrical defects

Open electric box in Basement

Exposed/unprotected cable on exterior

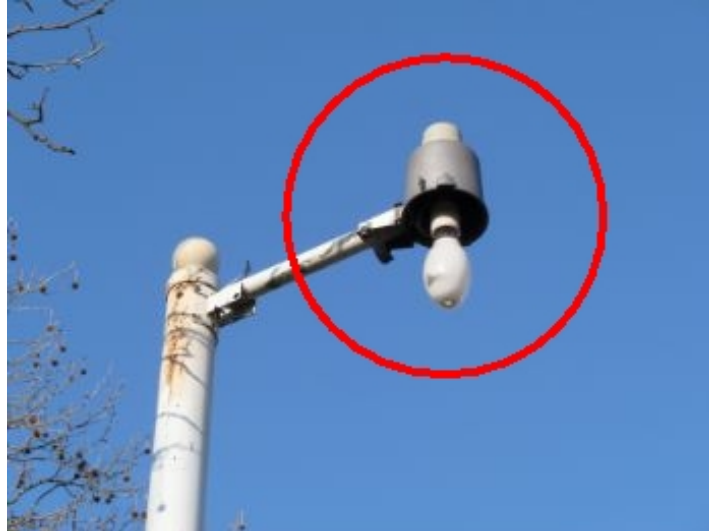
- Globe or lens missing from driveway light.

Missing globe or lens at driveway light pole

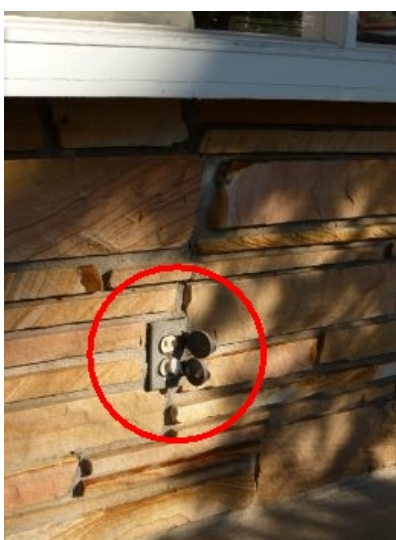
• **SAFETY CONCERN:** There is no GFCI protection at the kitchen, garage, bathrooms and exterior. This is a potential electric shock hazard. **HIGHLY RECOMMEND** engaging a qualified and licensed electrical contractor to install GFCI devices for protection against fatal shock.

Non-GFCI receptacle at exterior

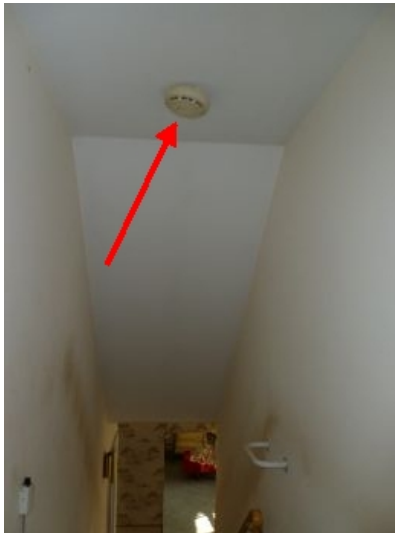
• Smoke detector was tested by pushing "TEST" button. Audible alarm sounded but TEST button remained stuck in position. Defective unit was removed. **HIGHLY RECOMMEND** replacing smoke detector unit.

Defective smoke detector
