PRIME Building Inspections

Home Inspection Report

999 Main Street, Anytown NJ, 01234
Inspection prepared for: John and Jane Doe
Inspection Date: 8/27/2011 Time: 11:00am - 4:00pm
Age: 1950 (61 years) Size: approximately 4,700 sq.ft.
Weather: 76 degrees. Rain

Inspection No. SCsample3
Report Date: August 30, 2011

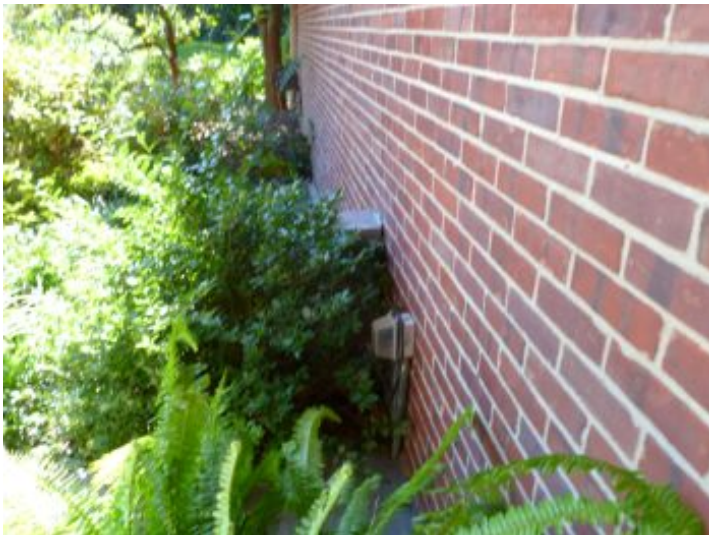
- Vegetation too close to the building can cause harm through root damage to the foundation, branches abrading the roof and siding, leaves clogging rain gutters and overgrown shrubs providing a path for moisture and insects into the home and other structures.
- RECOMMEND having vegetation trimmed, pruned, or removed from affected areas, and regular homeowner monitoring and landscaping maintenance thereafter.

Vegetation in close contact with building

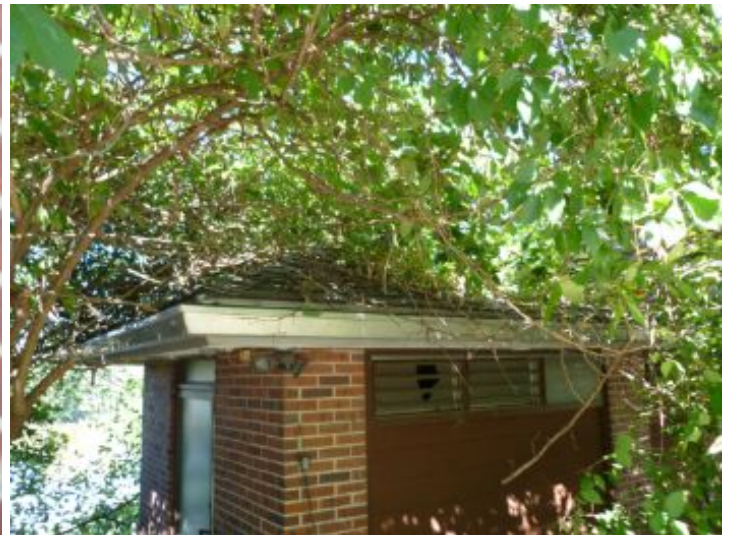
Trees and other vegetation on Pool House

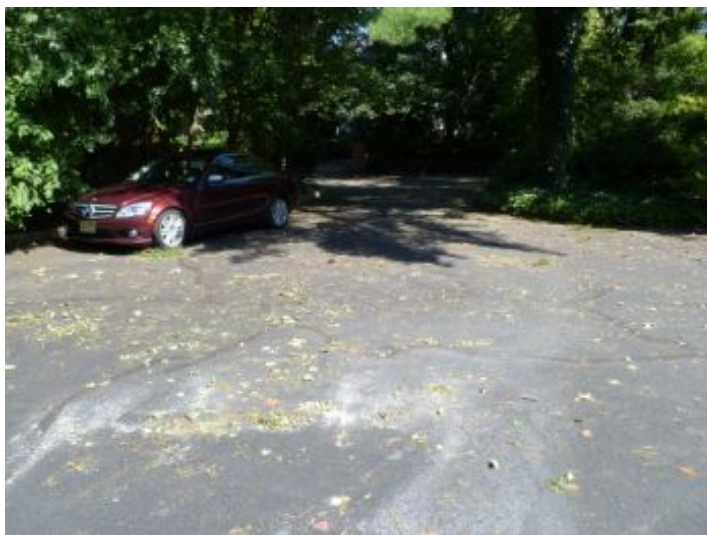
- Driveway is in functional condition with no major visible damage or material defects.
- IMPROVE: Recommend annual sealcoating to preserve asphalt for extended life.

Sealcoat asphalt driveway

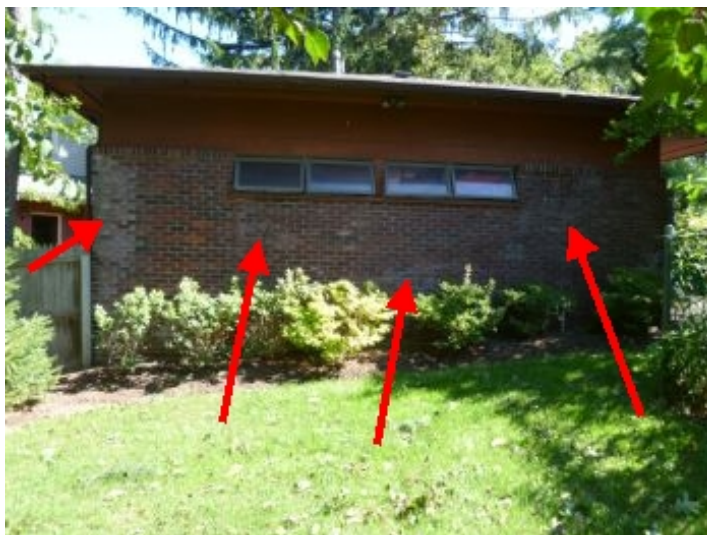
- Building skin is in good functional condition with normal wear and tear.
- RECOMMEND light powerwashing for improved appearance.
- Observed efflorescence on brick at Detached Garage. RECOMMEND washing with a diluted solution of light muriatic acid and light powerwashing.

Efflorescence on brick at Detached Garage

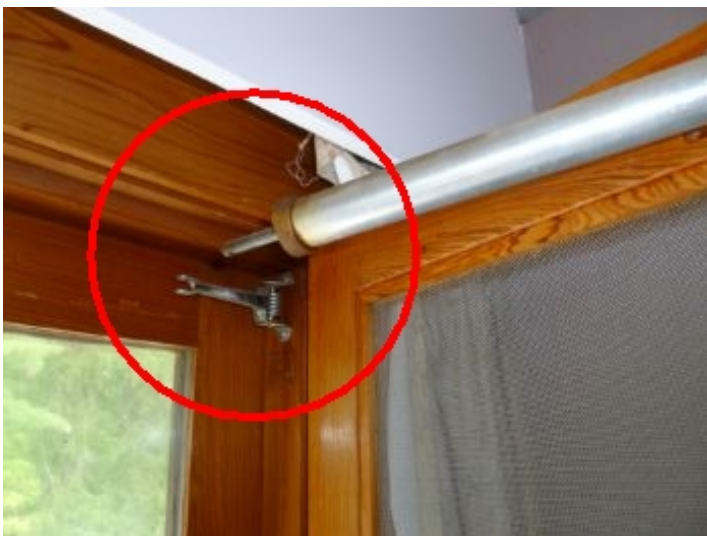
- Door at Bedroom #4/Rooftop Patio does not operate smoothly. RECOMMEND adjustments for smooth operation and repair closer for screen door.
- Fire-rated Garage entrance door is missing self-closing device required by code to maintain continuous fire-separation. RECOMMEND replacing standard hinges with UL-approved spring hinges to provide self-closing function to meet code.

Auto closer at exterior door in Bedroom #4 is defective

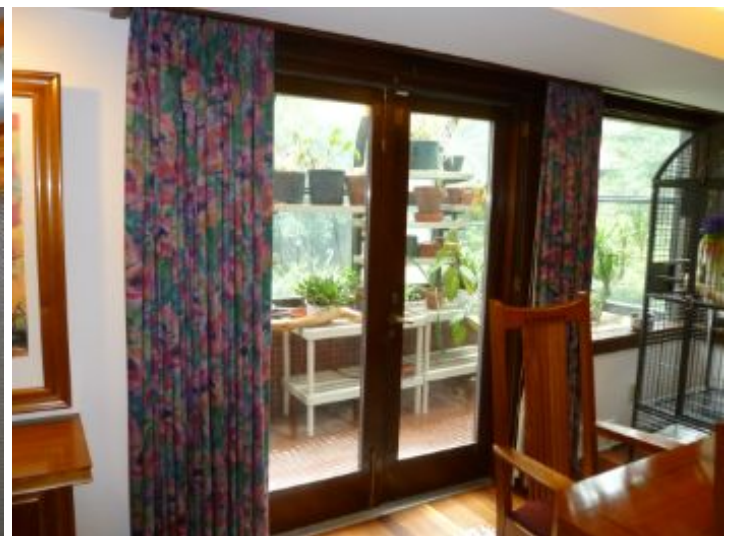
- Exterior doors are in functional condition, except as noted below.
- French doors at Dining Room/Greenhouse do not close properly. RECOMMEND realignment of tongue & groove weatherstripping and other adjustments for smooth operation and proper function.

Greenhouse door requires adjustment

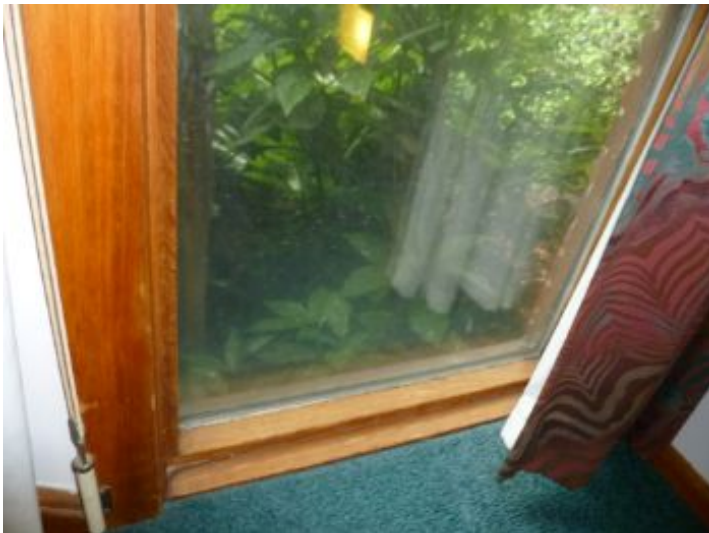
- Window glass within 18" of walking surface do not have tempered glass for safety protection, as required by current codes. RECOMMEND consultation with local building official to permit continuance of use; or replace existing glass with tempered glass.

No tempered glass

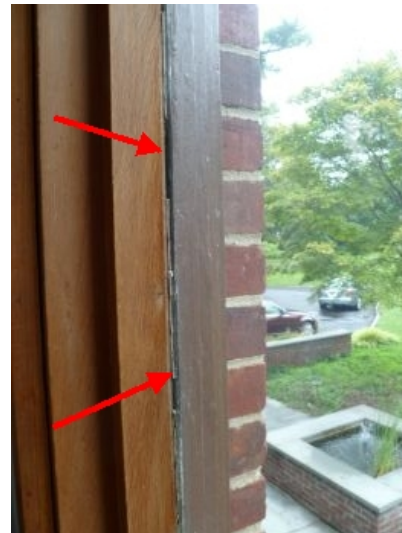
- Observed glazing putty at fixed window at East Stair between Level 3 and Level 5 was cracked and loose. RECOMMEND engaging a qualified glass contractor to repair this condition. Also observed window sill and frame at this window had minor water damage that is likely due to leakage or condensation from glass. RECOMMEND monitoring this window after repairs have been made to re-putty the glass.

Loose putty. No tempered glass.

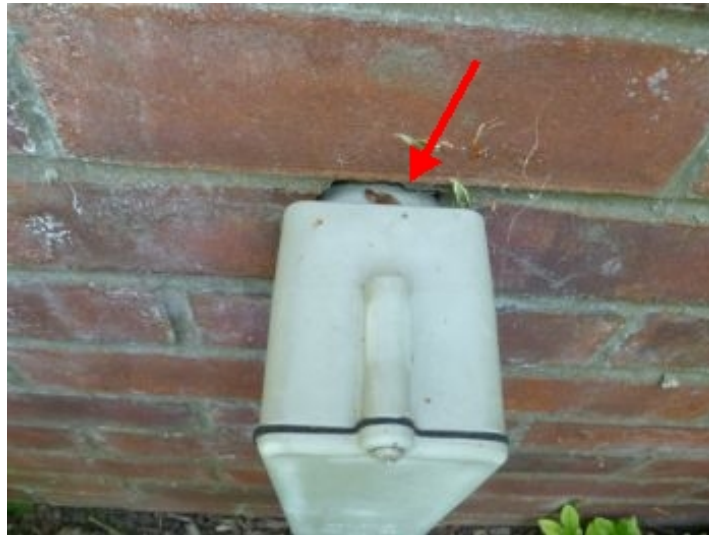
- Caulking and sealants are in functional condition with normal wear and tear. Some wall penetrations require caulking.

Caulk to prevent water entry

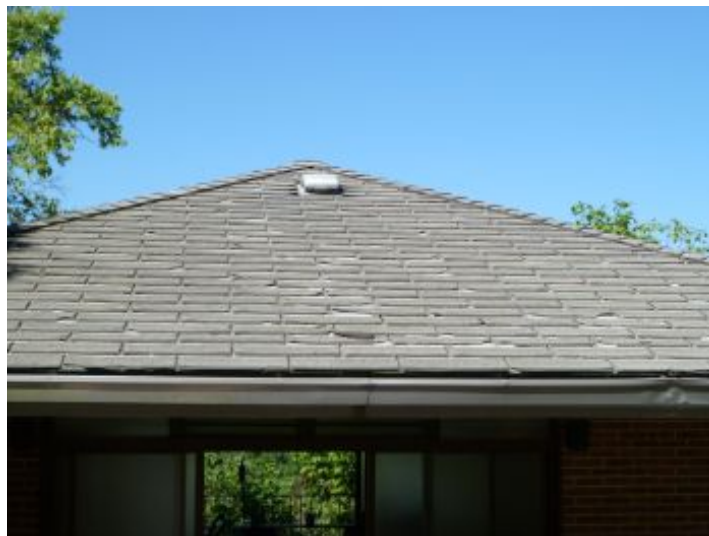
- Slate roof is in functional condition with no visible indications of water intrusion or any major visible damage or material defects, except minor algae growth over Living Room portion. RECOMMEND light powerwashing with hose spray directed downhill onto tile surfaces.
- Asphalt composition shingles at Detached Garage is in good functional condition with no major visible damage or material defects.
- Roof shingles over Pool House are in poor condition and has exceeded its useful service life. RECOMMEND replacement of roof shingles.

Roof shingles at Pool House at end of service life

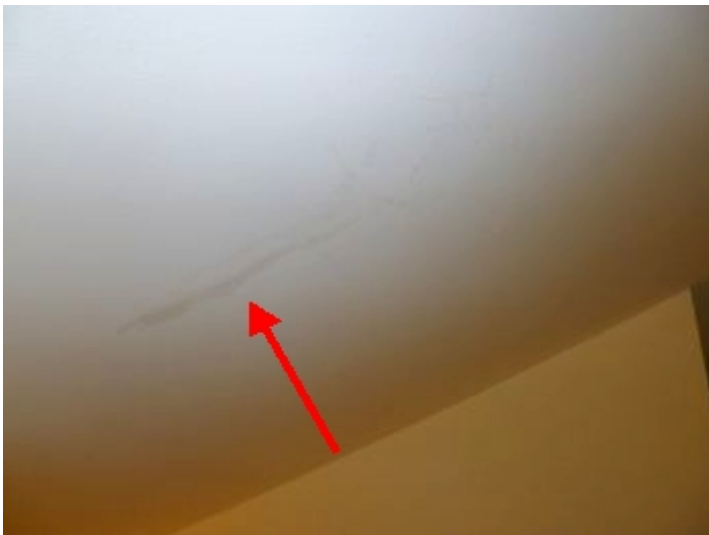
- Walls and ceilings are in good functional condition with no major visible damage or material defects, except as noted below.
- Water stain observed in Entrance Foyer ceiling above West Stairs at Level 5. This appears to be an old stain. RECOMMEND monitoring for moisture and active leaking. Prime area using stain-inhibiting primer and repaint ceiling to match surrounding surfaces.
- Minor cosmetic cracks were observed in some areas. This is normal and acceptable under most circumstances.

Water stain in ceiling above West Stair

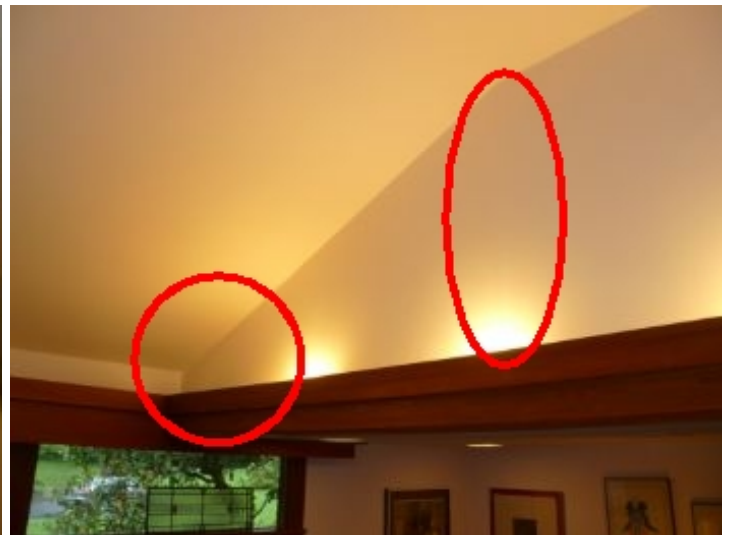
Minor cosmetic cracks

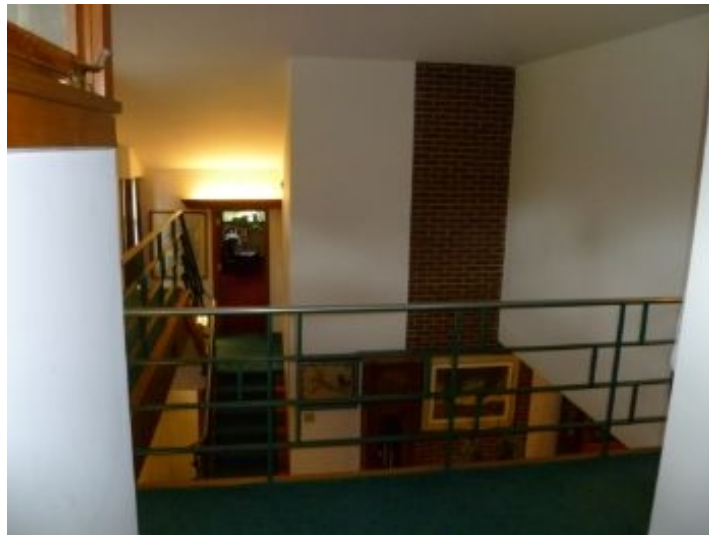
<i>Interior</i>		
Page 24 Item: 5	Stairs and Railings	<ul style="list-style-type: none">• SAFETY CONCERN: Guardrail over Level 5 Balcony was approximately 33" high and does not comply with current codes for 36" minimum height and non-passage of a 4" diameter sphere through guardrail. RECOMMEND consultation with local building official to permit continuance of use based on "grandfathering" of design.
Page 25 Item: 9	Garage Fire Separation Wall and Ceiling	<ul style="list-style-type: none">• SAFETY CONCERN: Window in (Attached) Garage wall is not compliant to current codes (NJ International Residential Code R302.6) for required fire separation between garage and dwelling portion. HIGHLY RECOMMEND engaging a qualified contractor to permanently cover window with 1/2" gypsum board on Garage side for safe and code-compliant occupancy.• SAFETY CONCERN: Current codes (NJ International Residential Code R302.5.2) require ducts penetrating the Garage fire separation wall be constructed of minimum No. 26 gage sheet steel or other approved material. The dryer vent duct material is undetermined. Also, the sprayed-on expandable foam insulation does not appear to comply with code to resist free passage of flame and other products of combustion (NJ International Residential Code R302.11, Item 4). HIGHLY RECOMMEND engaging a qualified and licensed HVAC contractor to evaluate dryer duct material and fireblocking material for compliance to code; and to remove and replace dryer vent and fireblocking for safe occupancy, compliance with code, and proper function.• SAFETY CONCERN: Observed air supply grille in Garage ceiling. NJ International Residential Code R302.5.2 prohibits openings in ducts that penetrate the fire separation wall between the garage and dwelling. This is a safeguard to avoid potential backdraft of carbon monoxide and other lethal gases entering the dwelling portion from the garage. HIGHLY RECOMMEND engaging a qualified and licensed HVAC contractor to remove, terminate and properly cap the duct for safe and code-compliant occupancy.

- Stairs and handrails are in good, safe and functional condition with no major visible damage or material defects.
- **SAFETY CONCERN:** Guardrail over Level 5 Balcony was approximately 33" high and does not comply with current codes for 36" minimum height and non-passage of a 4" diameter sphere through guardrail. RECOMMEND consultation with local building official to permit continuance of use based on "grandfathering" of design.

Guardrail too low

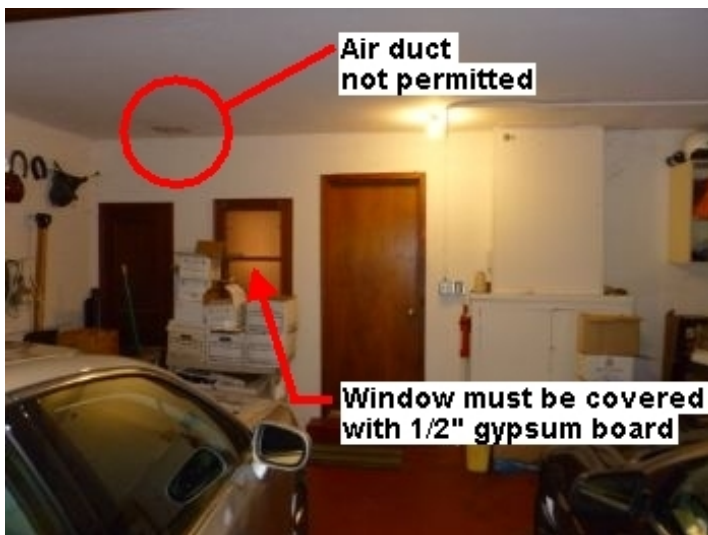
- SAFETY CONCERN:** Observed air supply grille in Garage ceiling. NJ International Residential Code R302.5.2 prohibits openings in ducts that penetrate the fire separation wall between the garage and dwelling. This is a safeguard to avoid potential backdraft of carbon monoxide and other lethal gases entering the dwelling portion from the garage. HIGHLY RECOMMEND engaging a qualified and licensed HVAC contractor to remove, terminate and properly cap the duct for safe and code-compliant occupancy.

Fire Separation Wall and Ceiling

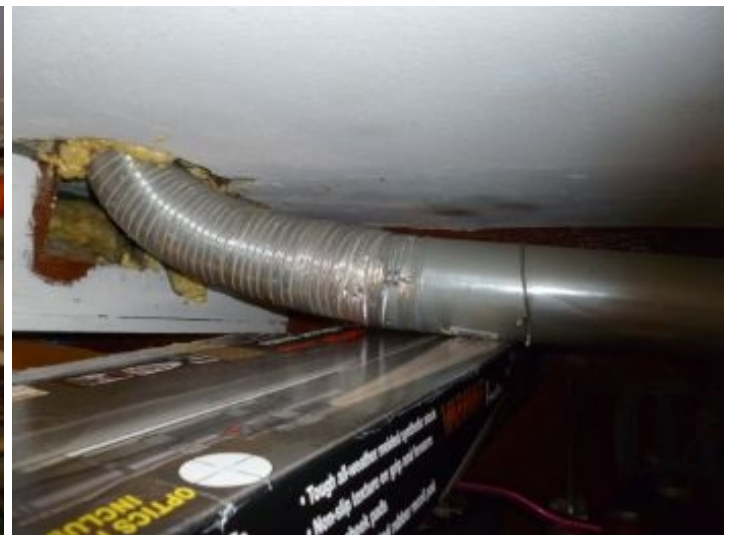
- SAFETY CONCERN:** Current codes (NJ International Residential Code R302.5.2) require ducts penetrating the Garage fire separation wall be constructed of minimum No. 26 gage sheet steel or other approved material. The dryer vent duct material is undetermined. Also, the sprayed-on expandable foam insulation does not appear to comply with code to resist free passage of flame and other products of combustion (NJ International Residential Code R302.11, Item 4). HIGHLY RECOMMEND engaging a qualified and licensed HVAC contractor to evaluate dryer duct material and fireblocking material for compliance to code; and to remove and replace dryer vent and fireblocking for safe occupancy, compliance with code, and proper function.

Evaluate dryer vent duct and fireblocking through fire separation wall

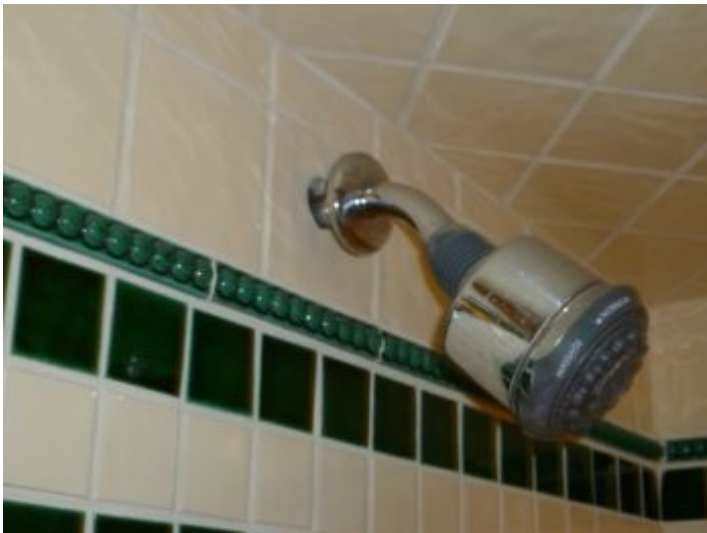
- Showers were test-operated and functioned normal.
- Showers are in good functional condition with no major visible damage or material defects.
- Shower surrounds are ceramic tile observed in good condition with no major cracks or missing grout to permit water intrusion behind wall surface.
- Shower surrounds in Pool House are painted concrete walls.
- Shower head at Pool House Men's Room is loose.
- Shower head at Master Bathroom #1 is loose.

Loose showerhead in Master Bathroom #1

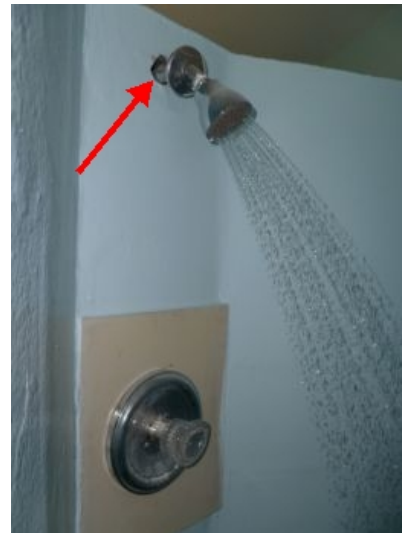
Loose showerhead Pool House Men's Room

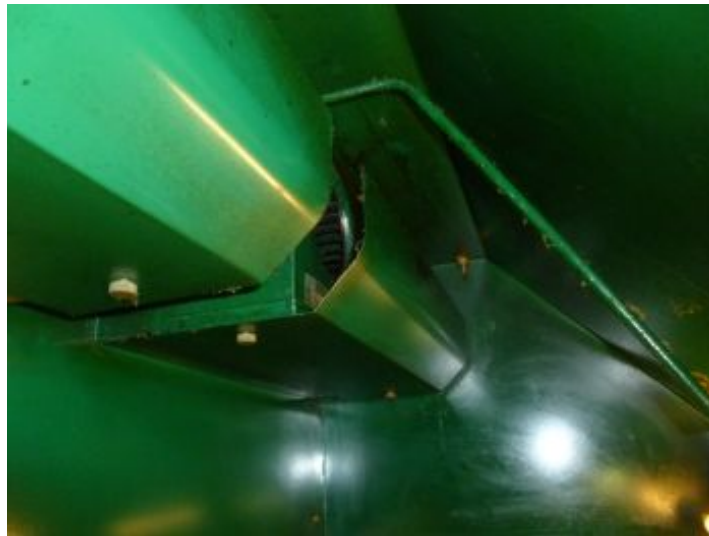
- Vented to exterior.
- Test-operated and functioned normal.
- Exhaust fan and hood are in functional condition with normal wear and tear, except as noted below.
- Fans and filters are greasy and require cleaning.

Exhaust fan is greasy and needs cleaning

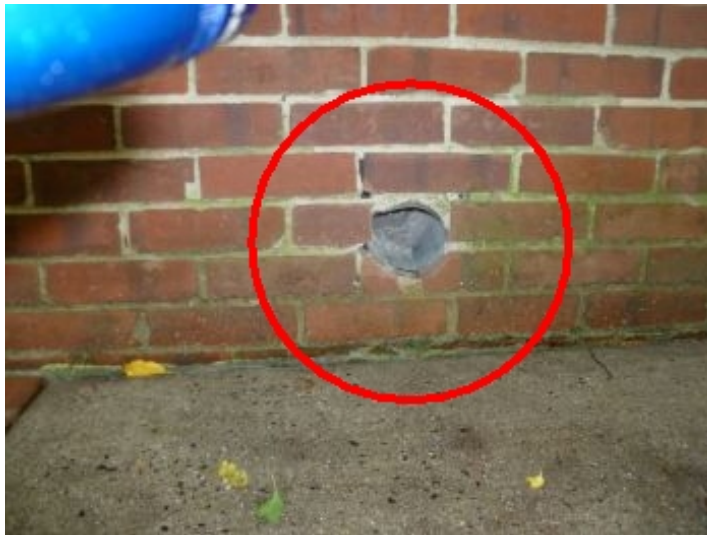
- Observed in Garage where metal corrugated vent was improperly connected to rigid duct. (Male) corrugated vent must be inserted into (Female) rigid duct to prevent lint build-up. Improper duct connections and lint build-up are common causes of house fires. RECOMMEND removing and re-installing rigid duct in reverse position for safe and proper operation.
- Observed exterior termination cap and hood for dryer vent was missing. RECOMMEND installation of termination cap and hood to prevent exposure to weather draft and entry of pests and vermin to interior of house.
- IMPROVE: Observed outlet opening for exterior termination cap and hood was installed very low to ground. This outlet should be elevated to prevent easy entry of water, snow, pests and vermin into dryer vent and interior of house. RECOMMEND elevating outlet to at least 18" above grade.

Exterior termination cap and hood for dryer vent is missing

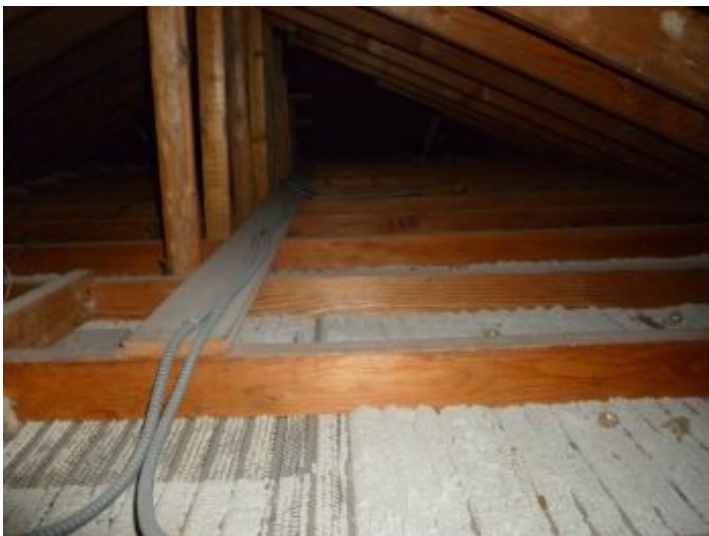
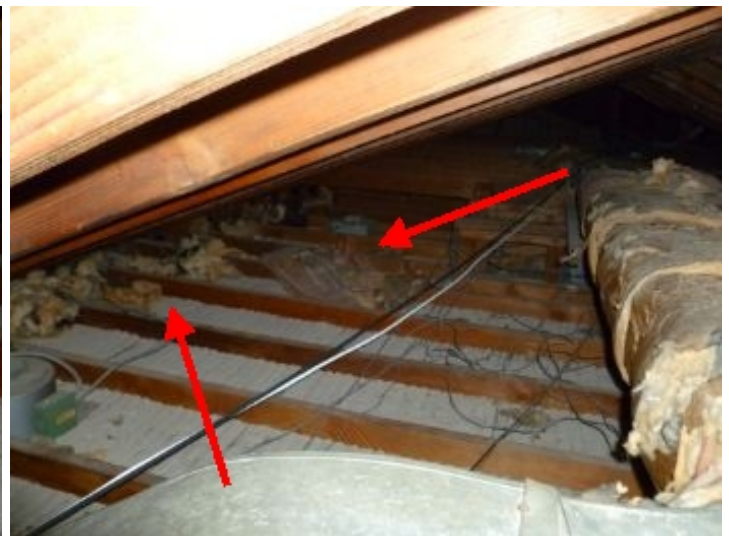
- Limited presence of insulation is not adequate to meet current standards or energy subcode. Where present, insulation was sporadic and disturbed. RECOMMEND installation of attic insulation to meet minimum code requirements or R-30 value, whichever is greater.

No insulation in large areas of Main House attic space Sporadic and disturbed insulation at Main House attic

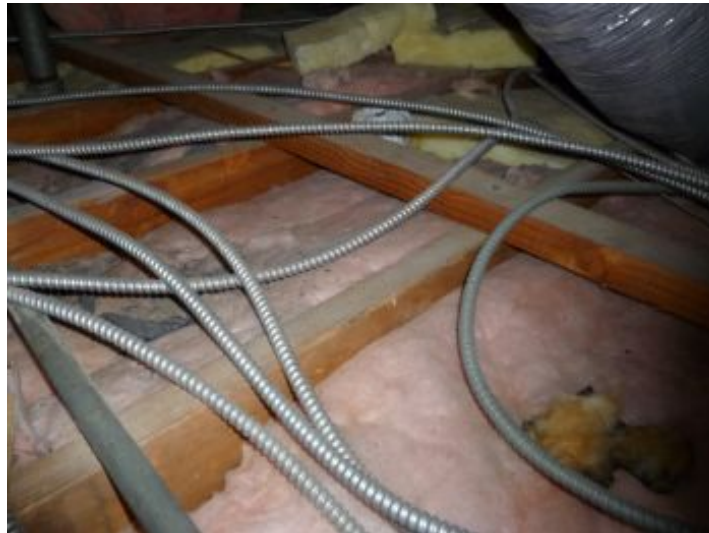
Sporadic and disturbed insulation in some attic areas

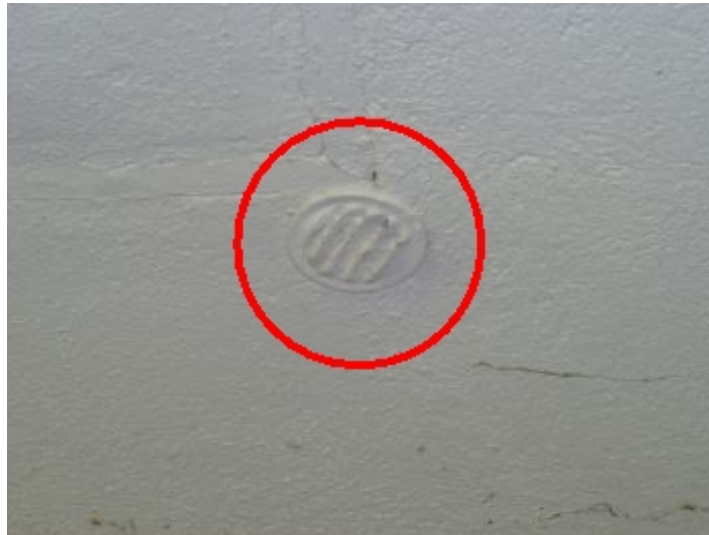
- Pool House: Observed several soffit vents were covered with paint and partially or wholly covered the openings. RECOMMEND removing and replacing all soffit vents to provide ample intake ventilation through attic.

Soffit vents covered with paint at Pool House

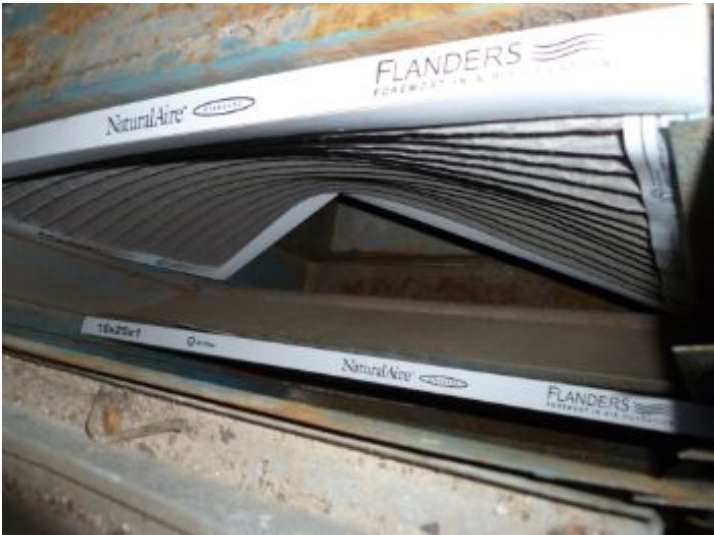
- Filters in both furnaces are dirty. RECOMMEND replacement of filters.
- One filter in Zone 2 Furnace is not properly installed. RECOMMEND proper replacement with new filter.

Improper filter installation at Zone 2

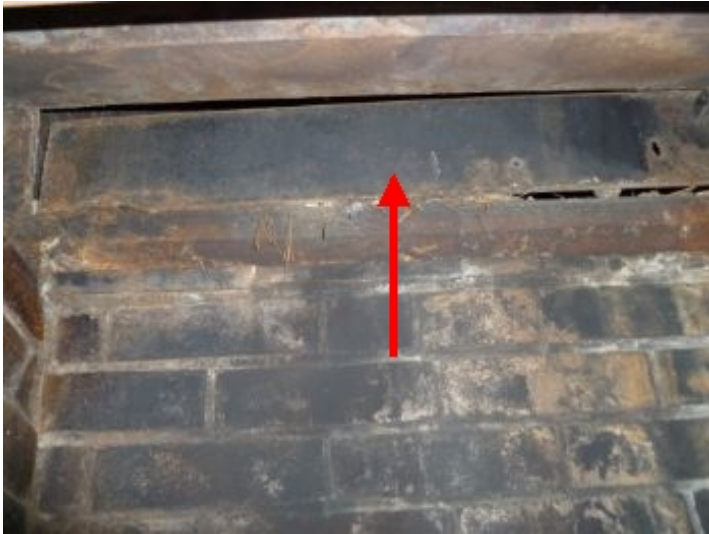
- Fireplaces are in good functional condition with normal wear and tear, except as noted below.
- Damper in Living Room fireplace was difficult to operate. RECOMMEND cleaning and adjustments for smooth and proper operation.
- RECOMMEND engaging a qualified and experienced chimney sweep to clean and remove any creosote build-up in flue for safe occupancy and efficient operation.

Fireplace damper at Living Room difficult to operate

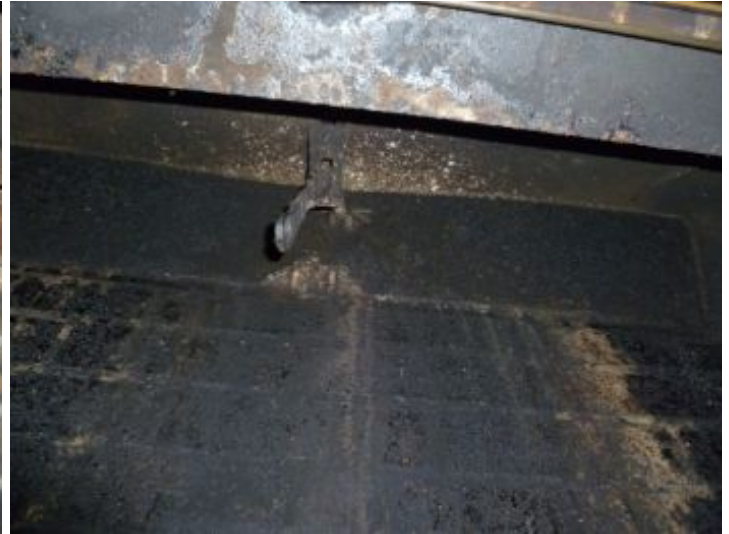
Soot and creosote build-up in fireplace

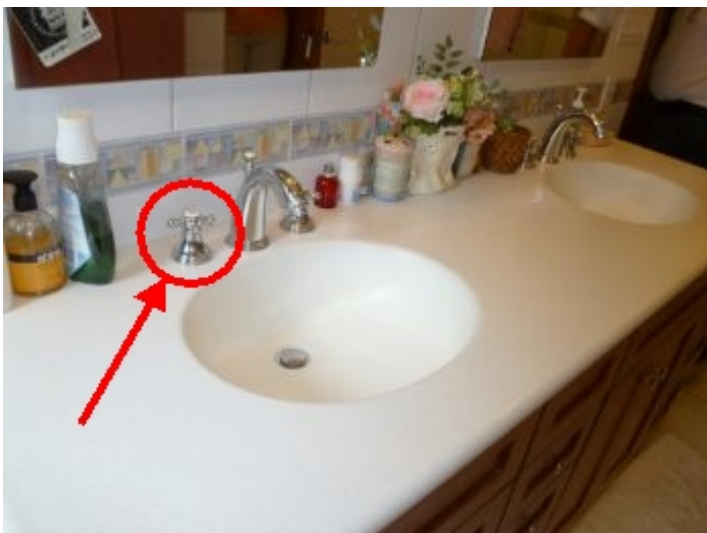
- Hot water faucet at left sink in Bathroom #2 is not functional. No water flow. RECOMMEND checking shut-off valve below sink. If no water flow is present or other problems, engage a qualified and licensed plumbing contractor to make repairs.
- Faucet handle missing from hot water supply faucet for clothes washer. RECOMMEND installing replacement handle for proper function.
- Cold water faucet at laundry sink leaks. RECOMMEND engaging qualified and licensed plumbing contractor to repair faucet for proper function.
- Faucet at Family Room wet bar was tested on a very limited basis due to limited use of sink and functional uncertainty of faucets and sinks. Observed water flow at hot water faucet. Cold water faucet was not tested. RECOMMEND cleaning sink and drain; then running faucets to determine functionality. Engage a qualified and licensed plumbing contractor if problems appear.

Hot water faucet not functional

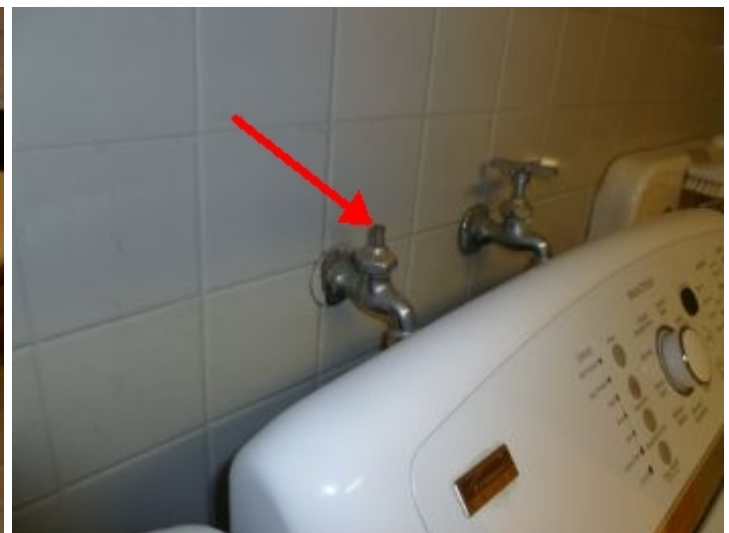
Missing faucet handle at clothes washer

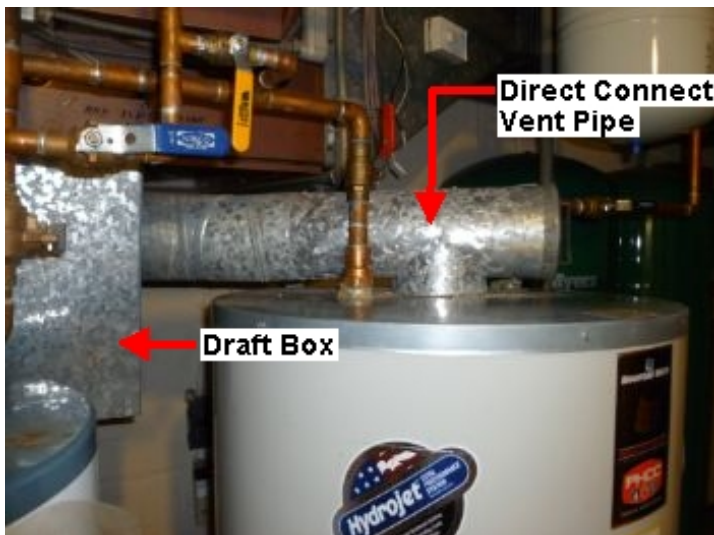
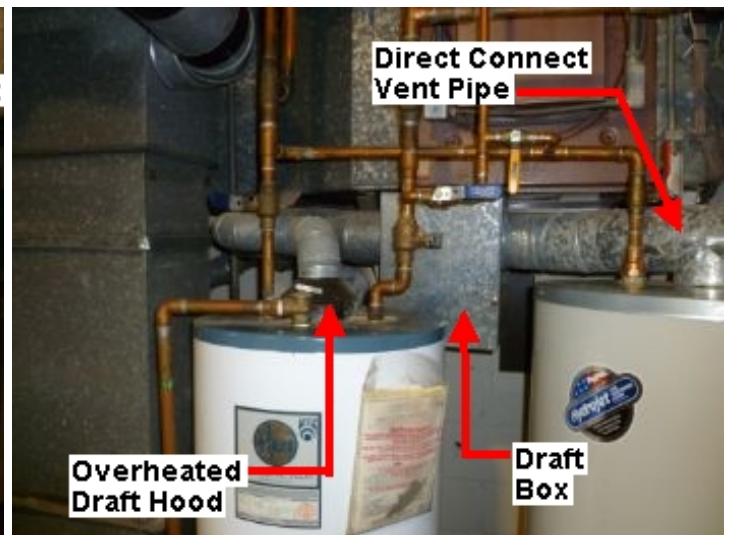
• **SAFETY CONCERN:** Metal vent pipe exhausting flue gases from primary 40 gallon Rheem water heater may not be installed properly. A straight vertical rise is required at the draft hood/collar before an elbow or bend can be used. Other routing and dimensional requirements must also be maintained for safe and code-compliant use. **HIGHLY RECOMMEND** engaging an experienced licensed plumbing contractor for further evaluations and to re-install vent pipe to comply with codes for safe occupancy and efficient operations.

Non-standard vent pipe

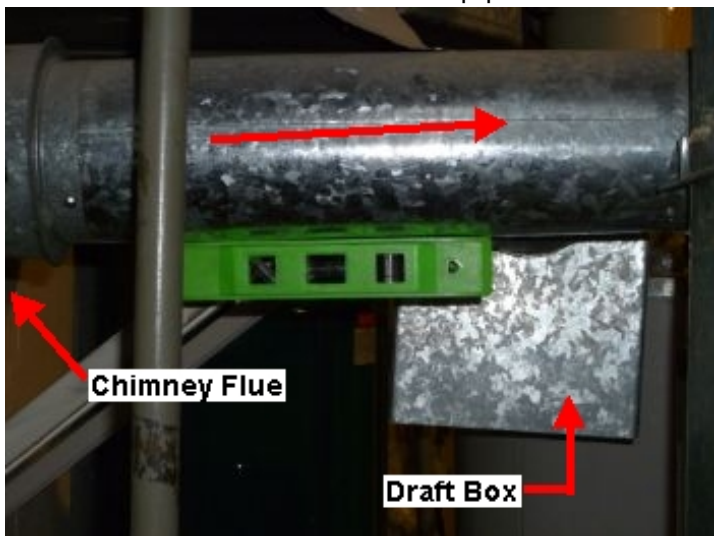
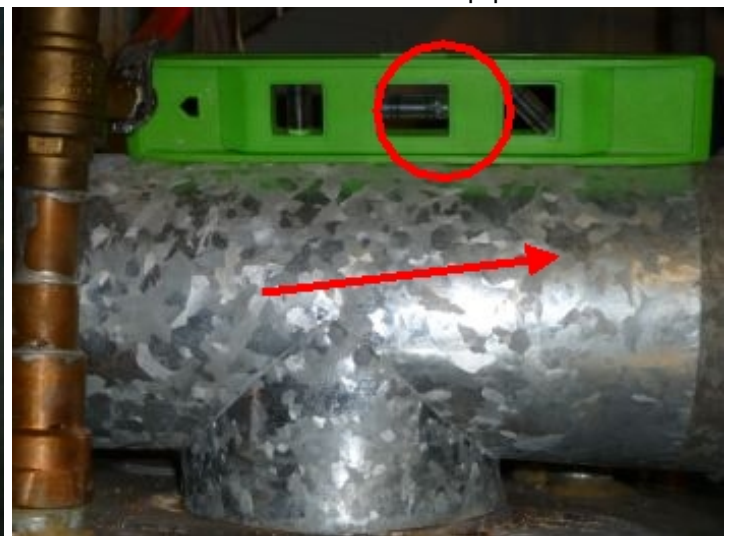
• **SAFETY CONCERN:** Metal vent pipe exhausting flue gases from primary 75 gallon Bradford-White water heater is improperly pitched in the wrong direction. Vent pipes are required to pitch upwards and away from the appliance at a minimum pitch of 1/4" per foot. Other routing and dimensional requirements must also be maintained for safe and code-compliant use. **HIGHLY RECOMMEND** engaging an experienced licensed plumbing contractor for further evaluations and to reinstall vent pipe to comply with codes for safe occupancy and efficient operations.

Improper Pitch

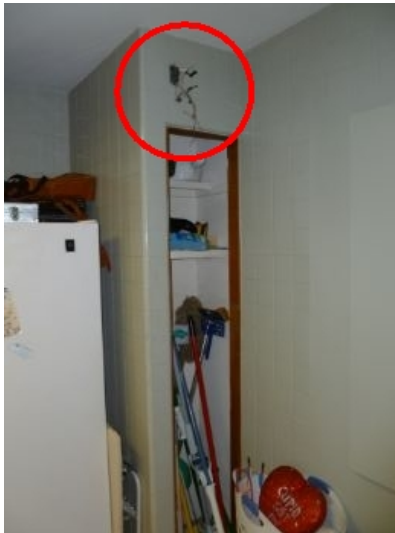
- Where visible for inspection, distribution wiring are functional condition with no major visible damage or material defects.
- Open junction box on wall with no coverplate in corner of Furnace Room. RECOMMEND installing coverplate for safety against accidental contact with electricity.
- Exposed wiring and open electric box observed at former door chime location in Laundry Room. RECOMMEND engaging a qualified and licensed electrical contractor to properly remove and/or terminate wiring in accordance with code and to install coverplate.

Exposed wiring and open electric box

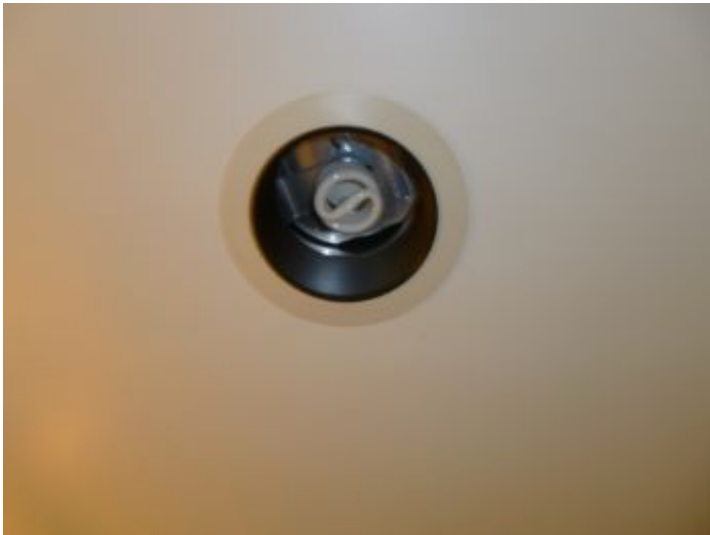
- A representative number of wall and light switches were test-operated and observed to be in normal functional condition, except as noted below.
- One recessed ceiling light in Bathroom #2 was non-functional. RECOMMEND check for defective light bulb and replace as necessary.
- Two light switches in attached Garage with missing coverplates. RECOMMEND installing coverplates to safeguard against accidental contact with electricity.
- Several recessed ceiling lights in Family Room were non-functional. RECOMMEND checking light bulbs and replace as necessary; otherwise engage a qualified and licensed electrical contractor to repair condition as necessary to restore functionality.
- Cracked coverplate in ganged wall switches in Master Bathroom #1. RECOMMEND replacing coverplate.
- Lay-in fluorescent ceiling light in Fitness Room is defective. RECOMMEND replacing fluorescent light tubes.

Non-functional light in Bathroom #2

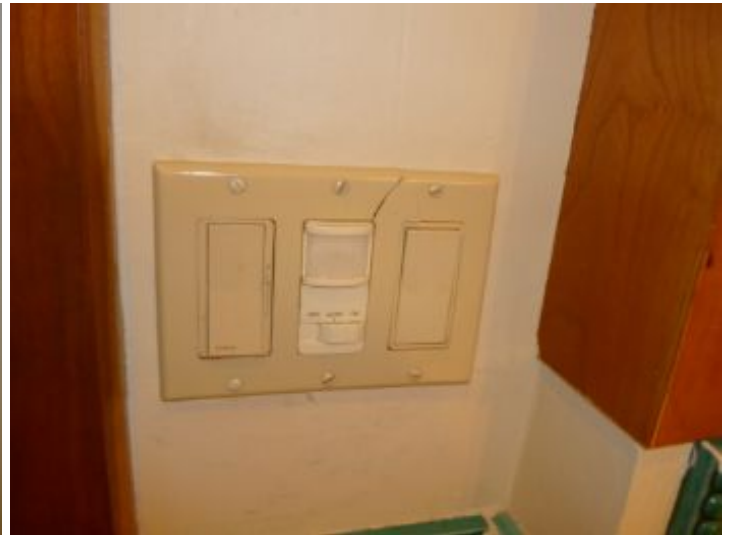
Cracked wallplate in Master Bathroom #1

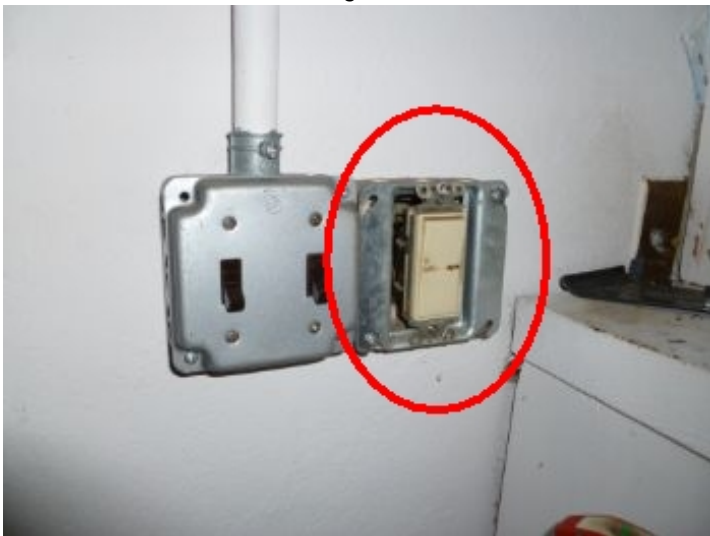
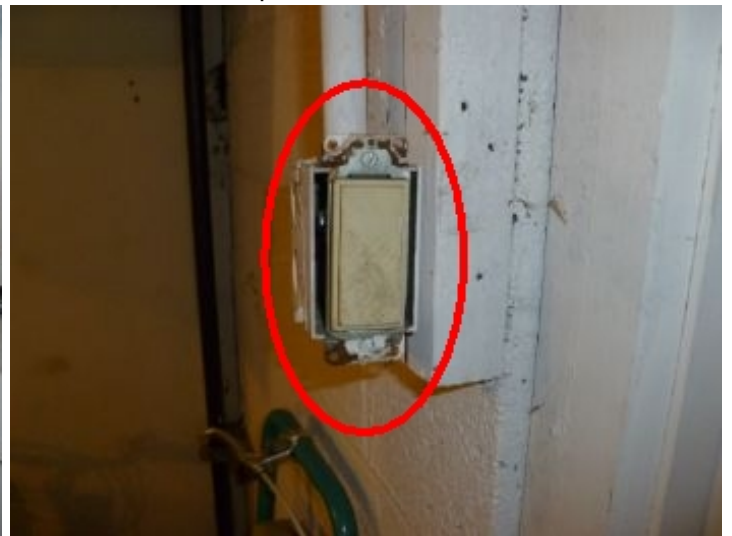
Missing wallplate at light switch

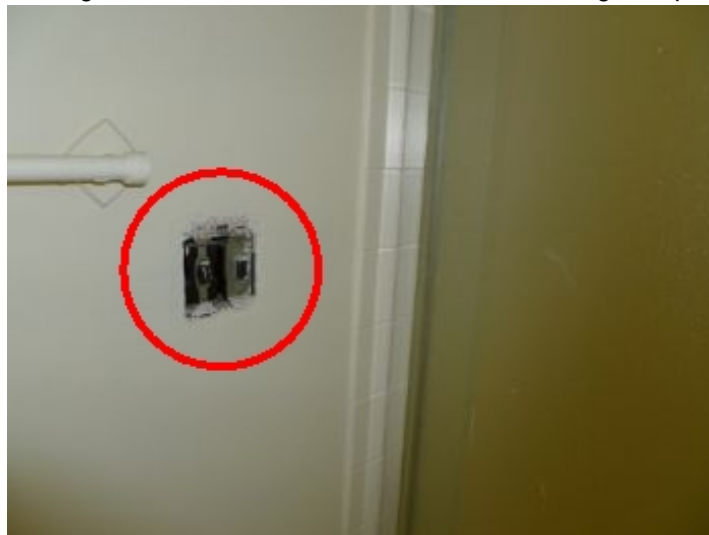
Missing wallplate at light switches in Pool House Women's Room

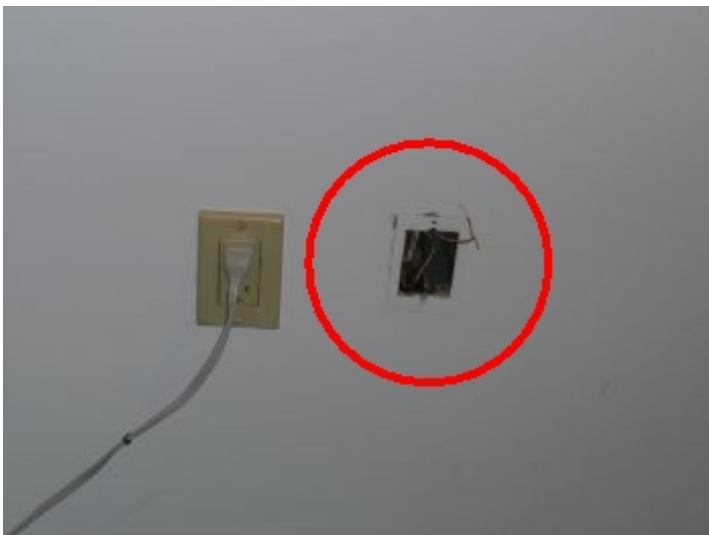
- A representative number of receptacle outlets were test-operated and observed to be in normal functional condition, except as noted below.
- Coverplate missing at receptacle outlet in Bedroom #2. RECOMMEND installing coverplate to safeguard against accidental contact with electricity.
- Receptacle outlet at kitchen counter behind refrigerator observed with improper "open ground". RECOMMEND engaging a qualified licensed electrical contractor to repair for safe and functional use.
- Top receptacle at outlet in southwest corner of Master Bedroom #1 is non-functional - does not allow plug to be inserted. RECOMMEND engaging a qualified and licensed electrical contractor to replace duplex receptacle device for safe use and full function.
- Open electric box with no coverplate at Hallway in front of Bedroom #3. RECOMMEND installation of coverplate.

Open electric box outside Bedroom #3

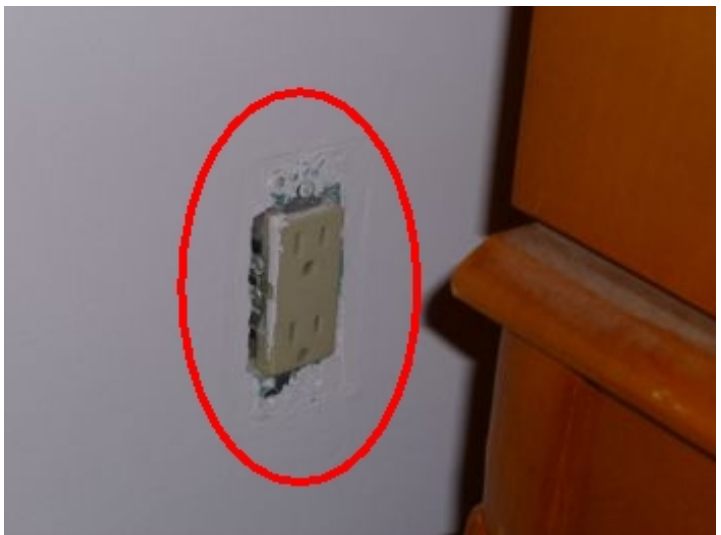
Missing receptacle coverplate at Bedroom #2

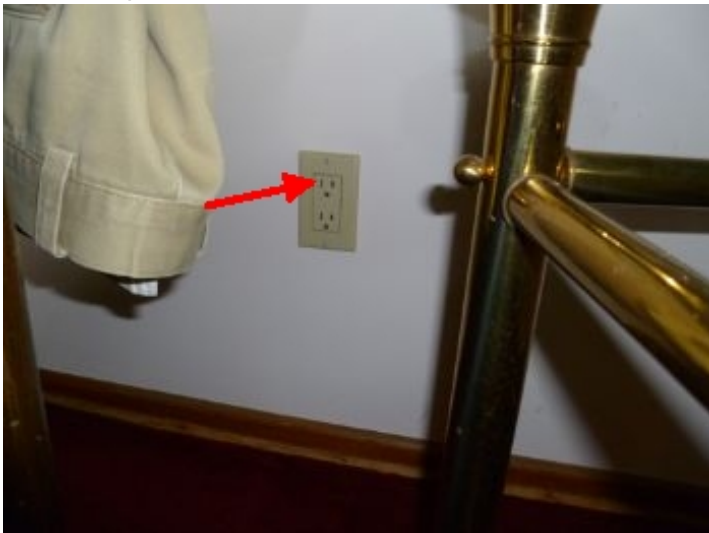
Top receptacle defective

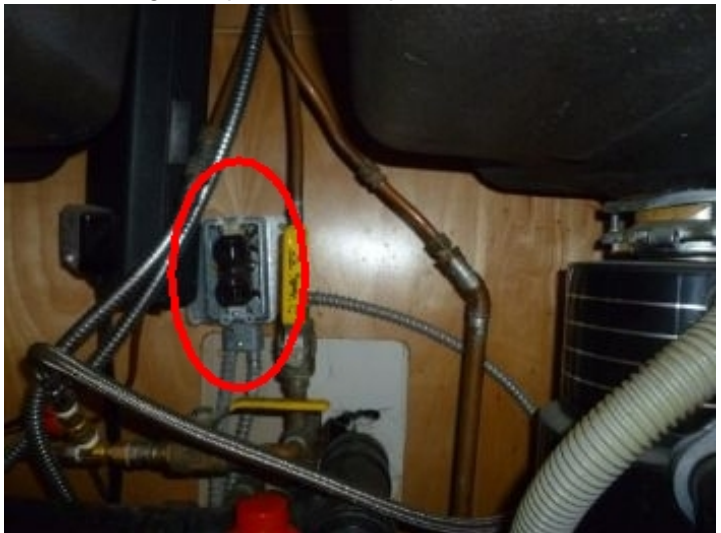
No coverplate at receptacle below Kitchen sink

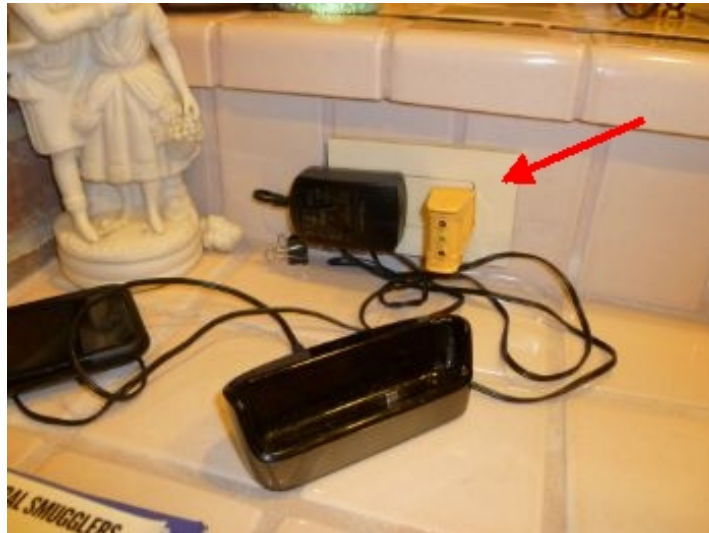
Open Ground at this Kitchen outlet

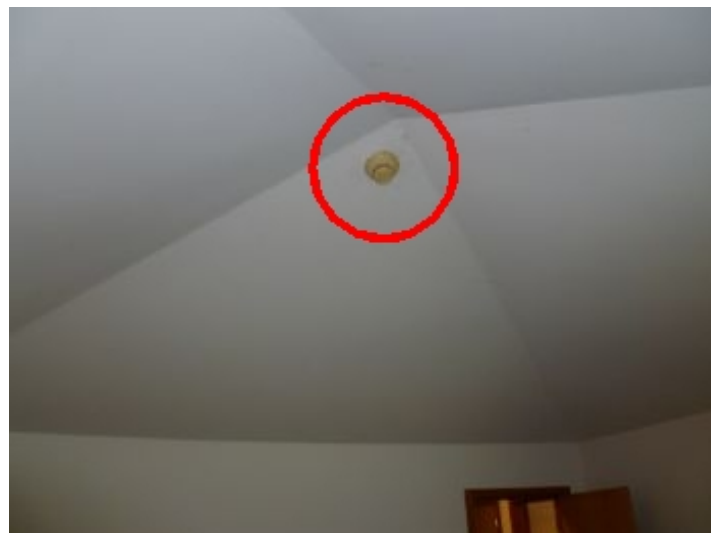
Smoke Detector unreachable for testing due to height
