PRIME Building Inspections

Home Inspection Report

246 Main Street, Anytown NJ, 01234
Inspection prepared for: John and Jane Doe
Inspection Date: 8/17/2011 Time: 1:00pm - 4:00pm
Age: 1995 (16 years) Size: 3,484 square feet
Weather: 84 degrees Sunny

Inspection No. SCsample2
Date of Report: August 18, 2011

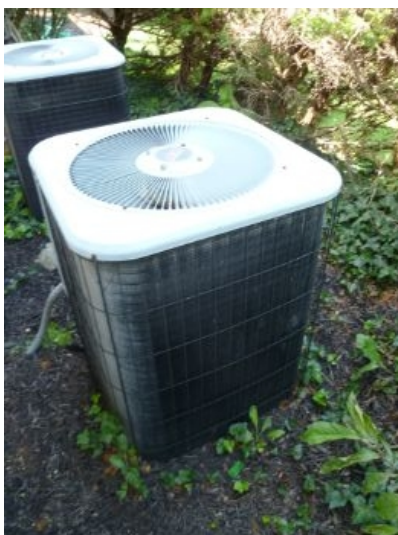
- Observed landscaping was recently trimmed, pruned and planted with new materials. New mulch was applied in plant beds.
- Bottoms of AC compressors on left (east) side of house were partially covered with mulch. This prevents free-flow air circulation around the units and promotes premature degradation of components due to overabundance of water. RECOMMEND removing mulch to expose bottoms of AC compressor pads and regrading mulch to divert water drainage from rear yard away from AC compressors.

Mulch covering base of AC units

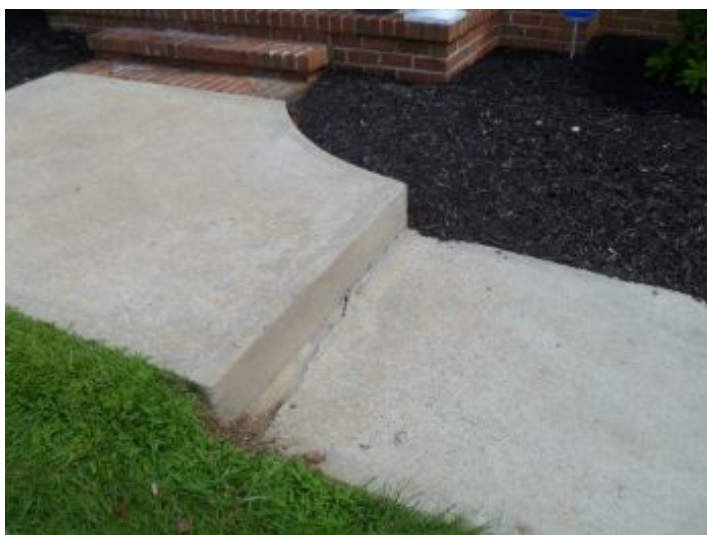
- Walkways are in functional condition with normal wear and tear, except as noted below.
- Observed large crack at front walkway step was repaired. RECOMMEND monitoring of crack for future spalling, horizontal movement and/or vertical displacement to prevent potential trips and falls. Repair as soon as possible upon any discovery of spalling, movement or displacement.

Crack at front walkway

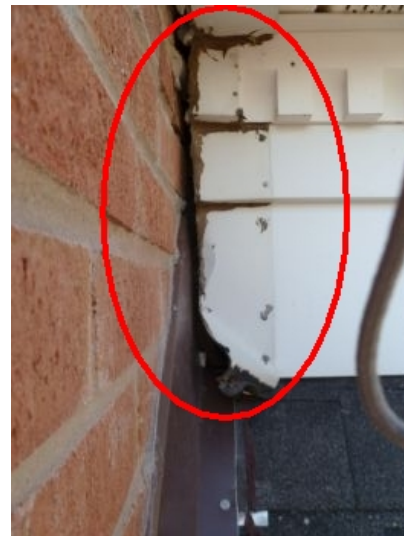
- Siding and flashing against wall at backside of east chimney is damaged due to reconstruction of chimney. Sheathing is exposed due to missing flashing and underlayment. HIGHLY RECOMMEND engaging a qualified and experienced contractor to repair this area as soon as possible to prevent potential water intrusion to interior surfaces, premature degradation of building components and potential mold growth.

Repair siding, underlayment, flashing required

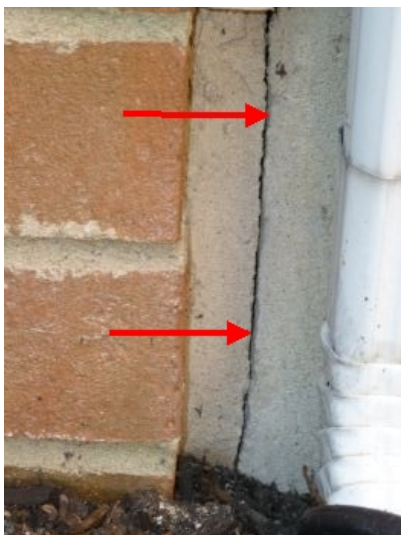
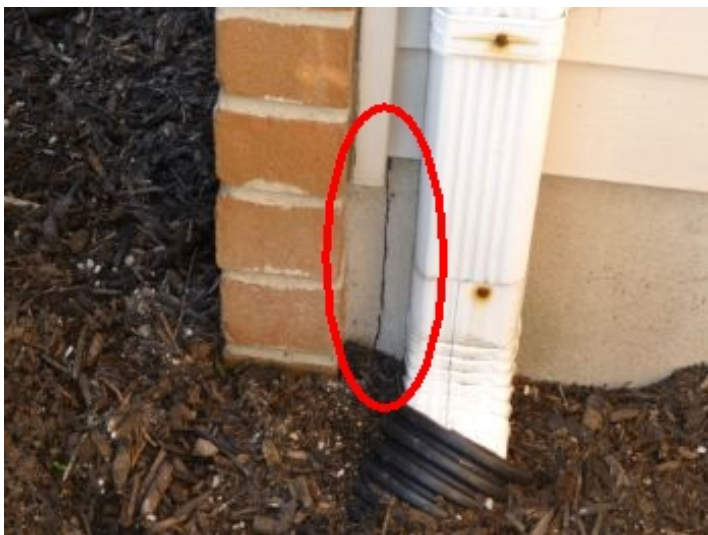
- Observed cracks at two locations between brick veneer and foundation corner. HIGHLY RECOMMEND engaging a qualified and experience contractor or licensed professional engineer for further evaluation to determine cause of cracks and prescribe measures to prevent water intrusion through wall.

Crack at foundation wall

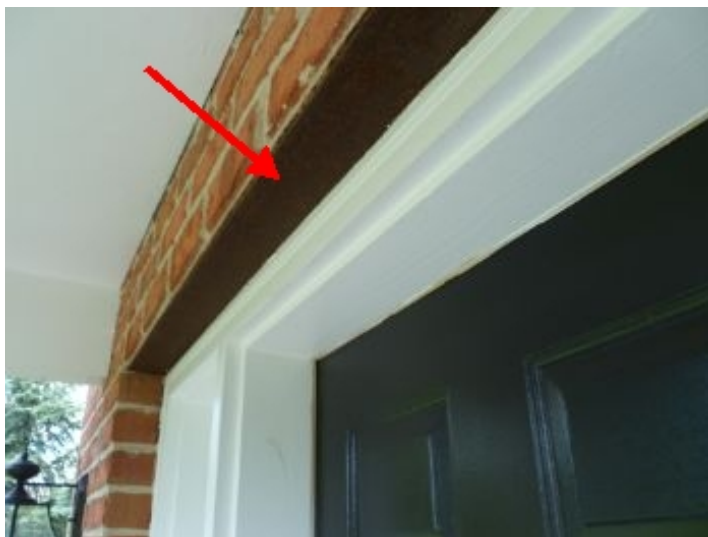
- Exterior doors are in functional condition with normal wear and tear.
- Steel lintel above front entrance doors is rusted. RECOMMEND removing rust, apply rust-inhibiting stain-killer and primer, and re-paint with enamel paint for metals.

Rusted lintel over front doors

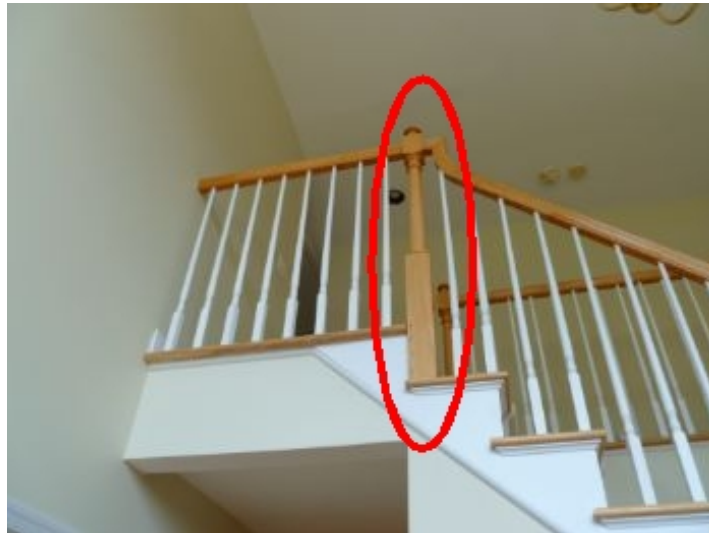
- **SAFETY CONCERN:** Observed newel posts at stair railings were loose and presents a dangerous condition. No apparent use of bolts provided to secure post to sturdy structure. HIGHLY RECOMMEND engaging a qualified and experienced contractor to secure newel posts to structure using wood lag bolts.

Loose newel post at stair

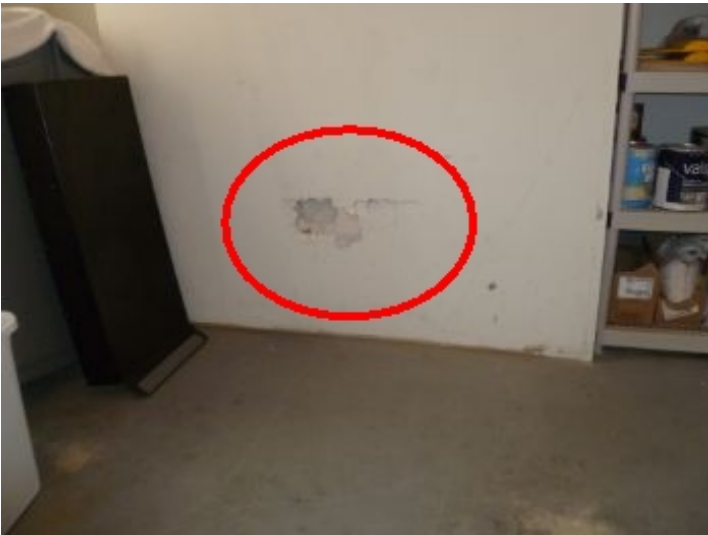
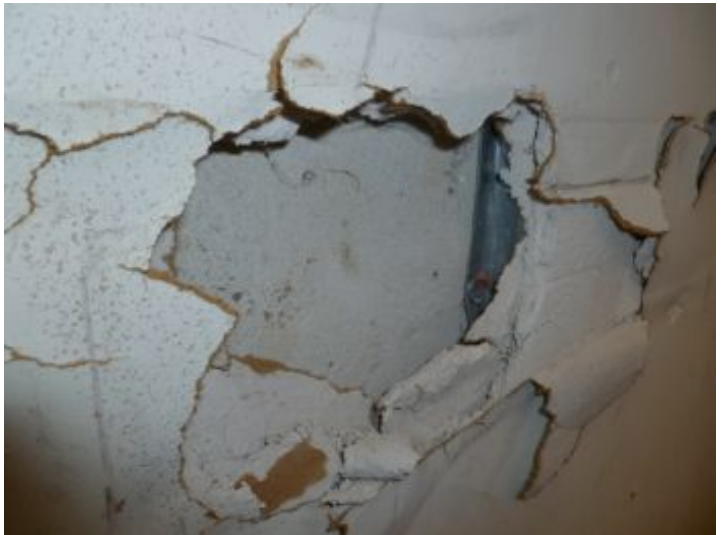
• **SAFETY CONCERN:** The common wall between the Garage and home is required by code to be rated for fire separation. Observed damage at this wall in Bay #1 behind the fireplace extension that breaches the fire separation. HIGHLY RECOMMEND immediate repair of this wall using Type X fire-code drywall by a qualified and experienced contractor to provide protection against spread of fire.

Damaged fire separation wall requires repair

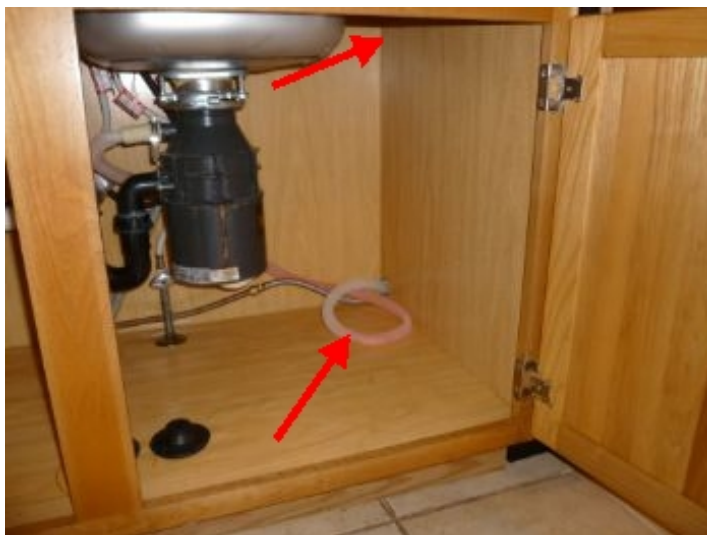
- Test-operated and functioned normal.
- Dishwasher is in good functional condition with no major visible damage or material defects, except as noted below.
- **SAFETY CONCERN:** Irregular drain line installation. Could not observe presence of "high loop" due to lack of access to rear of dishwasher. High loop is required at discharge line before it connects to disposal or sink drain to prevent siphoning of wastewater into dishwasher. Loop must be higher than "flood" level of sink. Alternative to high loop is installation of "air gap" device. HIGHLY RECOMMEND confirming presence of high loop in discharge line behind dishwasher. If not present, then provide high loop or air gap for safe and healthy use of dishwasher.

Adjust dishwasher drain to provide "High Loop"

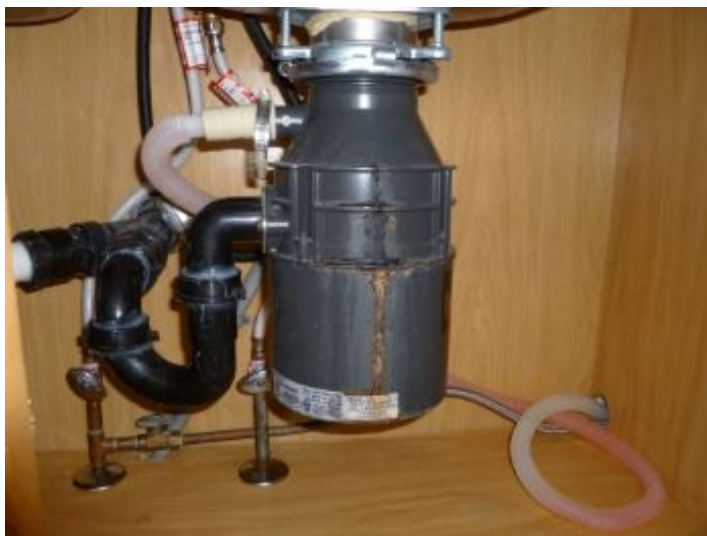
- Test-operated and functioned normal.
- Garbage disposal is in fair condition and may be near the end of its useful service life.

Garbage disposal near end of useful service life

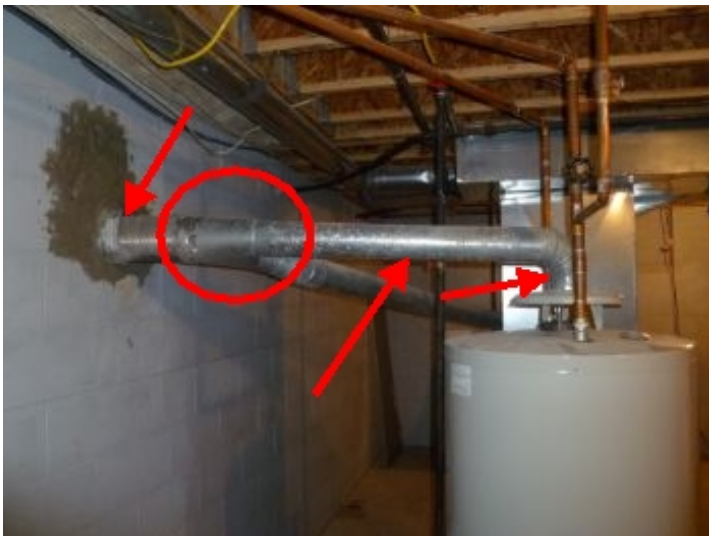
- SAFETY CONCERN: Observed Y-connector is not properly connected to flexible vent. (Male) Y-connector must be inserted INTO (female) flexible vent to prevent flue gases from entering house. HIGHLY RECOMMEND re-installation by a qualified and experience HVAC contractor.

- SAFETY CONCERN: 90 degree elbow at water heater is too close to draft hood. Only 3 inches were observed where 6 inches is required before a bend can be installed in flue vent to prevent flue gases from backdrafting. HIGHLY RECOMMEND re-installation by a qualified and experienced HVAC contractor.

Safety concerns at flue vent

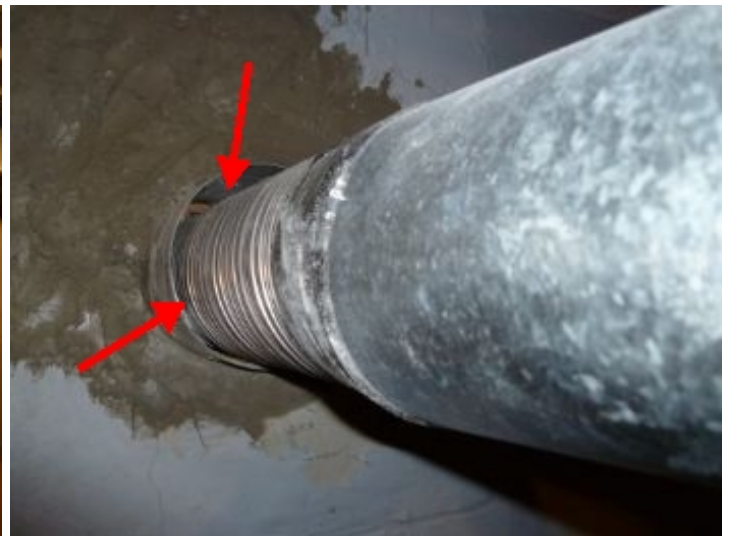
Fill void space with mortar

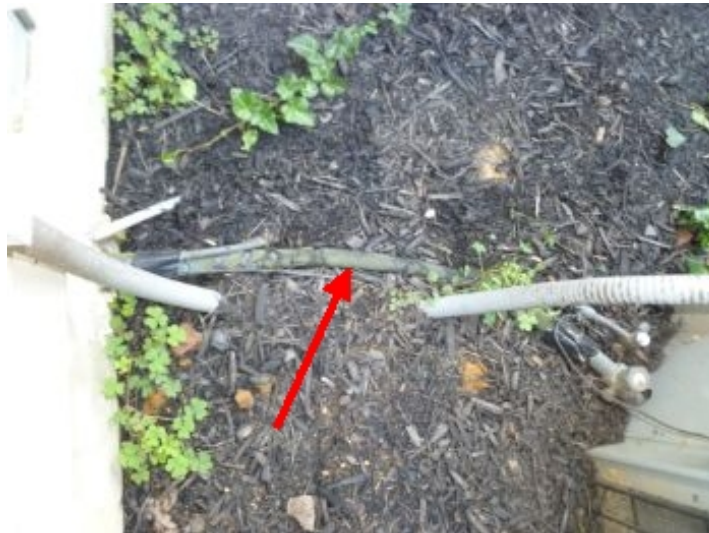
- Central air-conditioning cooling system was test-operated and functioned normal.
- Air-conditioning cooling system is in functional condition with normal wear and tear, except as noted below.
- The insulation at the refrigerant lines in each AC compressor/condensing unit is old and ineffective. RECOMMEND engaging a qualified and experience HVAC contractor to replace insulation.

Replace insulation at refrigerant lines

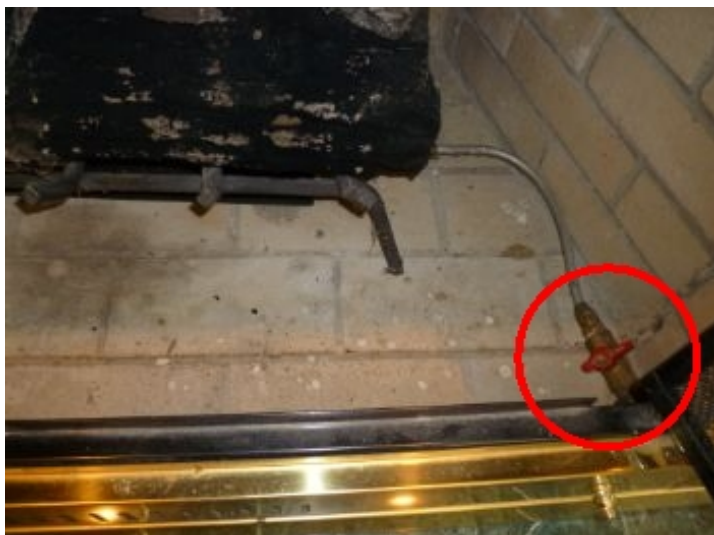
Gas shut-off at Living Room fireplace

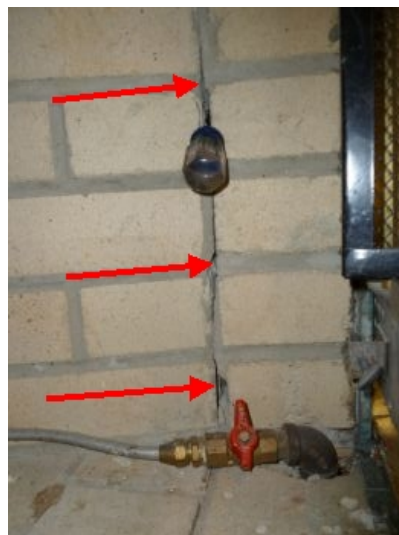
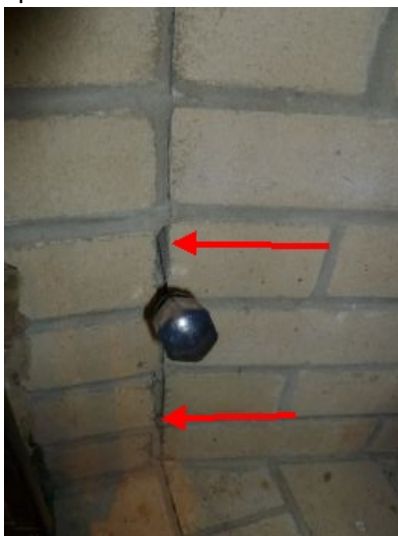
- Gas fireplace in Family Room was not tested because gas was shut-off.
- Gas fireplace in Living Room was not tested because gas was shut-off.
- Observed cracks at both sides of firebox in Living Room fireplace. HIGHLY RECOMMEND engaging a qualified and experience masonry contractor to repair cracks for safe operation and structural adequacy.

Crack at firebox in Living Room fireplace

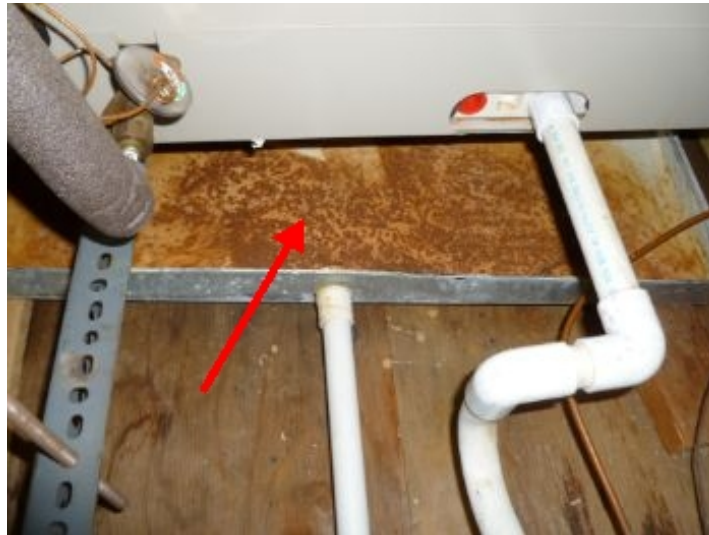
- Observed drip pan in attic was rusted. RECOMMEND engaging a qualified and experienced HVAC contractor to evaluate humidifier and to make repairs or replacement as necessary for proper function.

Rusted drip pan in attic

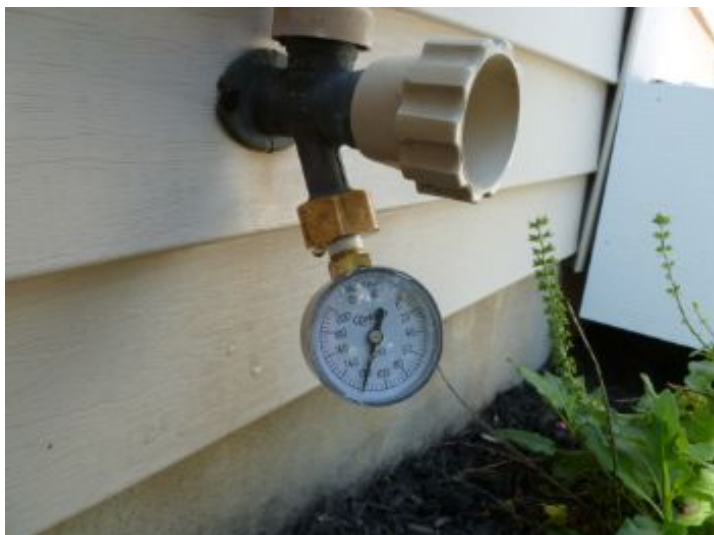
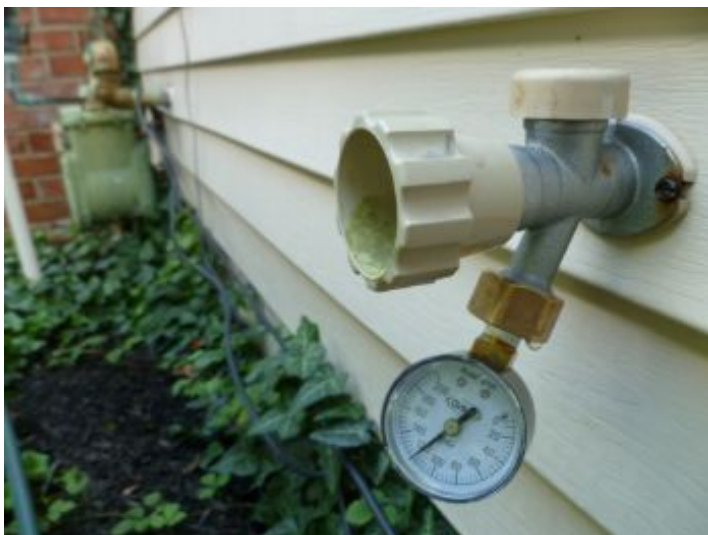
- The water pressure was tested and was found to be over 80 psi. The plumbing system may be prone to leaks in piping, fittings are other components. RECOMMEND notify the water authority or engage a qualified and licensed plumber to install a private pressure regulator to reduce the pressure to under 80 psi or under. Most jurisdictions require an expansion tank if a regulator is installed.

120 psi water pressure taken from rear hose bibb

120 psi water pressure taken at hose bibb at left side of house

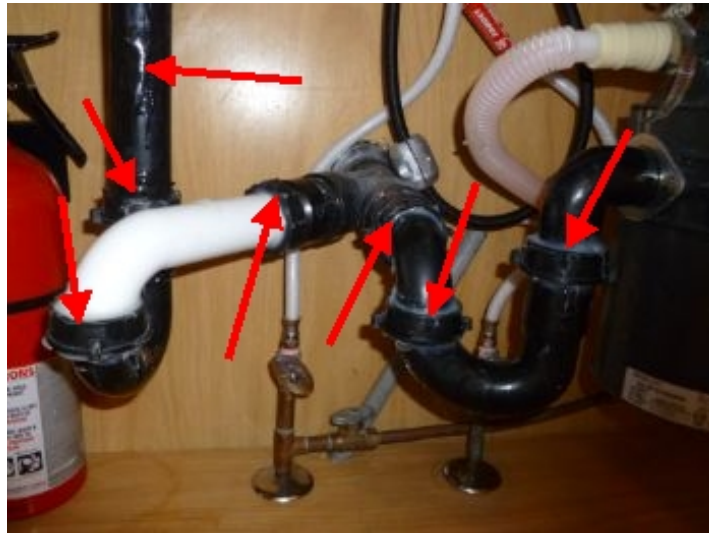
- Traps and drains are in good functional condition with no major visible damage or material defects, except as noted below.
- Observed unusual condition at Kitchen sink where silicone was applied all over sink traps and drain pipes. No leaks were observed. RECOMMEND monitoring for future leaks.

Silicone on trap and drain

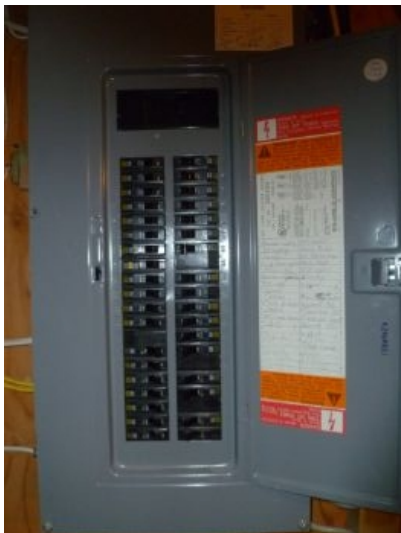
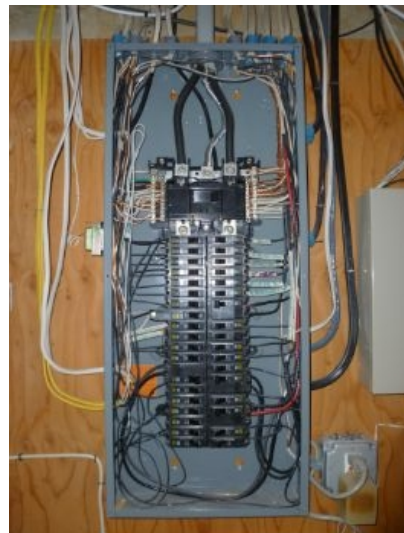
Main Electric Panel

Description: **Square D**
 Observations:
 • Main panel is in good functional condition with no major visible damage or material defects, except as noted below.
 • One screw is missing from the main electric panel. Code requires all screws to be used for safe and proper function. RECOMMEND installing missing (blunt tip) screw designed for electric panel use.

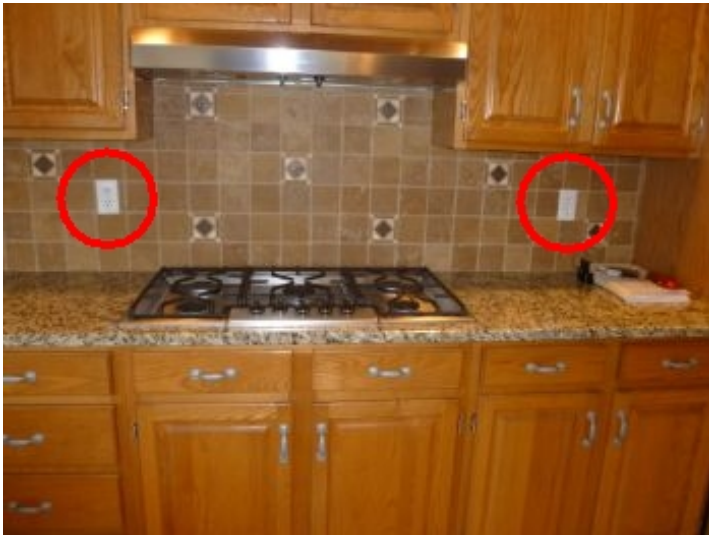
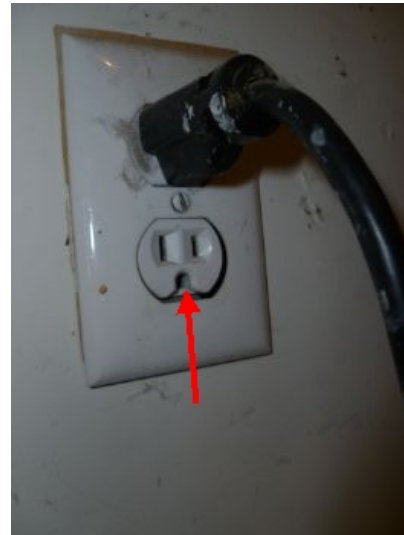
- All observed GFCI devices and GFCI-protected receptacle outlets were test-operated and functioned normal.
- GFCI receptacle outlets are in functional condition with normal wear and tear, except as noted below.
- **SAFETY CONCERN:** 2 standard receptacle outlets along kitchen counter at both sides of cooktop were not GFCI-protected. Code requires these outlets to be GFCI-protected. HIGHLY RECOMMEND engaging a qualified and licensed electrician to replace both outlets with GFCI receptacle outlets.
- **SAFETY CONCERN:** Observed standard receptacle outlet in Garage (where refrigerator is plugged into) is cracked and not GFCI-protected. HIGHLY RECOMMEND replacing receptacle with GFCI receptacle outlet for safe operation.

Replace standard receptacles with GFCI receptacle

Replace cracked receptacle in Garage with GFCI receptacle
