PRIME Building Inspections Home Inspection Report

888 Main Street, Anytown NJ, 01234 Inspection prepared for: John and Jane Doe Inspection Date: 10/10/2011 Time: 1:30pm - 4:00pm Age: 24 years (Built 1987) Size: Approx 1,800 sf Weather: Sunny. Approx 82 degrees

> Inspection No. SCsample4 Date of Report: October 11, 2011

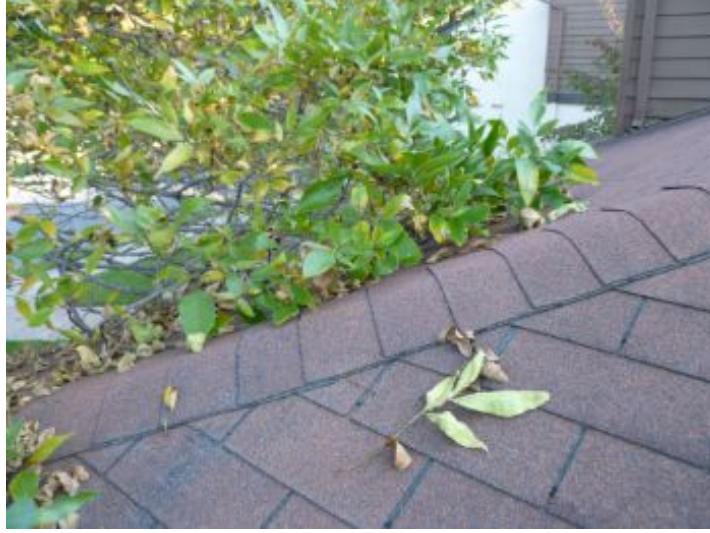
Trees are in contact with the house

Trees with overhanging branches extend across roof and gutters of house Observations:

• Trees too close to the building can cause harm through root damage to the foundation. branches abrading the roof and siding, and leaves clogging gutters and providing a path for moisture and insects into the home.

Tree in contact with roof

HIGHLY RECOMMEND having all trees trimmed and pruned away from house.

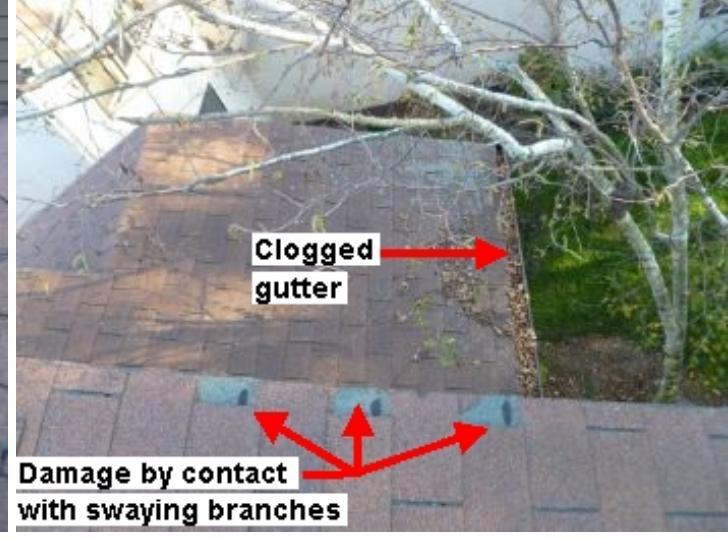
Tree in contact with roof cause damage to shingles

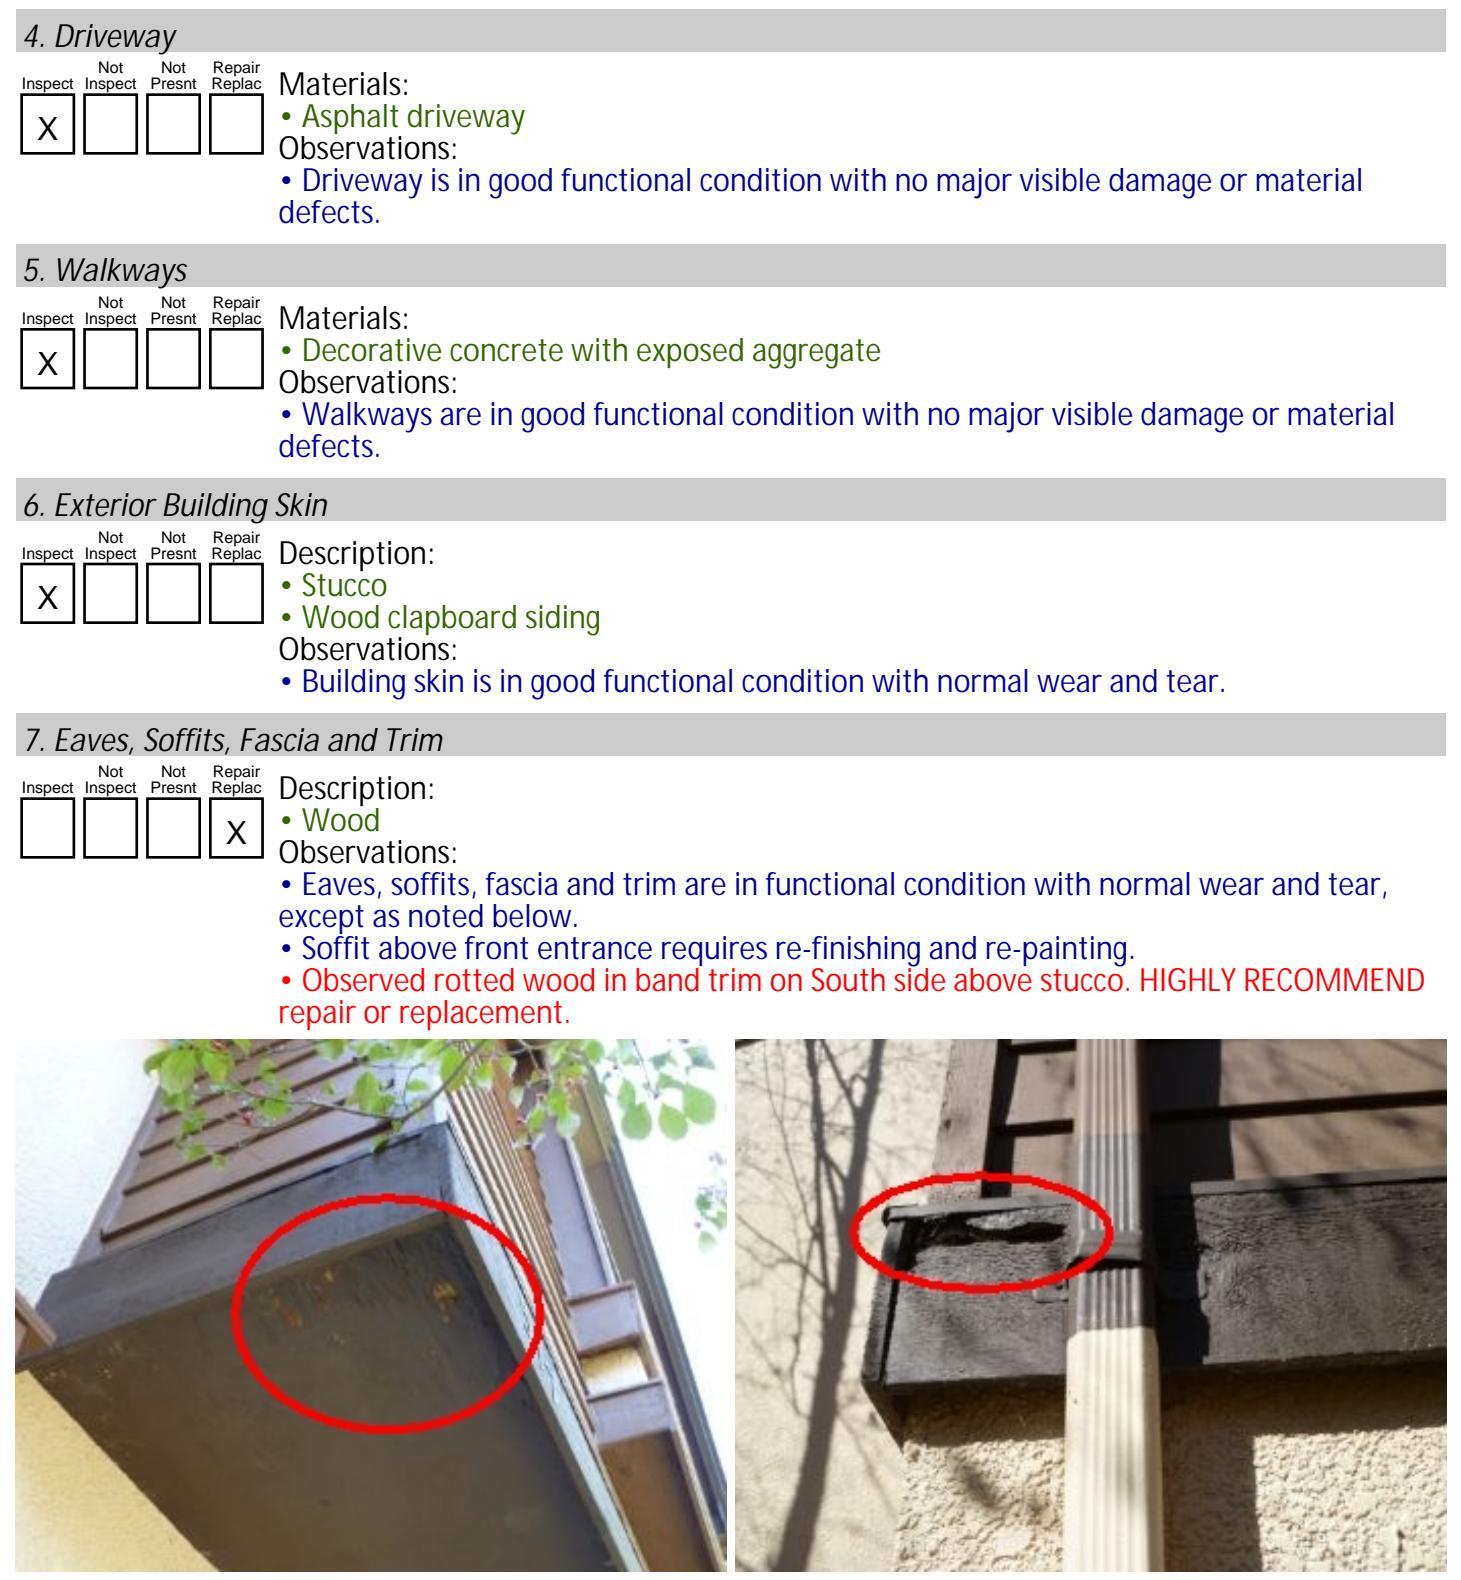
Observed rotted wood in band trim on South side above stucco.

Re-finish and re-paint front soffit

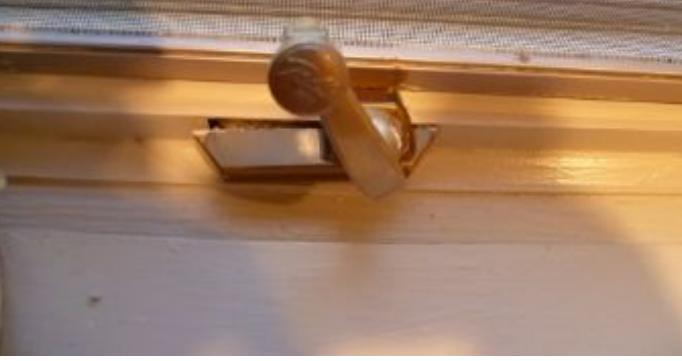
Non-functional window hardware

Window cannot be opened

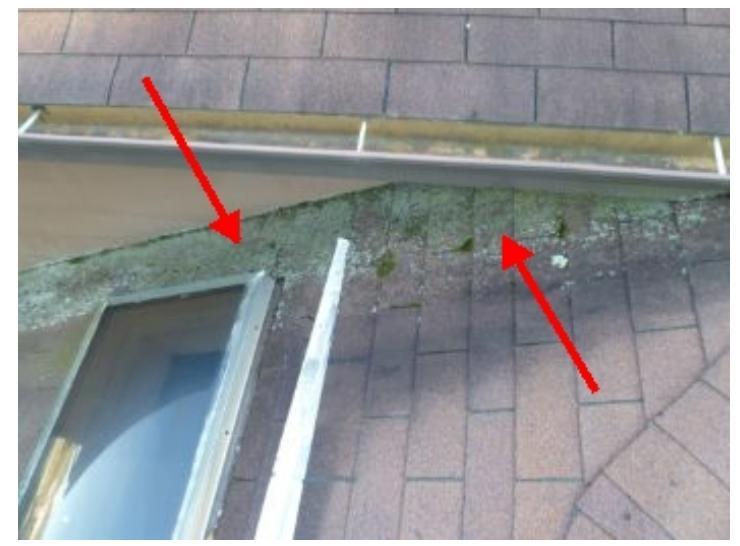
• Algae stains on roof shingles indicate a high moisture level in shingles. HIGHLY RECOMMEND engaging a qualified roofing contractor for further review and evaluation; and to repair and/or replace roof shingles as necessary.

Algae growth on roof

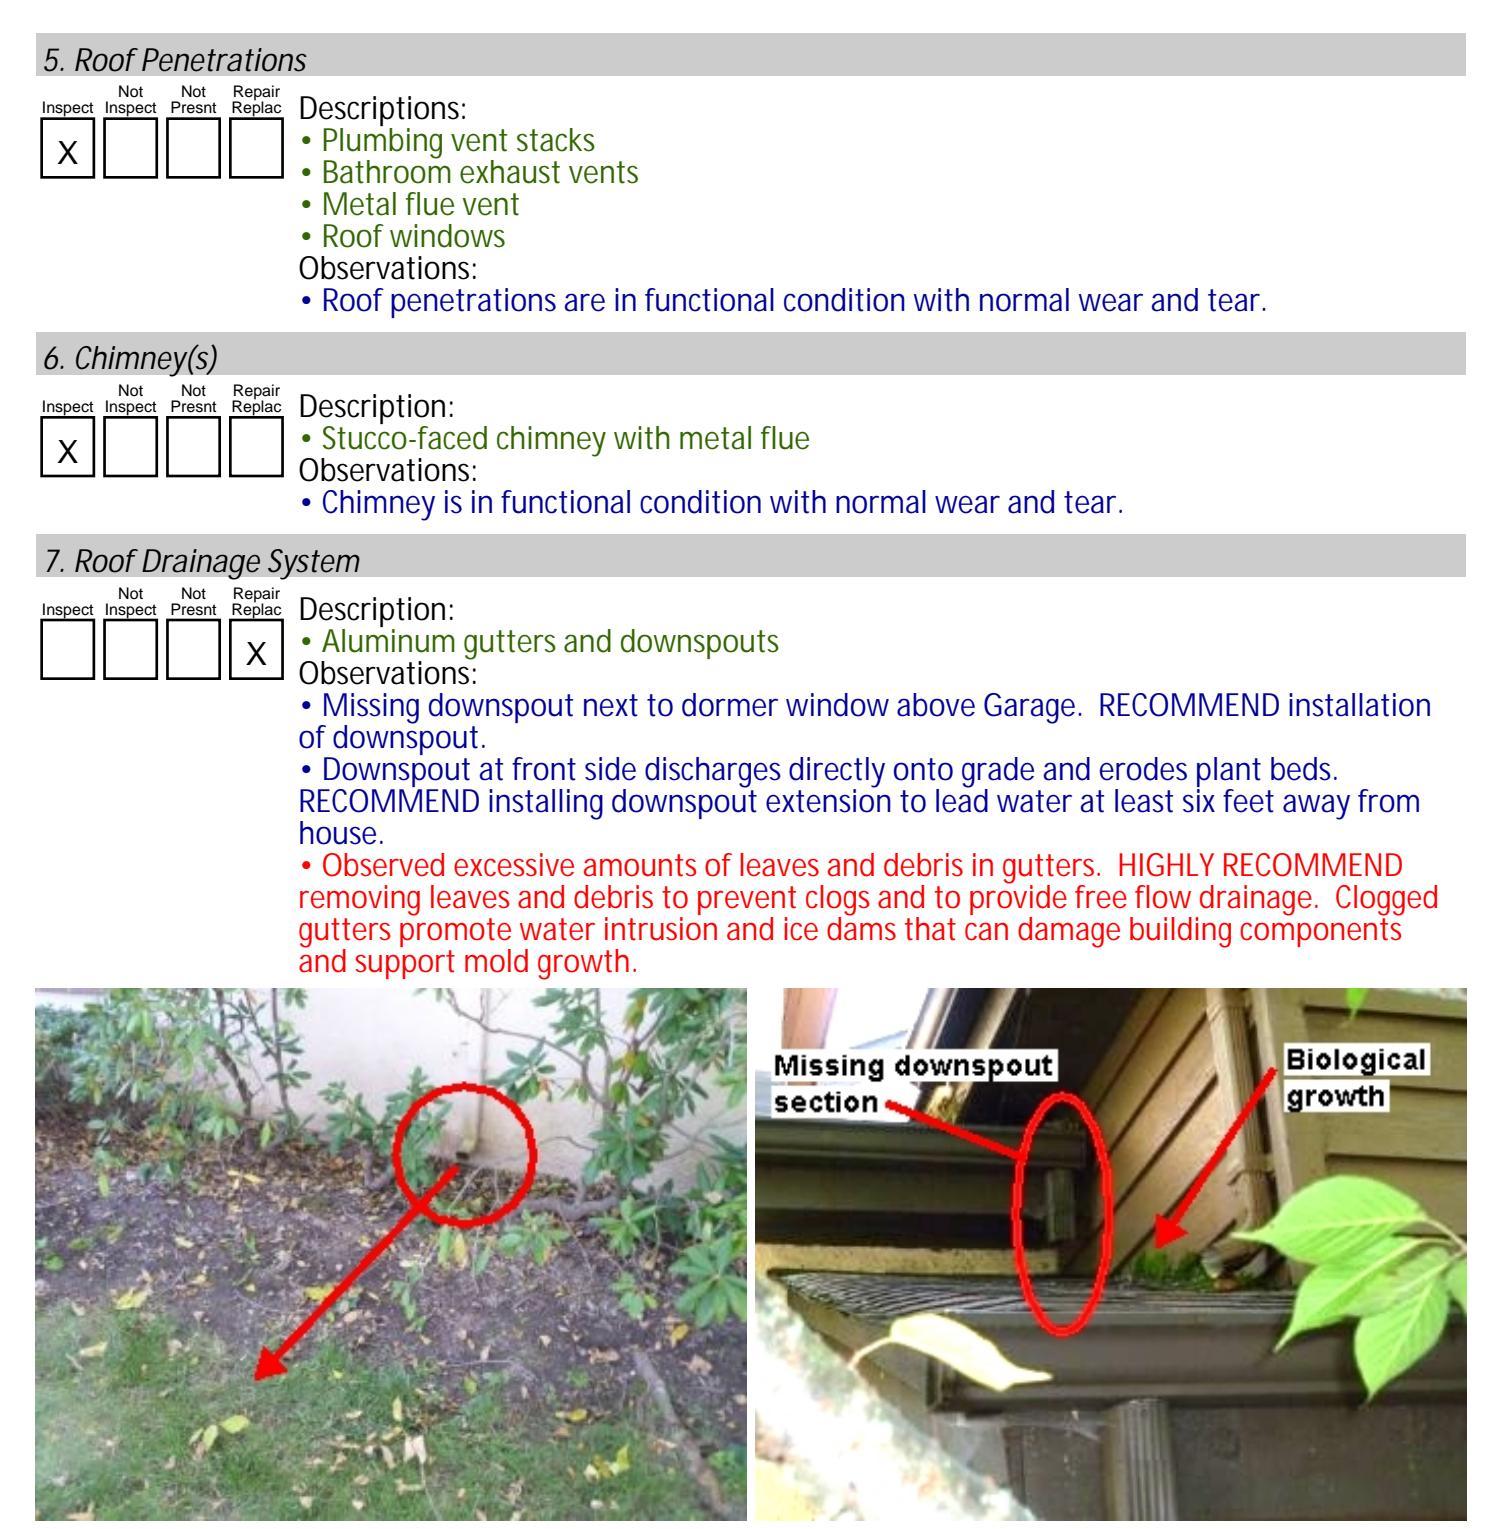
Missing downspout section

Add downspout extension

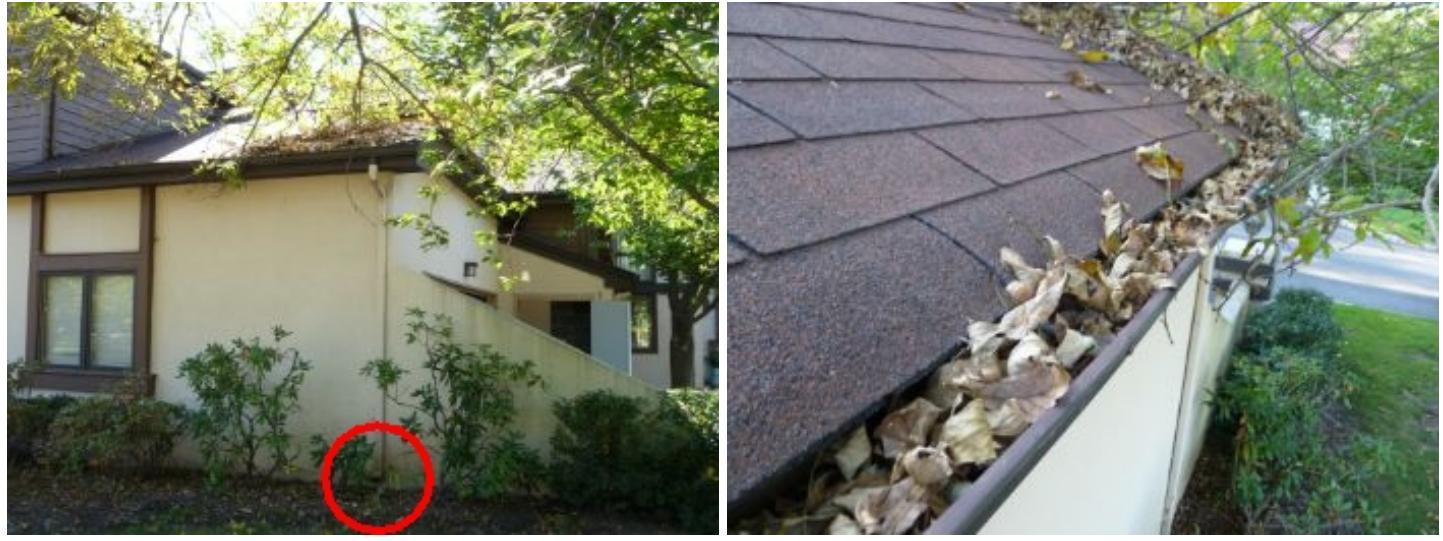
Leaves and debris in gutters

Add downspout extension

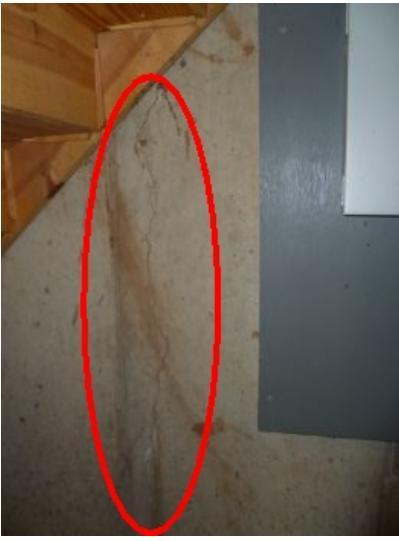
• Observed crack beneath basement stair next to security alarm panel. Crack was less than 1/8" in width at the widest gap. No indications of past or active water intrusion were observed. RECOMMEND monitoring for water intrusion and movement. Contact qualified licensed structural engineer for review and evaluation if future water intrusion and/or movement is evident.

Minor wall crack in foundation wall

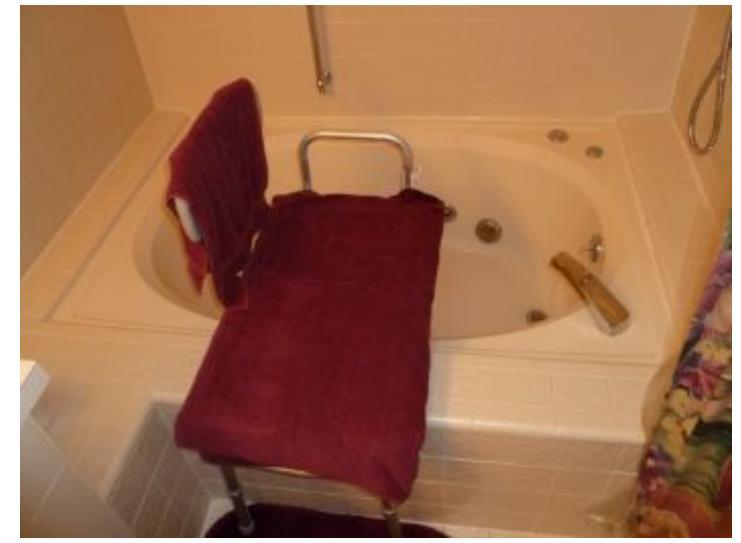
Whirlpool function was not tested due to obstruction in whirlpool tub.

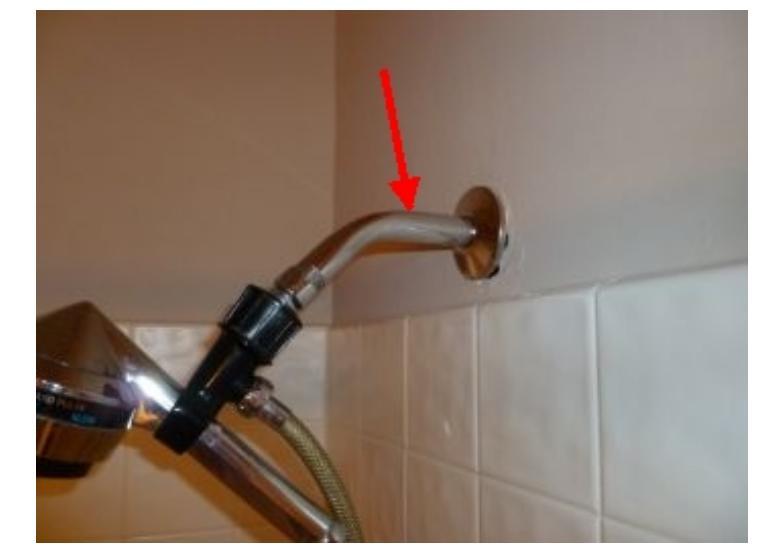
• Showerhead is loose and not secured to wall. RECOMMEND repair to prevent water intrusion to inside of wall and to prevent damage to pipes.

Showerhead not secured to wall

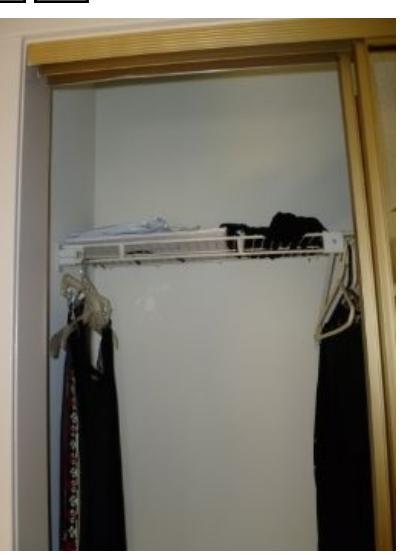
Limited attic access in closet

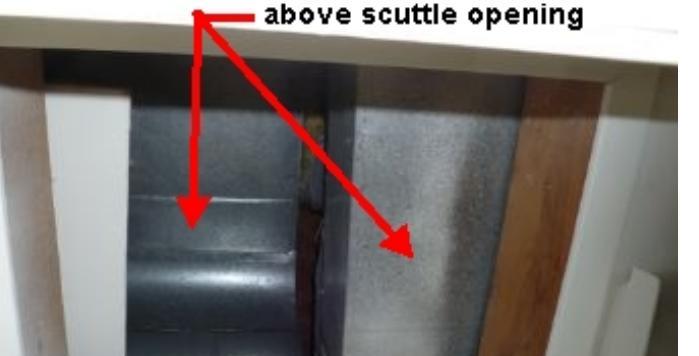
Limited attic access with overhead obstruction

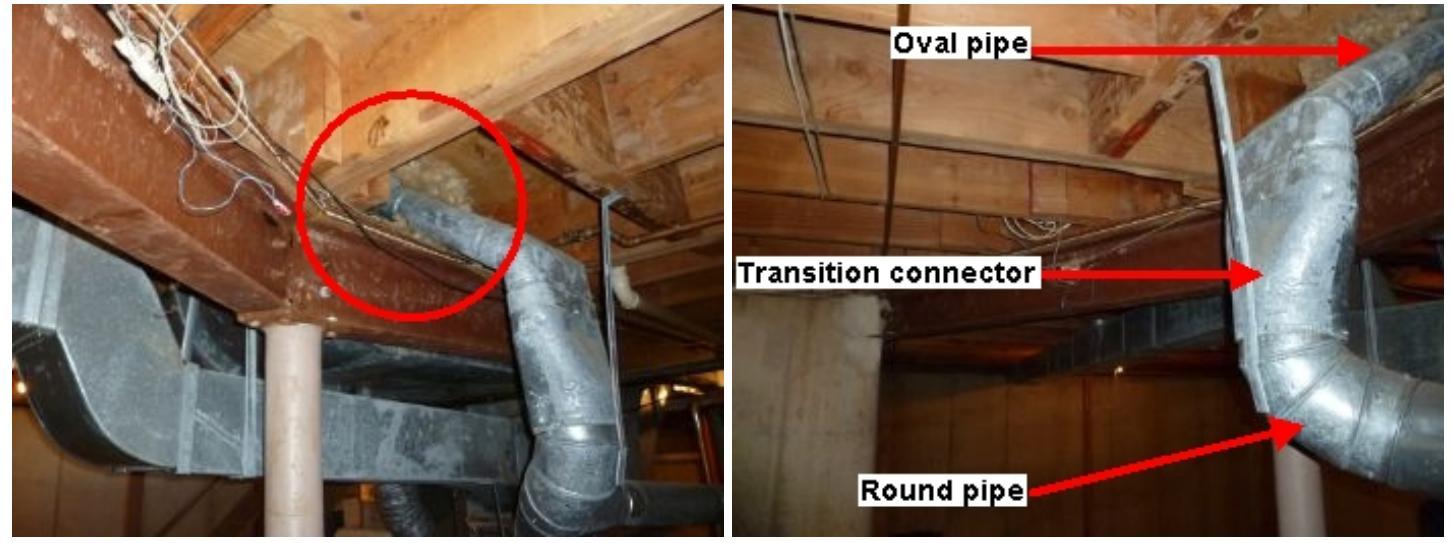
• Observed combined furnace/water heater vent pipe is too close to combustibles and does not meet current safety and fire prevention standards. HIGHLY RECOMMEND further review and evaluation by a qualified licensed HVAC contractor and to remediate deficiencies and defects to minimize fire risk.

• Observed transition connector pipe combining furnace and water heater vents are potentially undersized for safe exhaust of flue gases and efficient operation of appliances. HIGHLY RECOMMEND further review and evaluation by a qualified licensed HVAC contractor and to repair and remediate deficiencies and defects.

Vent pipe too close to combustibles

Review vent pipe sizes

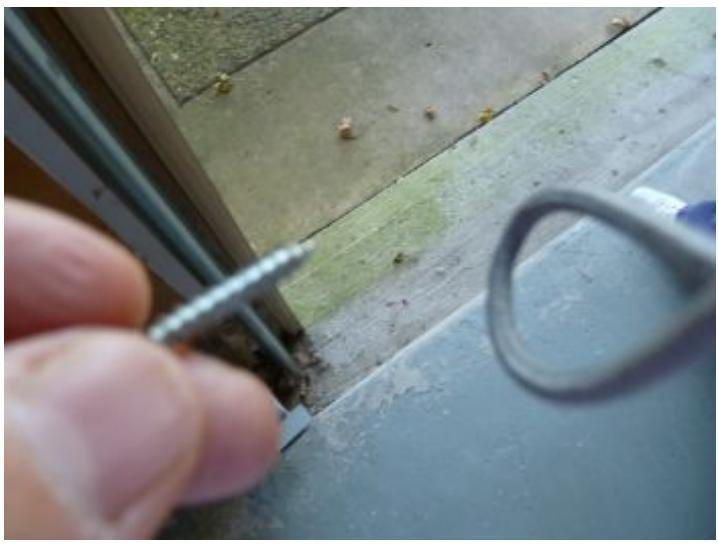
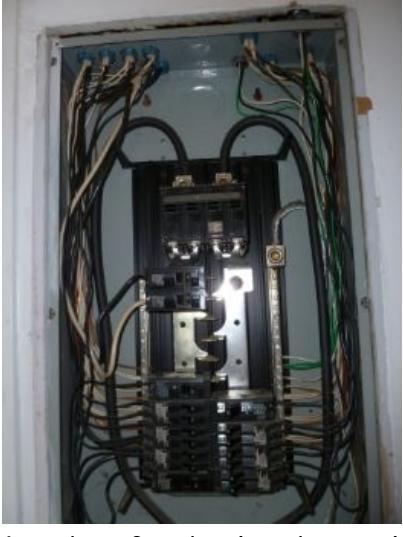
• Observed 3 screws were missing at dead front cover where 6 screws are required. One of the 3 installed screws was pointed and wrong size. Blunt-tip screws are required at electric panels to prevent accidental piercing of wires and cables. HIGHLY RECOMMEND engaging a qualified licensed electrical contractor to install proper screws.

Dointed scrow found at doad front cover

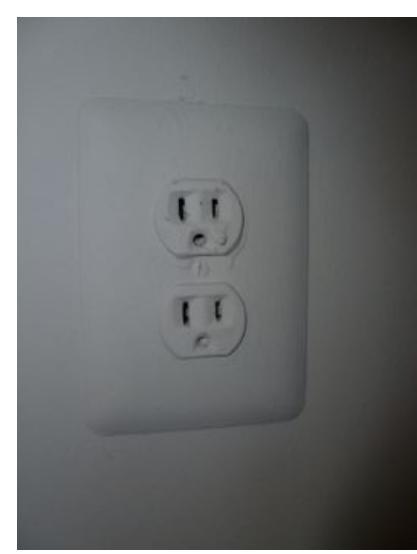
Outlet in Bedroom #2 blocked by paint
