PRIME Building Inspections

Home Inspection Report

123 Main Street, Anytown NJ, 01234
Inspection prepared for: John and Jane Doe
Inspection Date: 12/30/2011 Time: 1:00pm - 4:00pm
Age: 51 years (Built 1960) Size: approximately 2,007 square feet
Weather: 49 degrees. Sunny

Inspection No. SCsample1
Date of Report: January 2, 2012

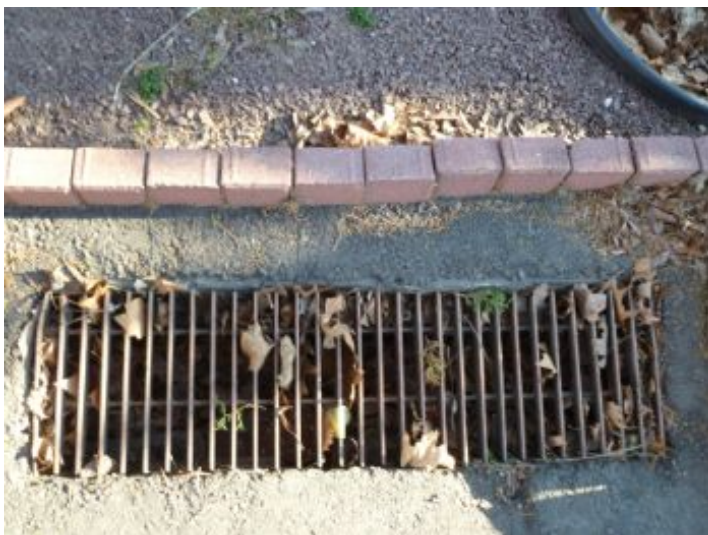
- Grading and surface drainage is generally away from foundation at most areas.
- Raised grade at retaining wall is moderately grade away from house towards east.
- Observed both area drains were filled with leaves and debris that clog and impede storm drainage. RECOMMEND removing leaves and debris.

Area drain at driveway filled with leaves/debris

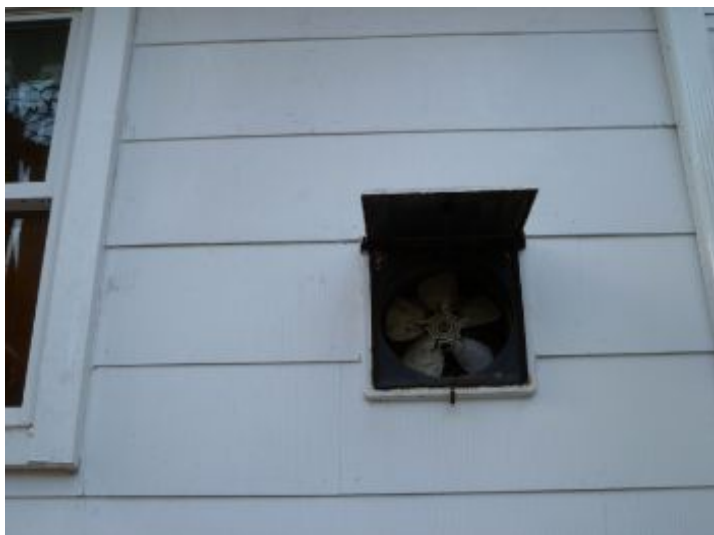
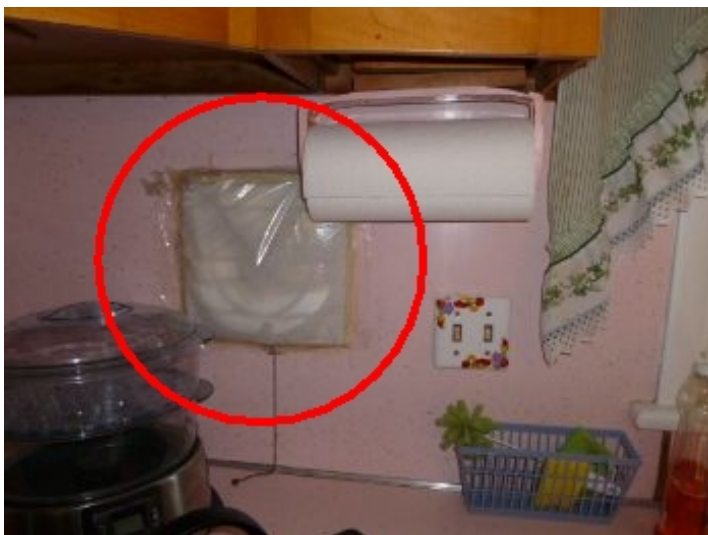
- Vented to exterior
- Not tested because unit was covered with plastic. Exterior cover was opened and exposed to weather.

Kitchen exhaust fan

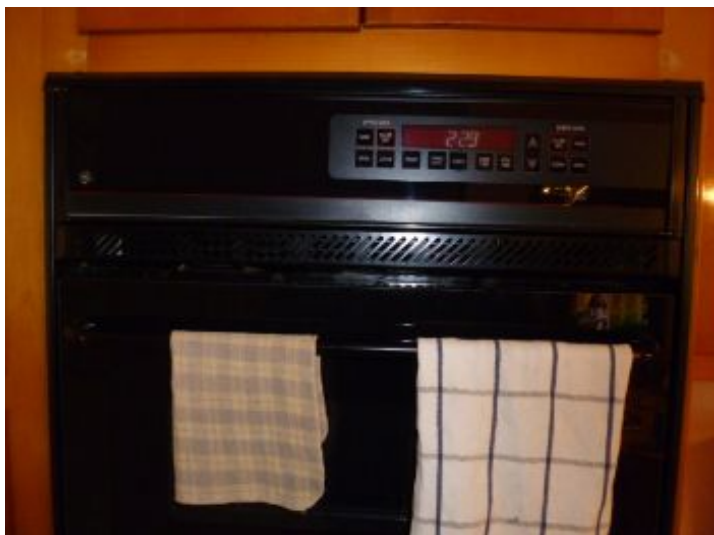
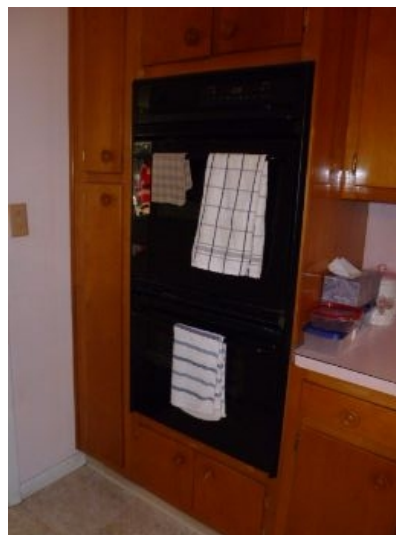
- Upper oven was tested and functioned.
- Lower oven was not tested because it was filled with cookware. Seller informed Buyer and Inspector that heating element was defective. RECOMMEND repair by a qualified appliance repair technician.

Double wall ovens

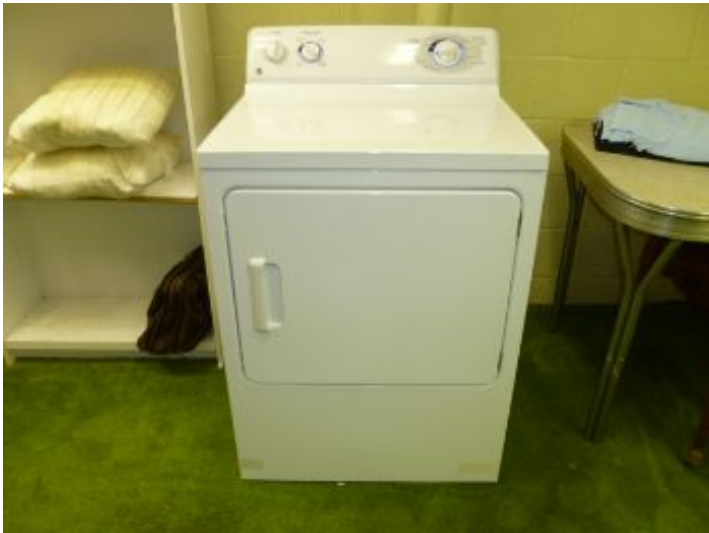
- Dedicated 220 volt electric receptacle outlet box was not permanently secured to wall. Current electrical and jurisdictional standards require permanent installation of outlet box. RECOMMEND engaging a qualified electrical contractor to provide permanent installation of outlet box.

Clothes dryer

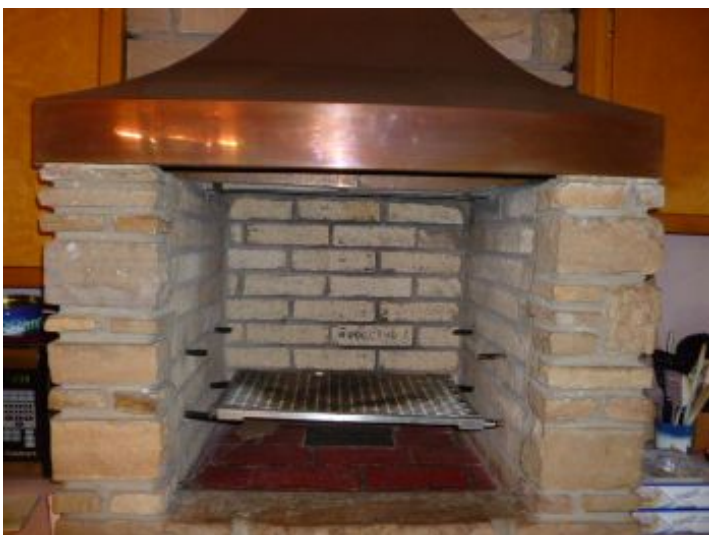
Page 31 Item: 11	Other Components	<ul style="list-style-type: none"> • Observed kraft-faced batt insulation was stuffed into flue opening of built-in oven/grille. HIGHLY RECOMMEND immediate removal to prevent accidental fire during use.
<i>Plumbing</i>

- RECOMMEND having flue and damper cleaned and inspected by a qualified and experienced chimney sweep before use.
- Observed kraft-faced batt insulation was stuffed into flue opening of built-in oven/grille. HIGHLY RECOMMEND immediate removal to prevent accidental fire during use.

Built-in wood fire grill/oven

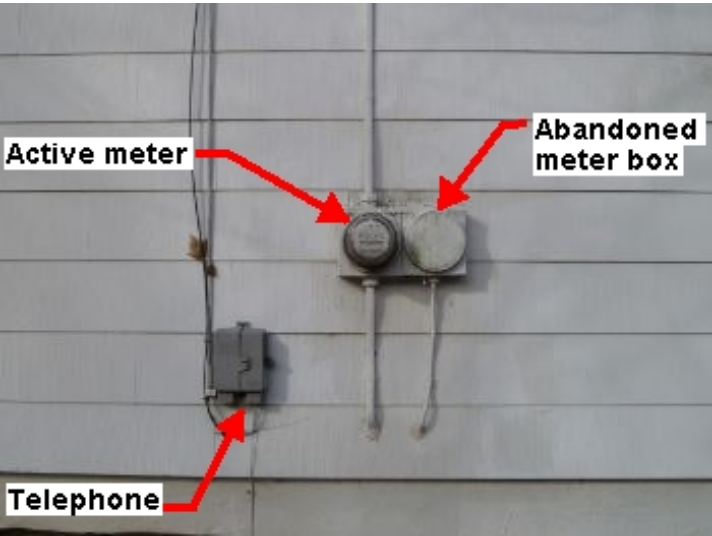
- Description:
- Overhead service with meter located on east side of house.
- Observations:
- Service entrance cables are touching trees, RECOMMEND review by the local Utility Company for repair as necessary.
 - Observed a double electric meter box with one active electric meter. This is an indication of two previous electric services entering the house in the past.

Double electric meter box

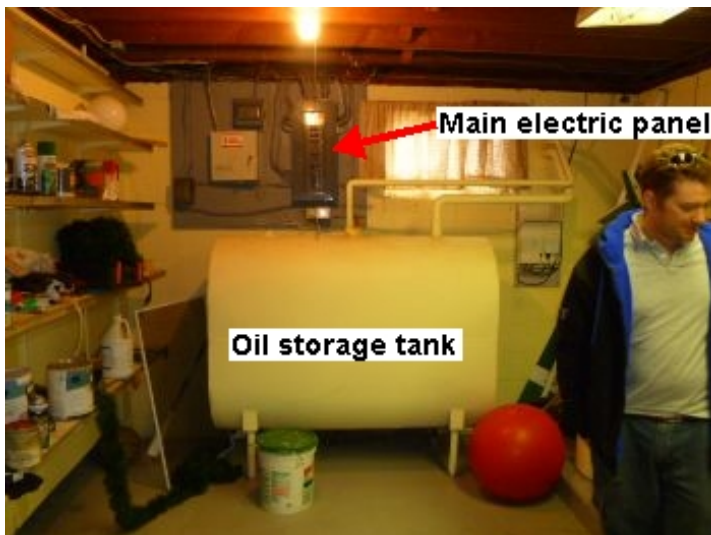
- Deadfront cover of main electric panel was not removed for internal inspection because of unsafe excessive height of panel. Electrical industry and jurisdictional standards require electric panels to be installed no higher than 80" from the floor for safe access and working space. RECOMMEND relocation of panel to a lower area to comply with current electrical standards and jurisdictional requirements.

- Circuits were not labeled and a directory was not available.

Main service panel and obstructions

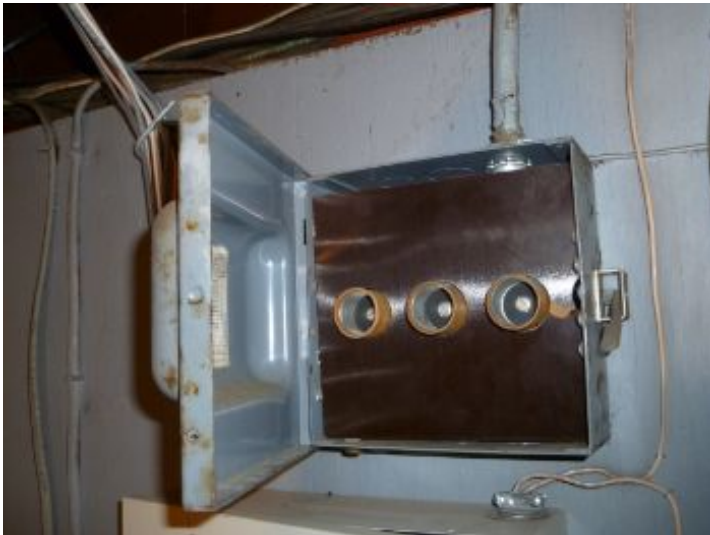
Abandoned secondary electric service panel

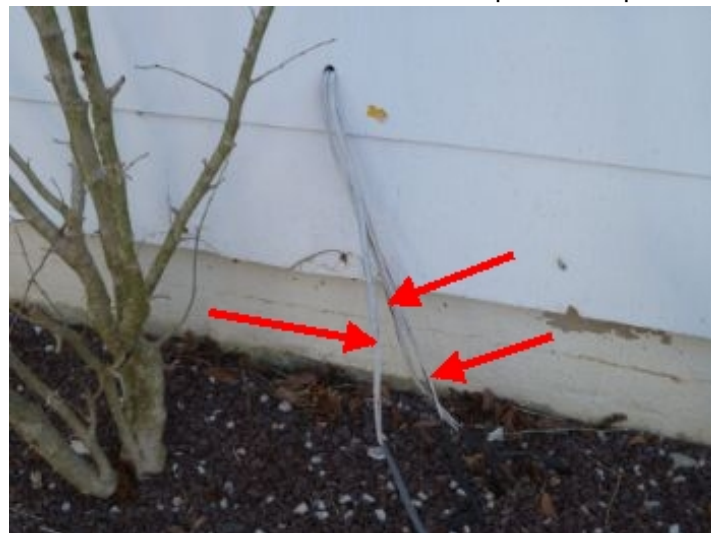
- Observed several exposed/unprotected electric cables on the exterior side and extended underground. The cables are subject to degradation by weather exposure, damage by tools and equipment, and are not moisture-resistant. This installation does not comply with electrical industry and jurisdictional standards. RECOMMEND engaging a qualified licensed electrical contractor to remove and replace of these cables with materials and installations that comply with jurisdictional requirements for personal safety protection.

Exposed/unprotected cables on exterior and underground
