PRIME Building Inspections

Home Inspection Report

999 Main Street, Anytown NJ, 01234
Inspection prepared for: John and Jane Doe
Inspection Date: 8/27/2011 Time: 11:00am - 4:00pm
Age: 1950 (61 years) Size: approximately 4,700 sq.ft.
Weather: 76 degrees. Rain

Inspection No. SCsample3
Report Date: August 30, 2011

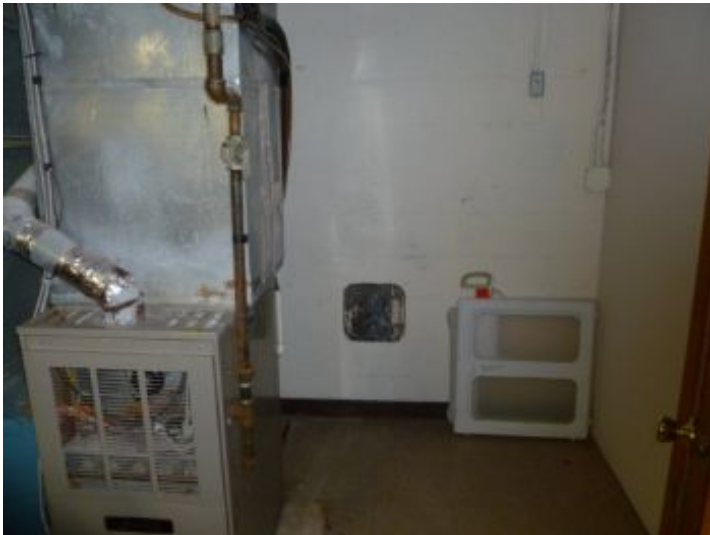
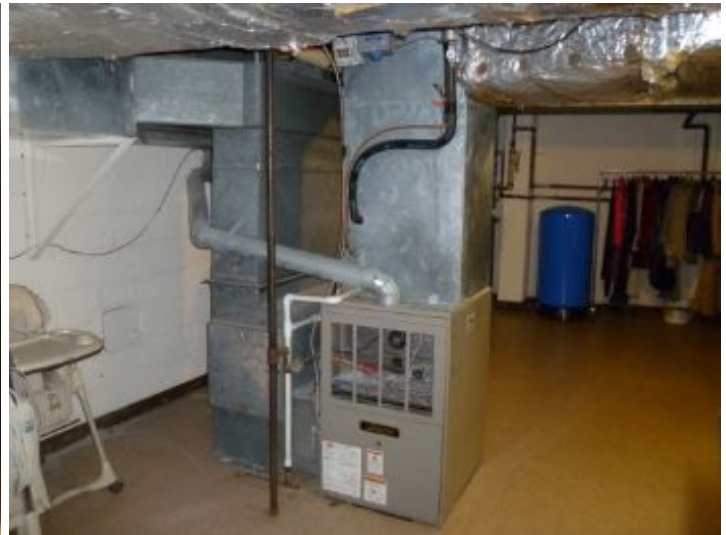
- Zone #1 Heating system is in functional condition with normal wear and tear. RECOMMEND engaging a qualified and licensed HVAC contractor for further evaluation and to perform a full system tune-up and any required repairs or replacements for safe operation and proper function.
- Zone #2 Heating system is in fair functional condition with visible indications of rust. RECOMMEND engaging a qualified and licensed HVAC contractor for further evaluation and to perform full system tune-up and any required repairs or replacements for safe operation and proper function.
- Detached Garage Heating system is in good functional condition with no major visible damage or material defects.

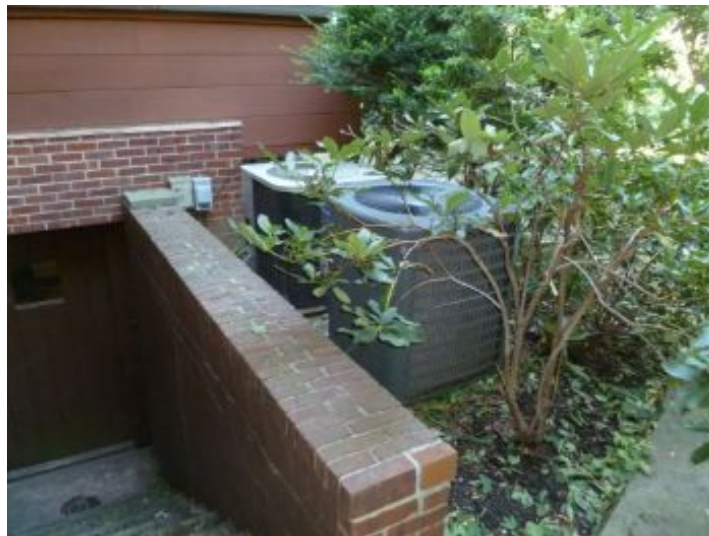
- Cooling system is in functional condition with normal wear and tear.

Exterior condenser/compressor units

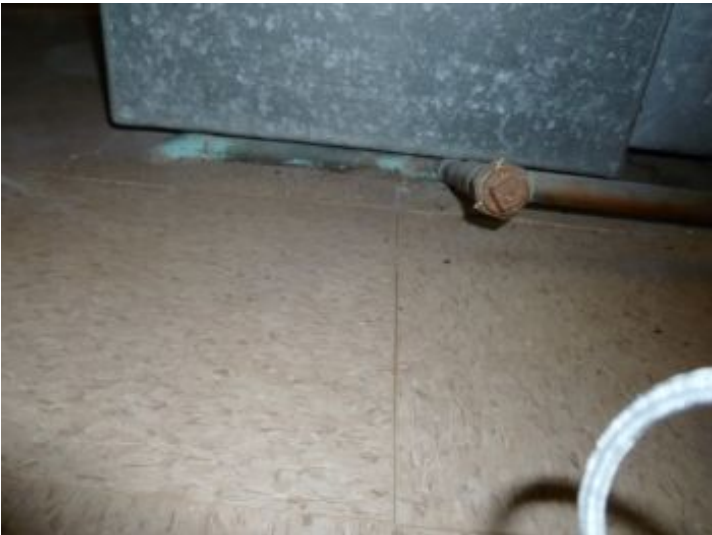
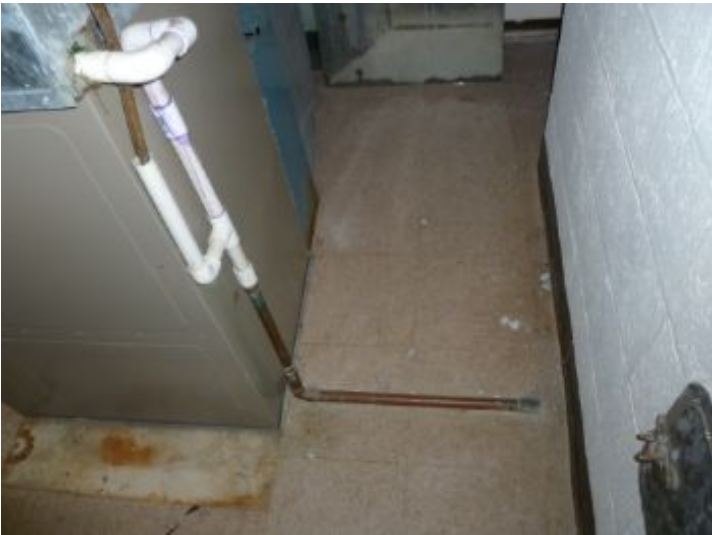
- Condensate drain is connected to an undetermined drain directly below concrete floor. Where visible for inspection, drain components are in functional condition.

Connected below slab

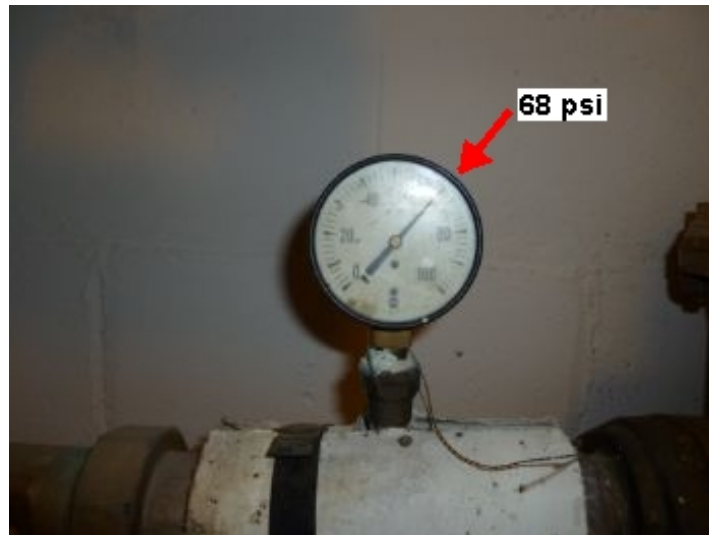
68 psi

- Water flow and pressure were observed to be adequate.

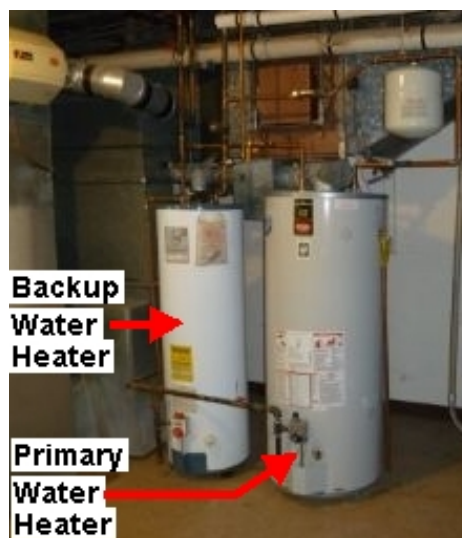
- Water heaters are in functional condition with no major visible damage or material defects.
- RECOMMEND engaging a qualified and licensed plumbing contractor to evaluate and assess tandem installation of both water heaters for safe, code-compliant and functional operation.

Double water heaters

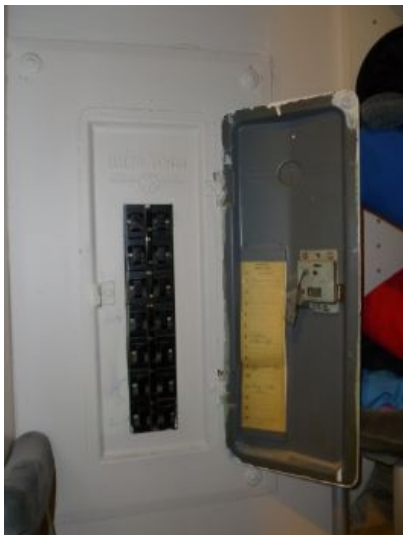
Sub-Panel in Walk-in Closet at Master Bathroom #1

- Due to the numerous sub-panels and complex electrical system, a full inspection of the electrical system would be too exhaustive and outside the scope of this general home inspection. RECOMMEND engaging a qualified and licensed electrical contractor to perform a complete inspection and detailed evaluation of the entire electrical system, with recommendations for any adjustments, repairs, replacements and upgrades as appropriate for safe occupancy, compliance with codes and functional operations.
- Open slot at disconnect box on Zone 2 Furnace. RECOMMEND installing blank slot cover to safeguard against accidental contact with electricity.

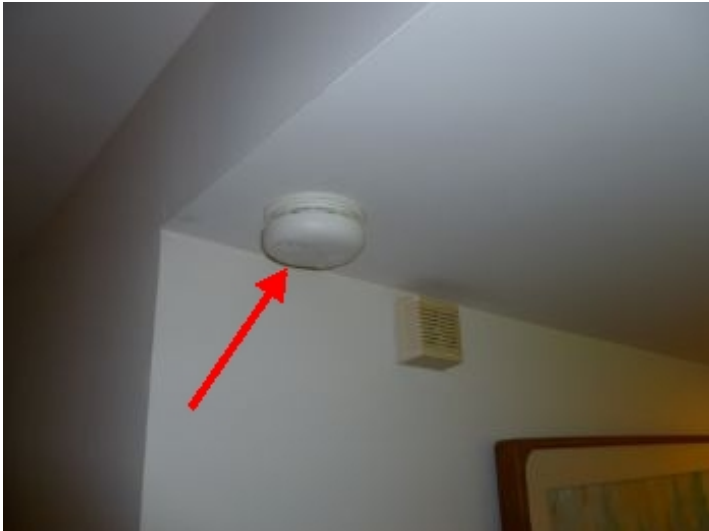
Smoke Detector outside Bedroom #2

- Smoke detectors were tested by pressing "test" button on unit to check for battery capability or AC function; and by using "Smoke Check" to simulate fire smoke.
- Smoke detector in the Kitchen was not tested. Seller advised that battery was removed due to annoyance with constant alarms caused by cooking smoke. RECOMMEND relocating smoke detector unit to a different location within the same vicinity and installing battery to restore smoke detector function for safety.
- Smoke detector installed at the peak of the Entrance Foyer was not tested due to unreachable height.
- Except one AC-powered smoke detector connected to central alarm monitoring service that is located above the East Stair outside Bedroom #4, other AC-powered smoke detectors connected to the central alarm monitoring service were not tested at Seller's direction.

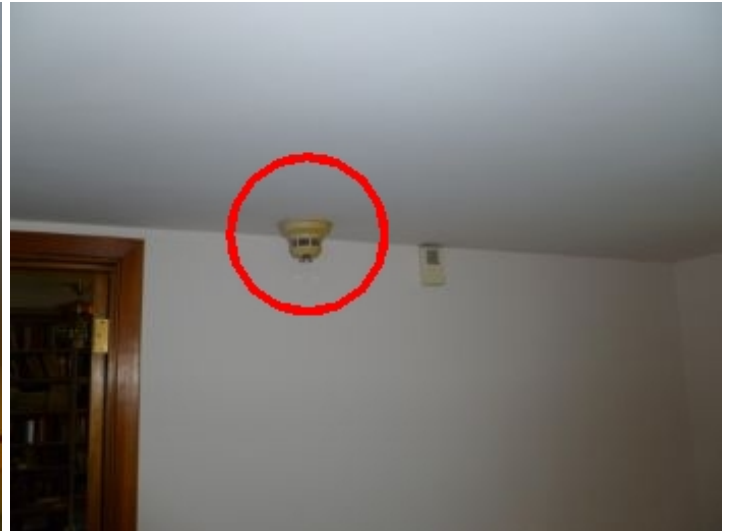
AC-powered Smoke Detector connected to central alarm monitoring service

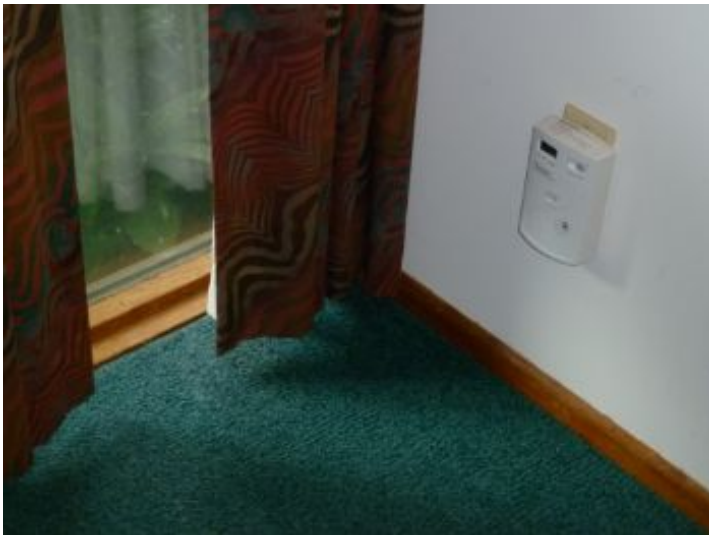
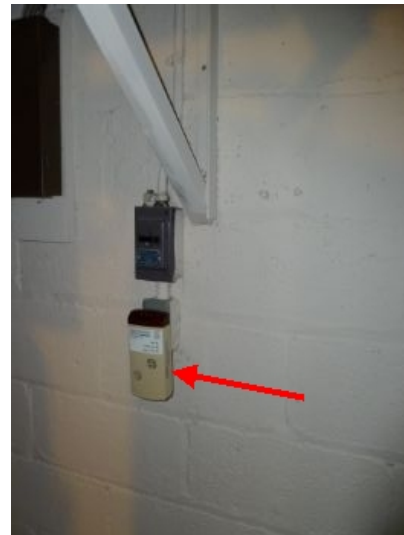
- Carbon monoxide detectors are in functional condition with no major visible damage or material defects.
- **SAFETY CONCERN: HIGHLY RECOMMEND** installing an AC-powered with battery backup Carbon Monoxide detector with an audible alarm inside or within close proximity of all Bedrooms and other sleeping areas.

CO Detector at Level 4

CO Detector behind water heaters
