PRIME Building Inspections Home Inspection Report

888 Main Street, Anytown NJ, 01234 Inspection prepared for: John and Jane Doe Inspection Date: 10/10/2011 Time: 1:30pm - 4:00pm Age: 24 years (Built 1987) Size: Approx 1,800 sf Weather: Sunny. Approx 82 degrees

> Inspection No. SCsample4 Date of Report: October 11, 2011

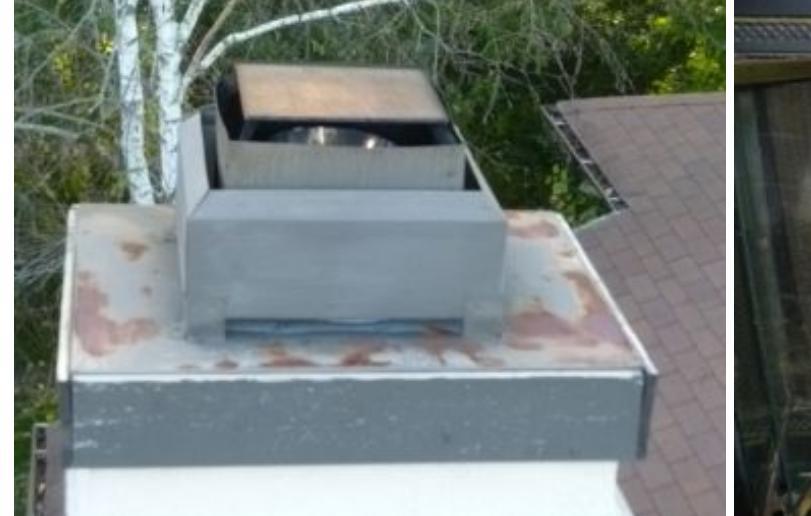
Fireplace chimney cap

- Replac Description:
 - Prefabricated wood-burning fireplace with metal chimney flue
 - Located in Living Room
 - Observations:
 - Fireplace is in functional condition with normal wear and tear.
 - Manual damper was test-operated and functioned normal.
 - Leftover ashes found in fireplace.
 - RECOMMEND engaging a qualified and experienced chimney sweep to inspect and clean chimney flue for safe and efficient operation.

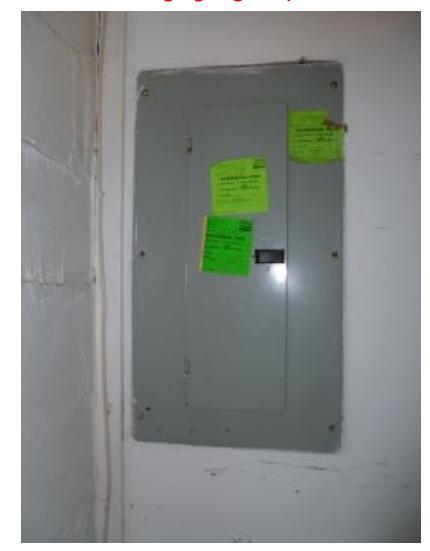
Main electric panel in Garage

• Main panel is in functional condition with normal wear and tear, except as noted below.

• Observed 3 screws were missing at dead front cover where 6 screws are required. One of the 3 installed screws was pointed and wrong size. Blunt-tip screws are required at electric panels to prevent accidental piercing of wires and cables. HIGHLY RECOMMEND engaging a qualified licensed electrical contractor to install proper screws.
